CONDITION STUDY FOR
CURRITUCK COUNTY

**CURRITUCK COUNTY COURTHOUSE
CURRITUCK COUNTY
NORTH CAROLINA**

MARCH 1993

CONDITION STUDY
FOR THE
RENOVATION AND REPAIR OF THE
ORIGINAL CURRITUCK COUNTY COURTHOUSE

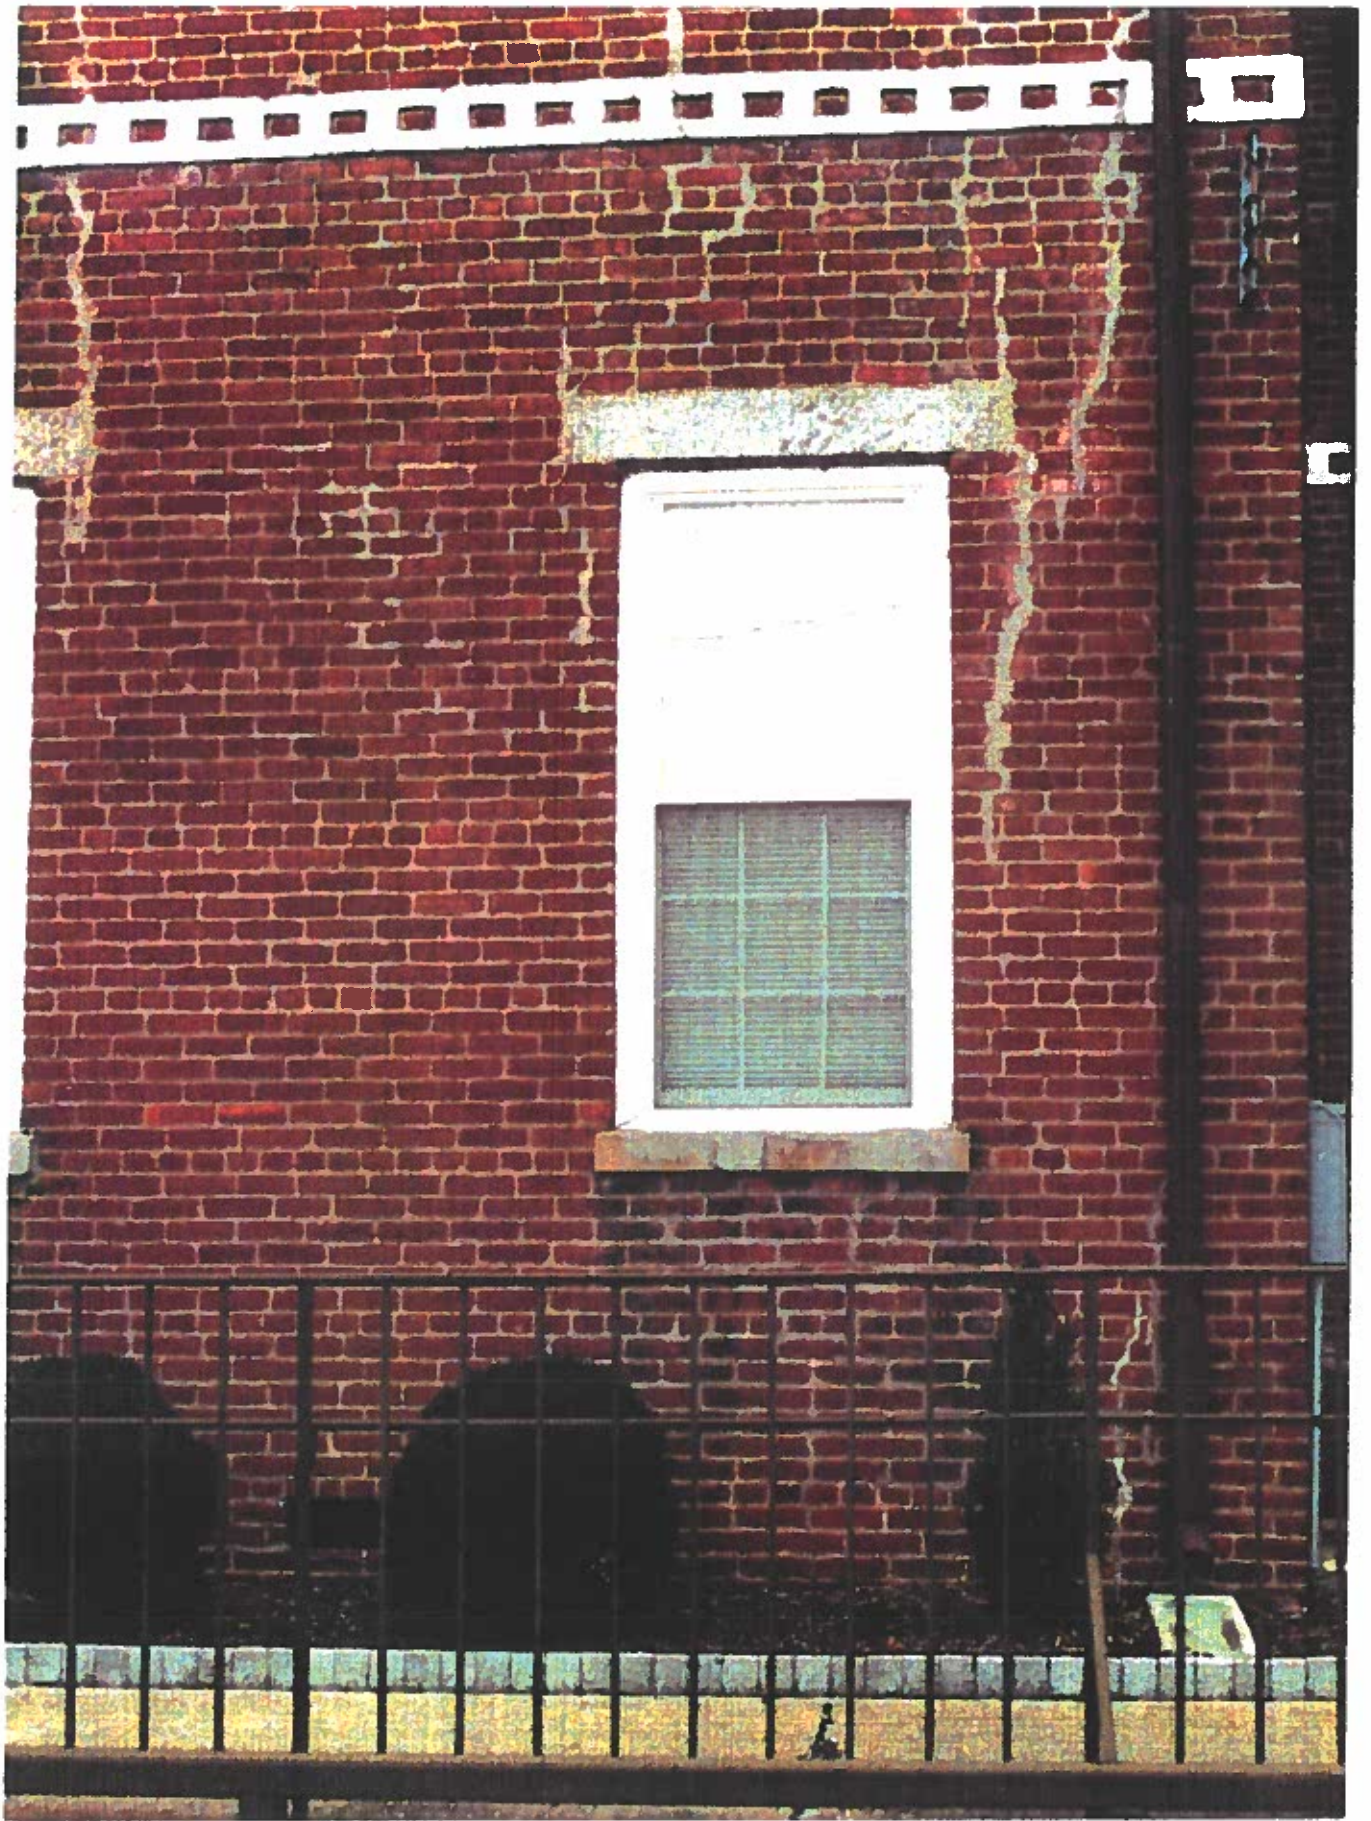
Exterior brick work on the south-east side is exposed to prevailing winds from Currituck Sound and shows evidence of weathering. Vertical lines of stress around windows on the eastern portion of the structure have been filled with mortar and are unsightly. The masonry cracks can be tuck-pointed with mortar of a matching color, or the cracked bricks can be removed and replaced with new bricks although matching will be difficult and will require skilled masons.

MASONRY CONDITIONS AT EAST ELEVATION

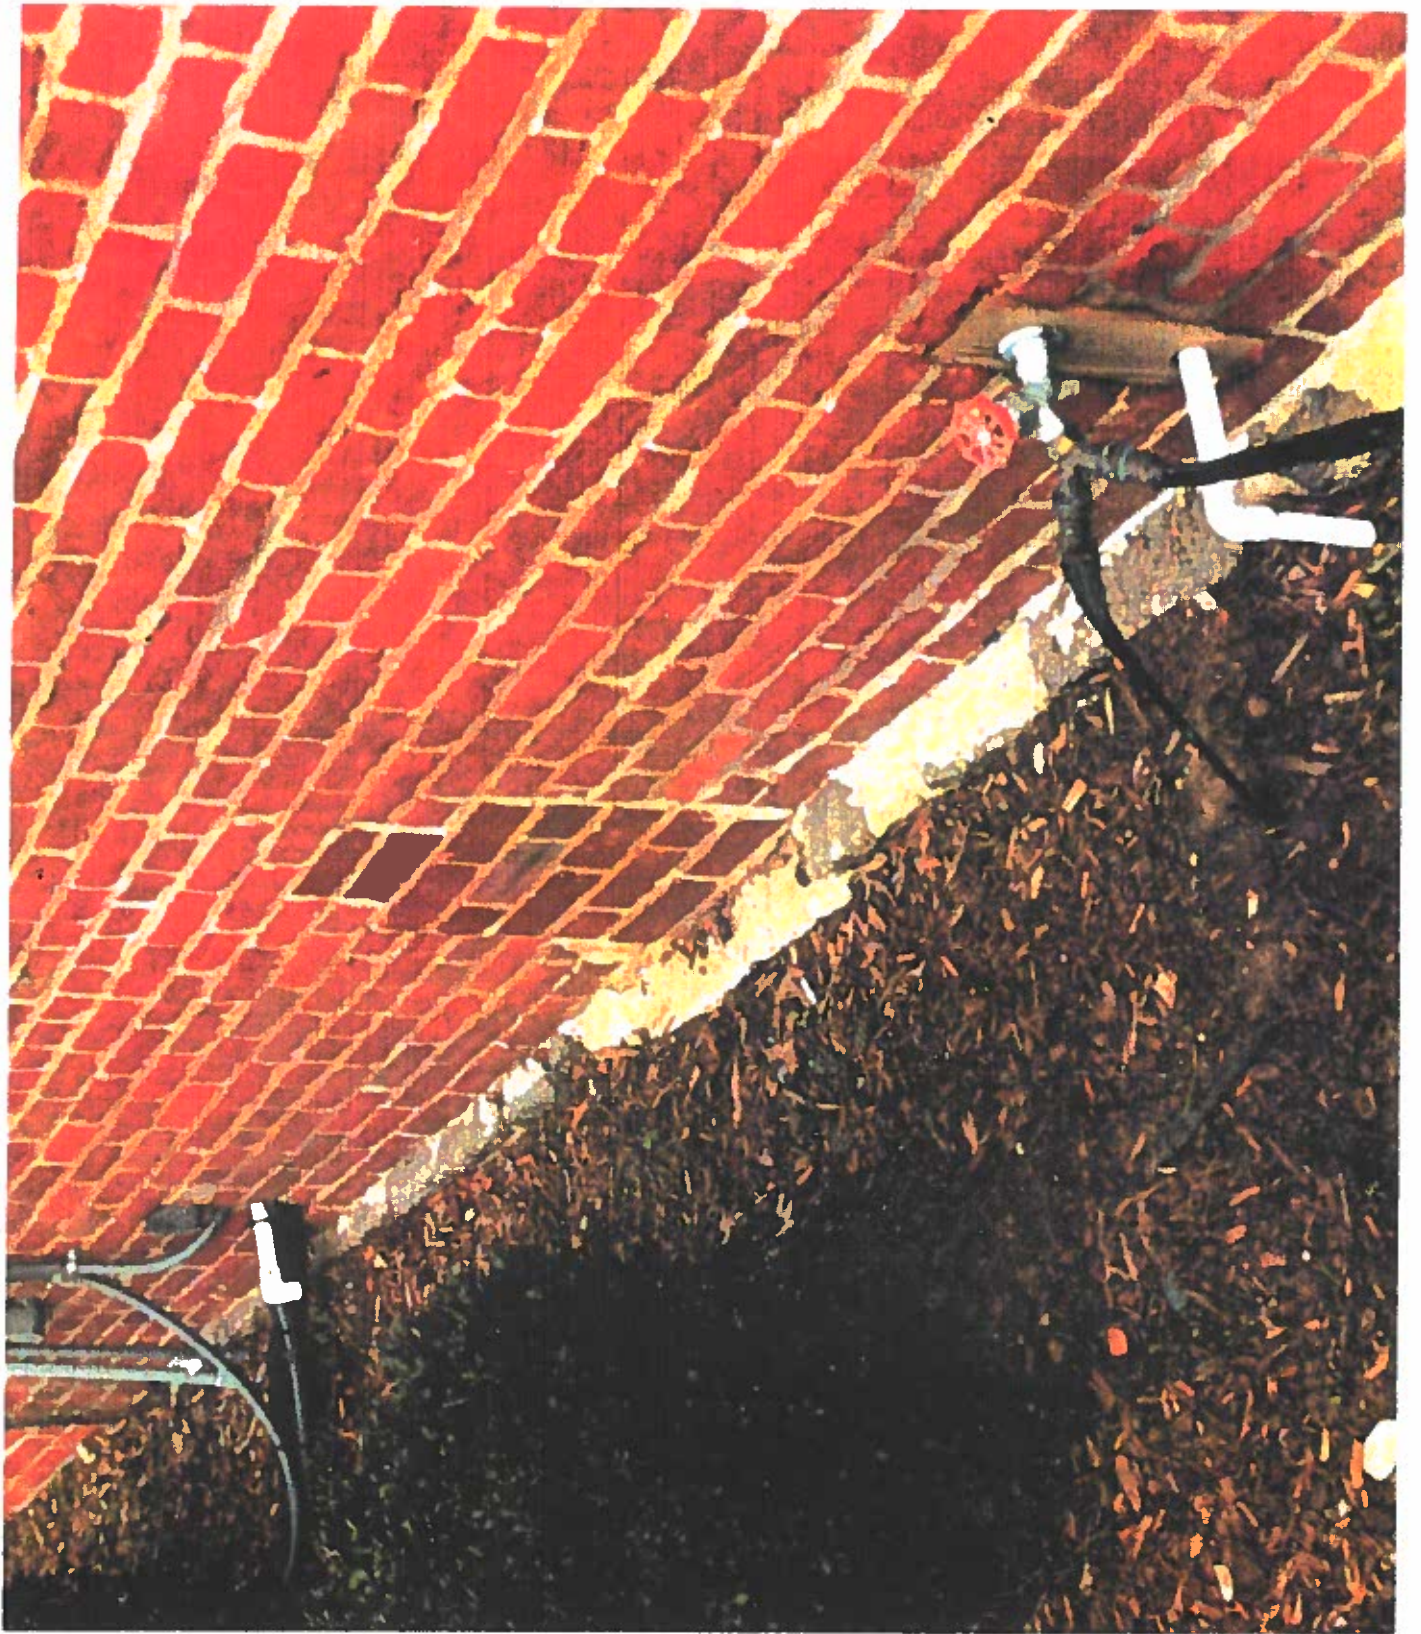
MASONRY REPAIRS

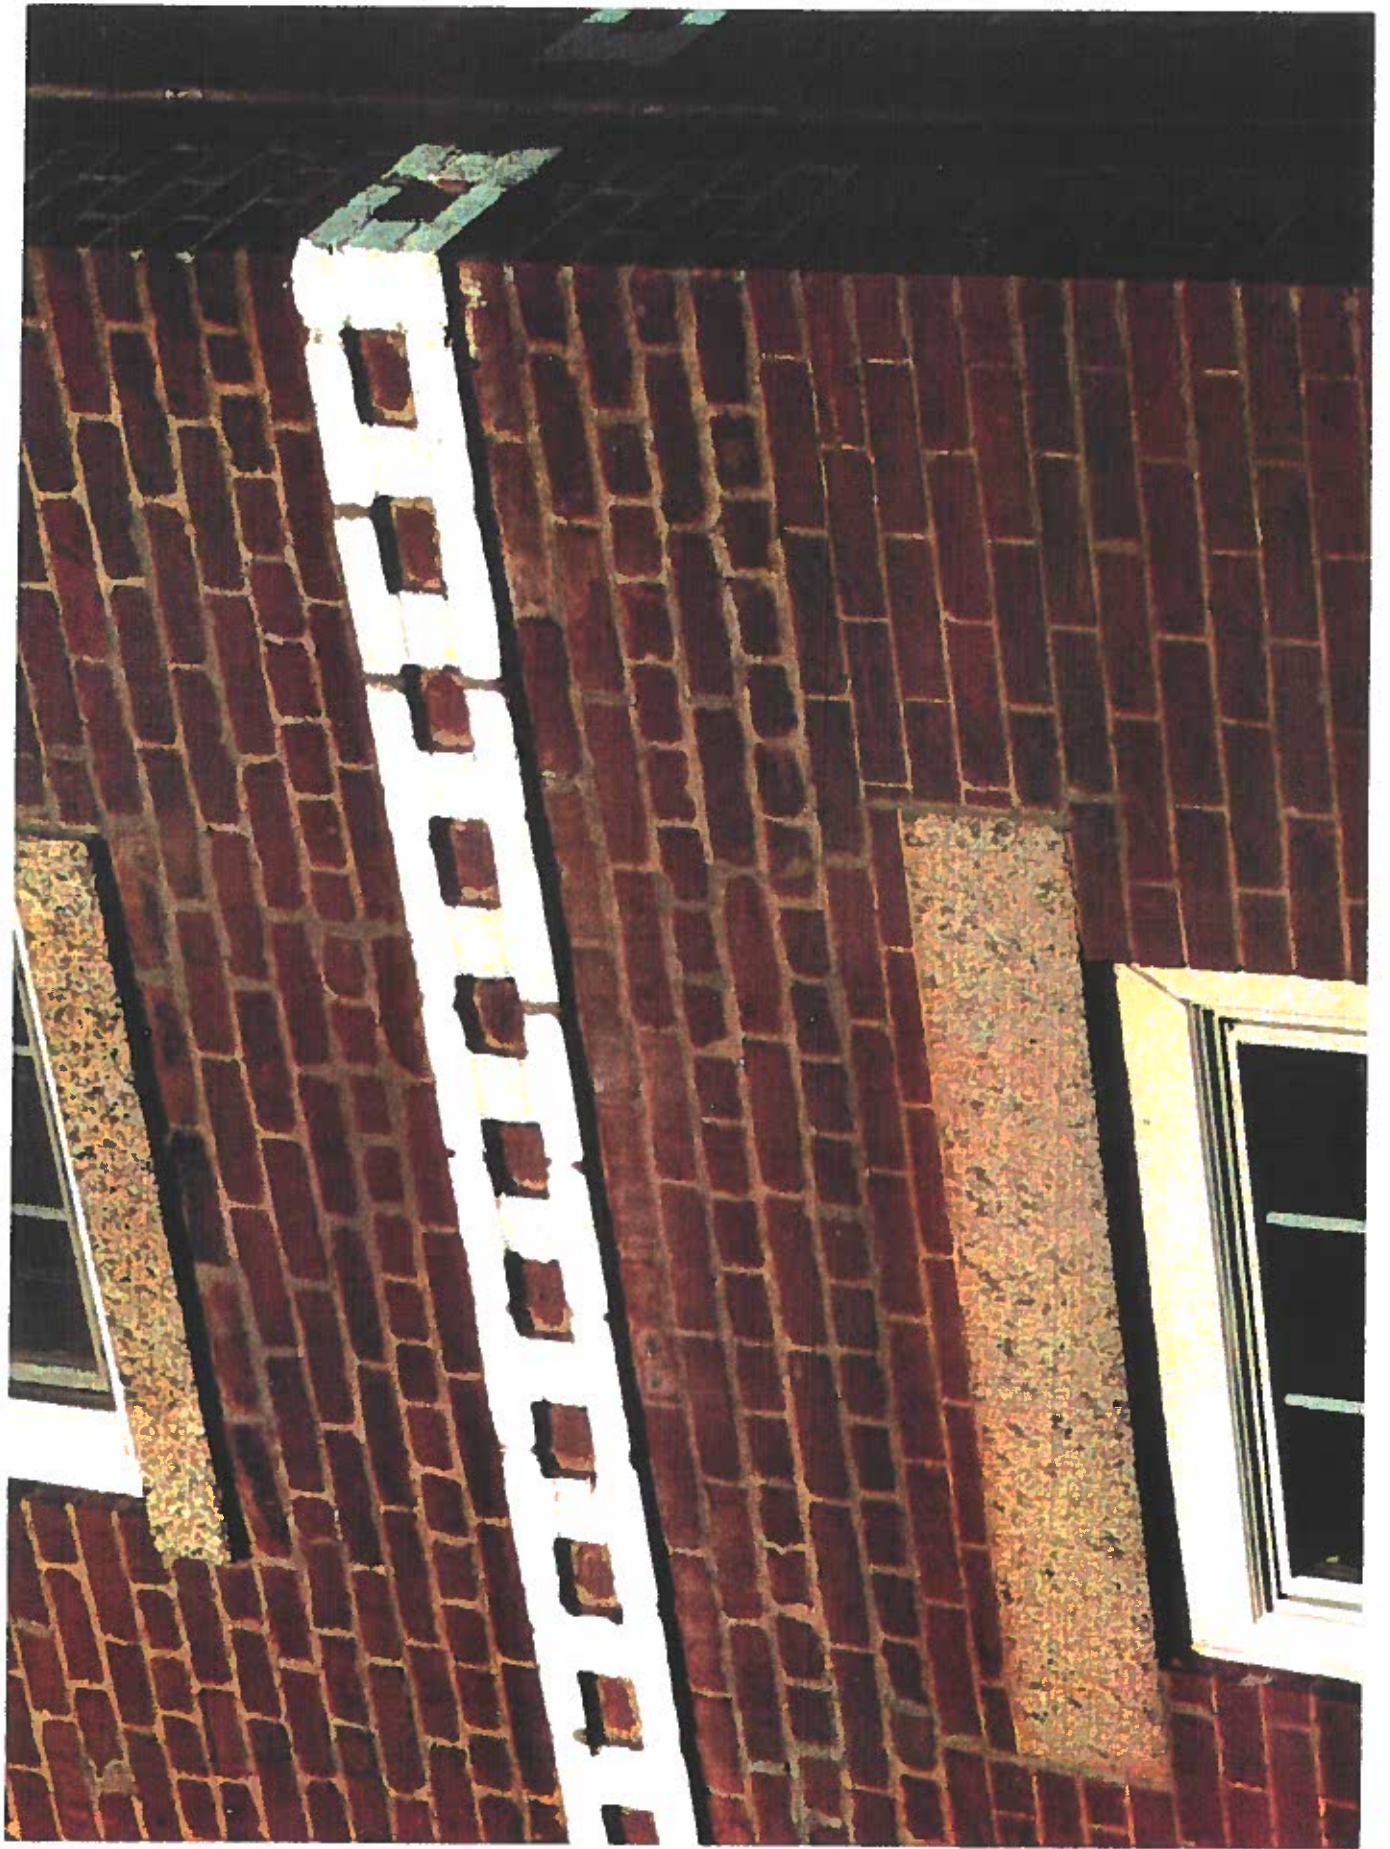
The decorative white paint on the brick courses at the second floor and window head level should be considered. If the white decoration has historical significance or sentimental value it could remain, of course. Another solution: extend the painted band around the 1952 and 1989 additions.

TRIM BAND

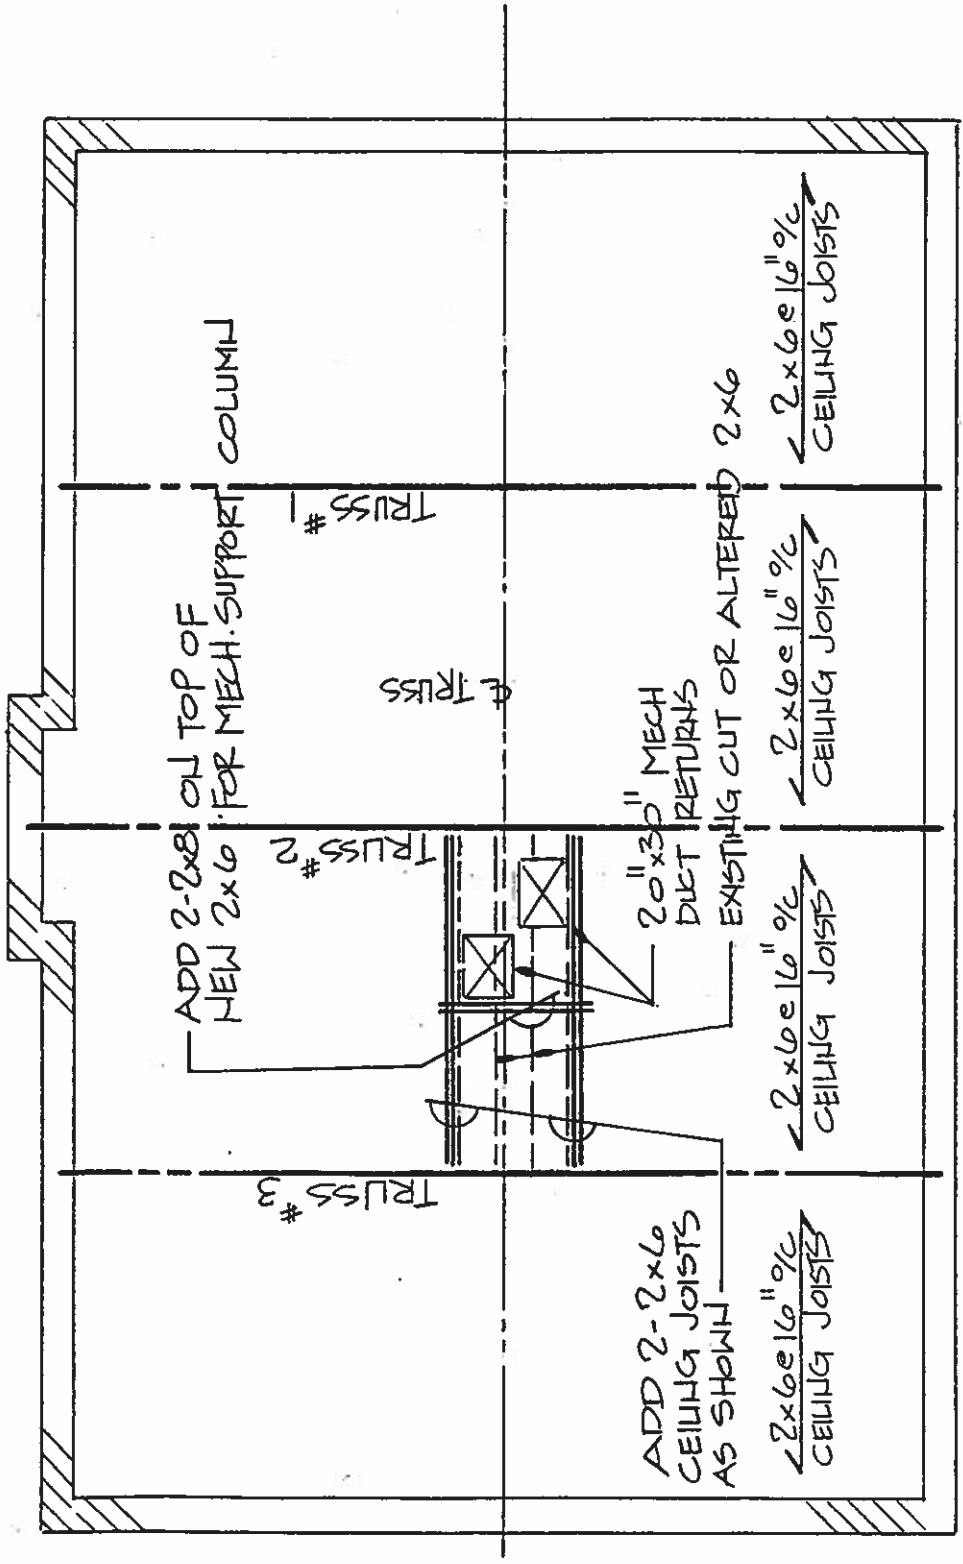
SKETCH SHEET SK-1

In the area of the duct work shown in photographs #9 and #10 there appears to be some deflection of the plastered ceiling. In our opinion this is occurring because the weight of the mechanical units above is supported on ceiling joist that have been altered or cut completely to accommodate the ducts shown in photograph #10. Photograph #9 shows a ceiling joist that was cut ceiling joist. This condition can be corrected by adding ceiling joists and bridging the cut joist with 2-2 x 8 joist or by supporting the mechanical units from the top chords of the trusses. See "Partial Plan" on sheet SK-1 for details of bridging the cut ceiling joist.

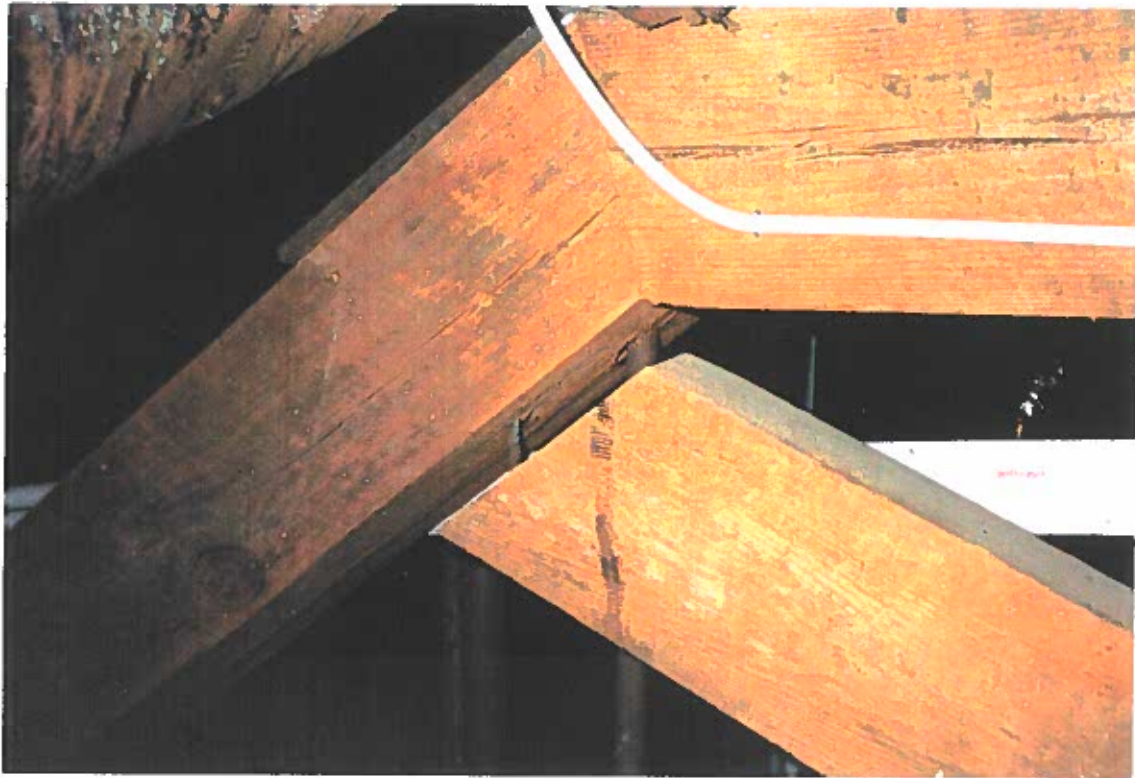
PHOTOGRAPH #1

The trusses overall are in excellent condition considering their age. There is some checking or splitting in the top chord and diagonals. Checking occurs because of the volume change in the wood members as the wood loses its moisture. Since the checking occurs in members which are axially loaded and the actual stresses in these members is less than half the allowable, it is our opinion that the checking in these members is not detrimental to the load carrying capacity of the trusses and therefore we do not recommend any repairs to the checks. Examples of the checking described above can be seen in photographs #1, #2, and #6.

Some of the diagonals adjoining the top and bottom chords have separated as much as 1-1/2". We recommend that the separations be closed in all conditions on all three trusses if the separation exceeds 1/4" and repairs be made to all diagonals at the top and bottom chords on all trusses in accordance with Details 1, 2, 3, and 4 on sketch sheets SK-3, SK-4, SK-5, and SK-6 respectively. See paragraph #1 for an example of the separation between the diagonal and the top chord.
