### **ENGINEERING REPORT**

THE GABLES SUBDIVISION

**COMMON AREA TURNOVER**

September 1, 2023

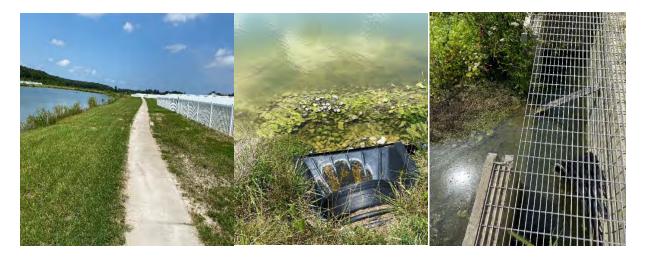
27. View of pond 1 from northwest.

28. Culvert entering Phase 1 pond.

29. Outlet control structure at Phase 1 pond.

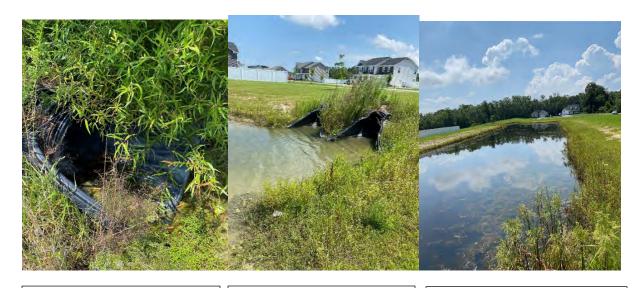
30. Culvert inlet to Phase 1 by Gables Place (needs minor vegetation removal).

31. Double culverts outletting to control structure (Phase 1 pond).

32. View across Phase 2 pond.

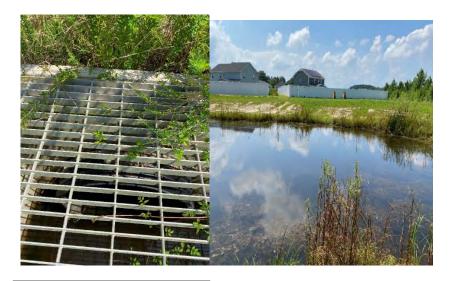
33. Pond 2 outlet control structure.

34. Another view across Phase 2 pond.

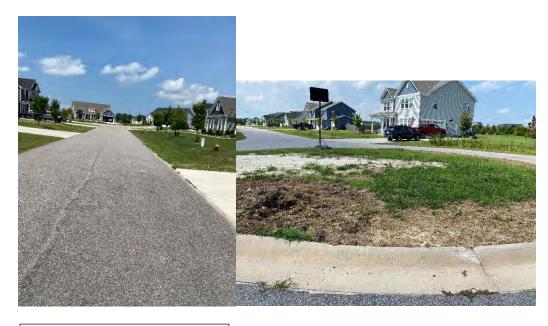
53. Typical view along residential street with street trees.

54. Cul-de-sac at end of Gables Place – curb needs minor repair. (Note: Island is a community association responsibility.)

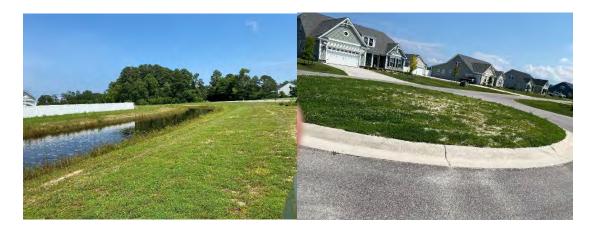
55. Open space between pond 2 and Guinea Road.

56. Cul-de-sac at end of Briton Way (association maintenance responsibility).

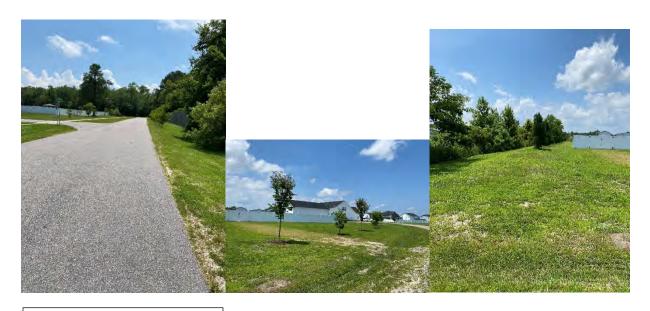
57. Streetscape along Gables Way entrance drive.

58. Streetscape along entrance drive looing north.

59. Berm and buffer to residential development to the south.

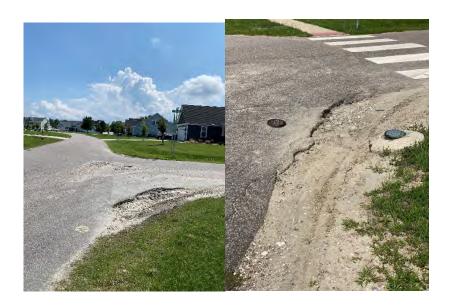
60. Roadway repair needed at the intersection of Gables Place and Artisan Way.

61. Roadway repair is needed at the intersection of Artisan Way and Thayne Dr. Upon completion of the punch list below, it is believed that the common areas and the common facilities serving The Gables are ready for turn-over to the Association:

Following completion of two roadway repairs that have been identified, shown in photos 60 and 61, along with a culvert & roadway swale certification, which is in progress, the NC Department of Transportation is expected to accept all roads within The Gables subdivision, Phases 1 and 2. Since these roads will be taken into the State system for maintenance; no roadway allocation is included in the required maintenance fund balance.
