2023 BEACH MONITORING AND BEACH STABILITY
ASSESSMENT
CURRITUCK COUNTY, NORTH CAROLINA

PREPARED FOR
CURRITUCK COUNTY

PREPARED BY
COASTAL PROTECTION ENGINEERING OF NORTH CAROLINA, INC.
ENGINEERING LICENSE CERTIFICATE #: C-2331

November 2023

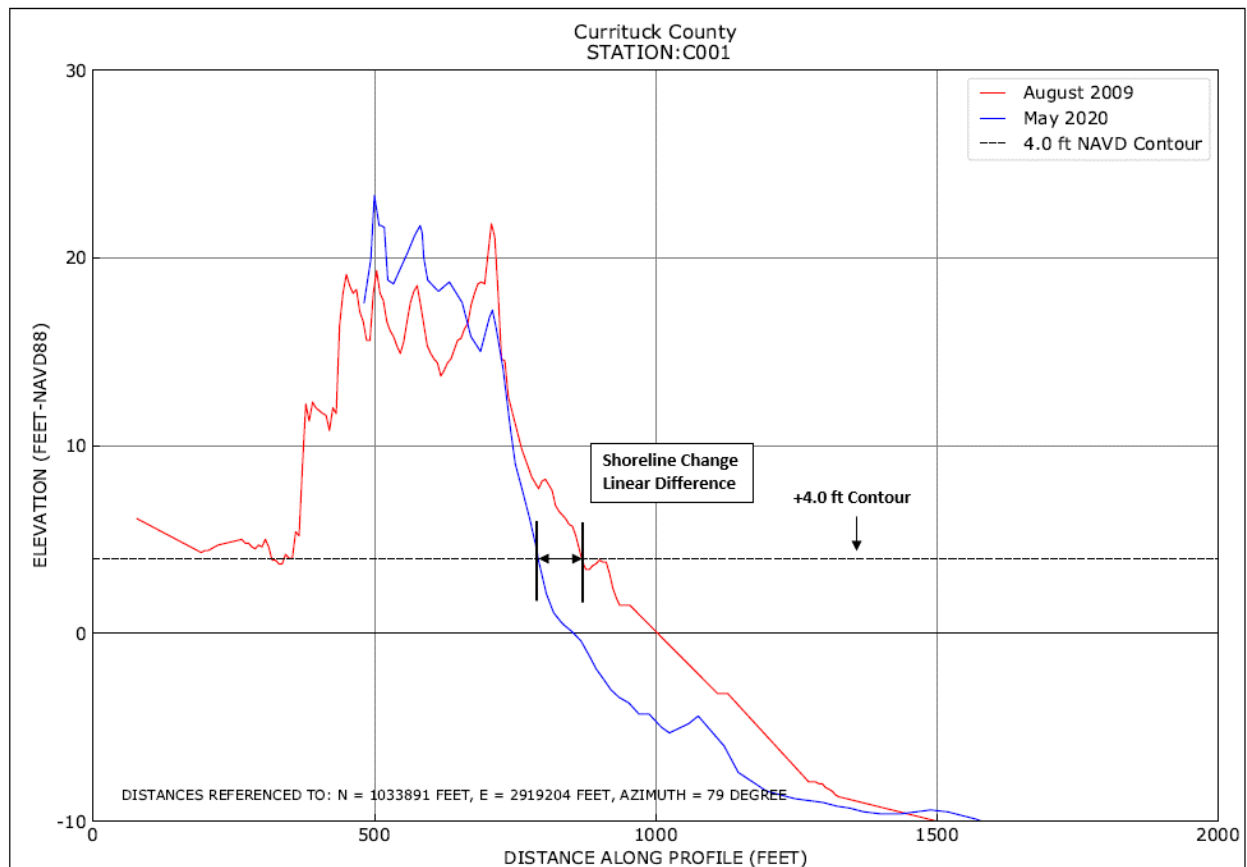
Shoreline change is calculated by comparing shoreline positions along shore perpendicular transects over time. This linear change in the position of the shoreline moving either landward or seaward, is often easier for the general public to visualize; however, shoreline changes are not always synonymous with volumetric changes. Figure 7 shows a typical comparison plot of two beach profile surveys conducted approximately 10.6 years apart along station C-001, illustrating graphically how the shoreline change is measured.

Figure 7. Beach Profile Cross Section Illustrating Shoreline Change.

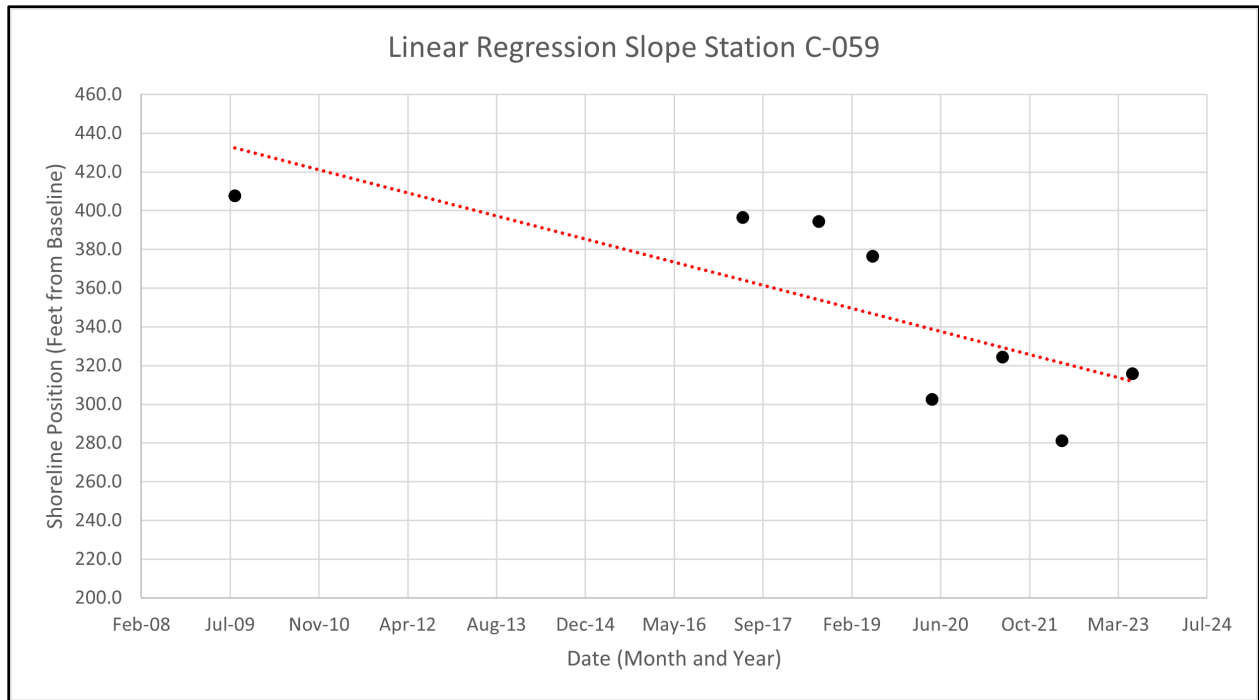
Rates computed for this 2023 Assessment were calculated using a linear regression method. The rate is calculated by determining the slope of the linear trendline for a certain shoreline position (+4 ft. NAVD88) for all available survey events. Figure 9 illustrates the approach showing shoreline positions (black dots) and the trendline for station C-059. These rates are described in terms of positive (+) for advance (shoreline moving seaward) and negative (-) for recession (shoreline moving landward).

Figure 9. Example of Linear Regression Slope

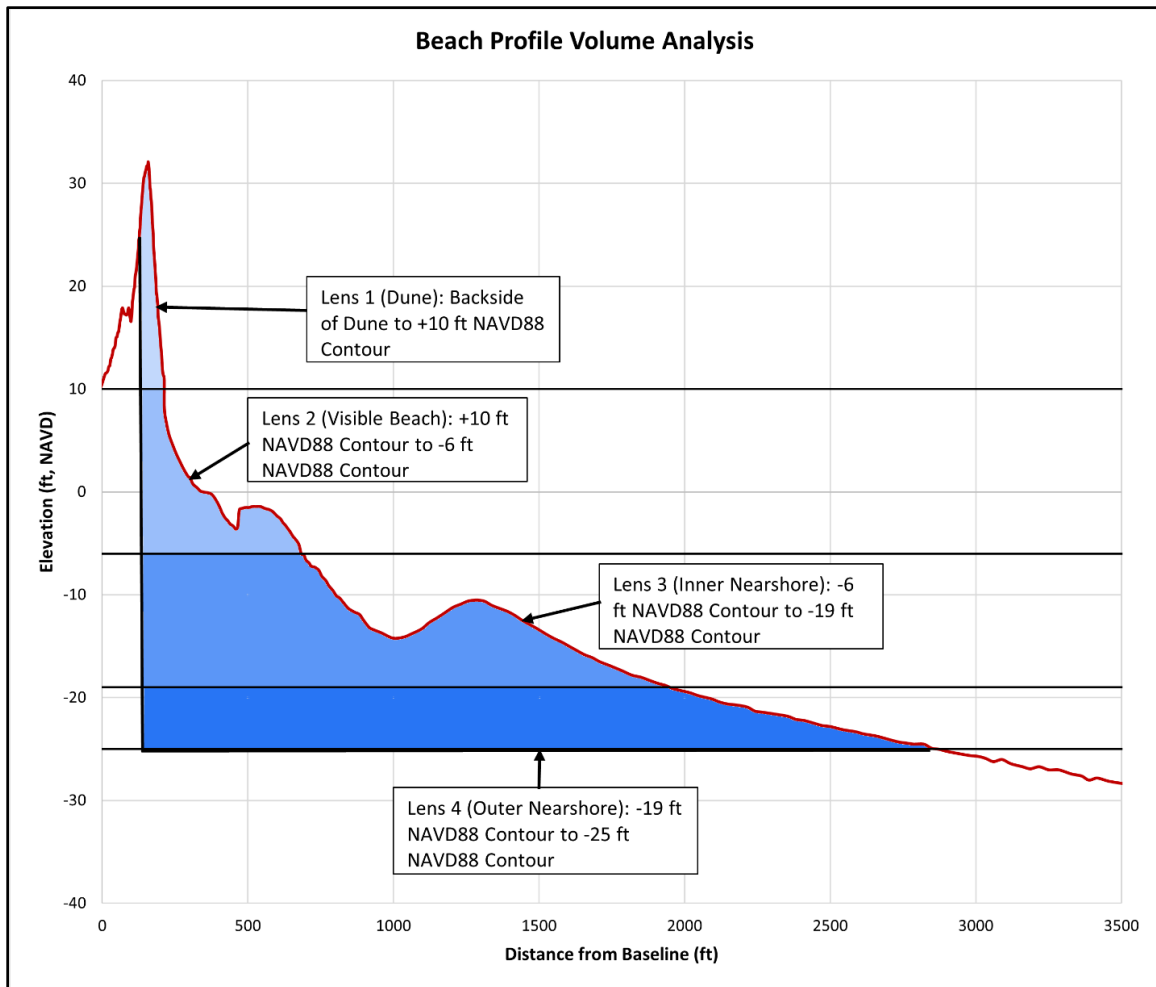
Figure 13. Beach Profile Cross Section Illustrating Lenses

- Lens 1 (Dune):** Volume from Backside of the dune to +10 ft. NAVD88 — The volume between the backside of the primary frontal dune and the +10 ft. NAVD88 contour is a measure of the sand quantity in the dunes. The +10 ft. NAVD88 contour typically is representative of the toe of the dune though this elevation can change seasonally and spatially. This lens of sand would also be landward of runup experienced during minor storms.
- Lens 2 (Visible Beach):** Usable Beach (+10 ft. to -6 ft. NAVD88) — This lens includes the dry-sand beach (“berm”) and wet-sand beach (sloping wave swash zone) to low-tide wading depth at -6 ft. NAVD88. This is the primary recreational portion of the beach.

- **Lens 3 (Inner Nearshore):** Outer Surf Zone (-6 ft. to -19 ft. NAVD88) — This lens represents the underwater part of the beach extending seaward of the bar to the previously established depth of closure.
- **Lens 4 (Outer Nearshore):** Outer limits of the Active Beach Profile (-19 ft. to -25 ft. NAVD88) — This lens represents the underwater part of the beach profile in and around the various observed depths of closure during this study.

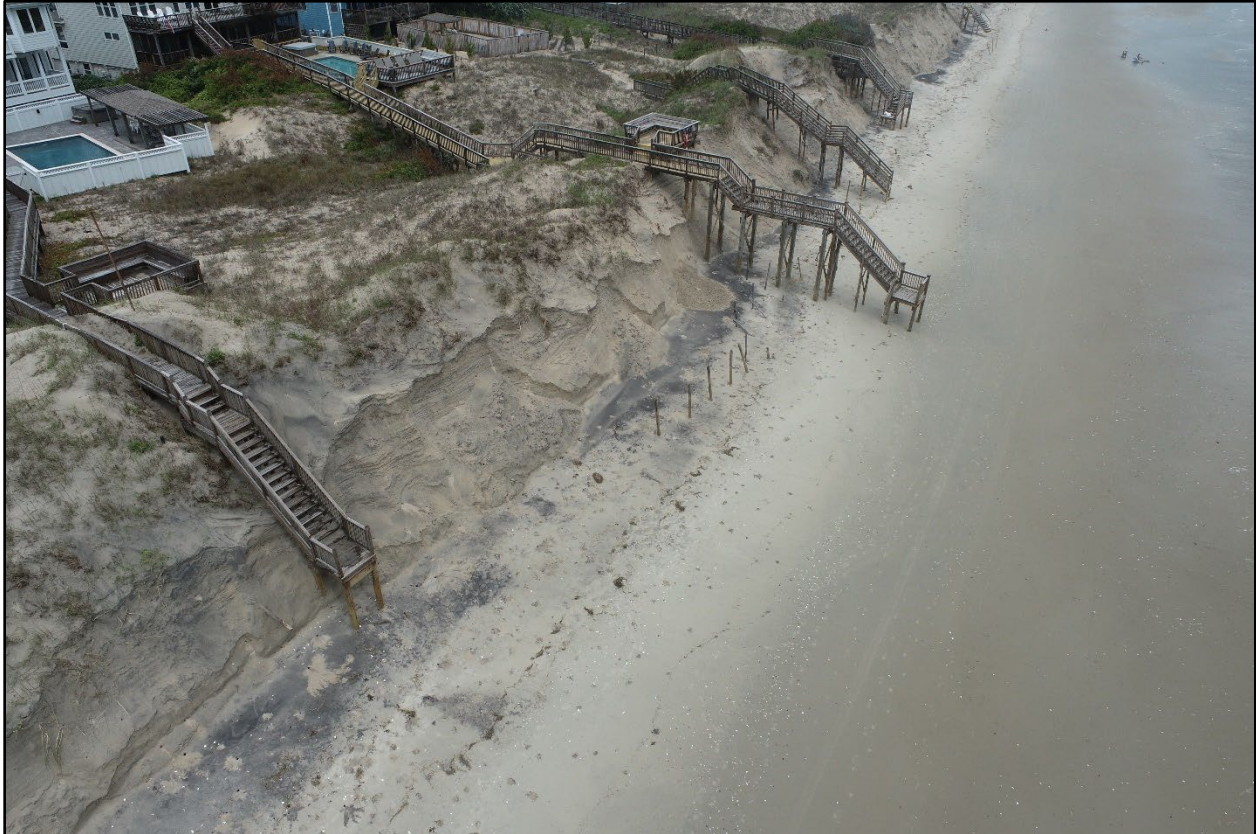
Figure 15. View of Dune Scarping approximately 500 feet north of Sta. C-060. (Photo date 5/15/22).

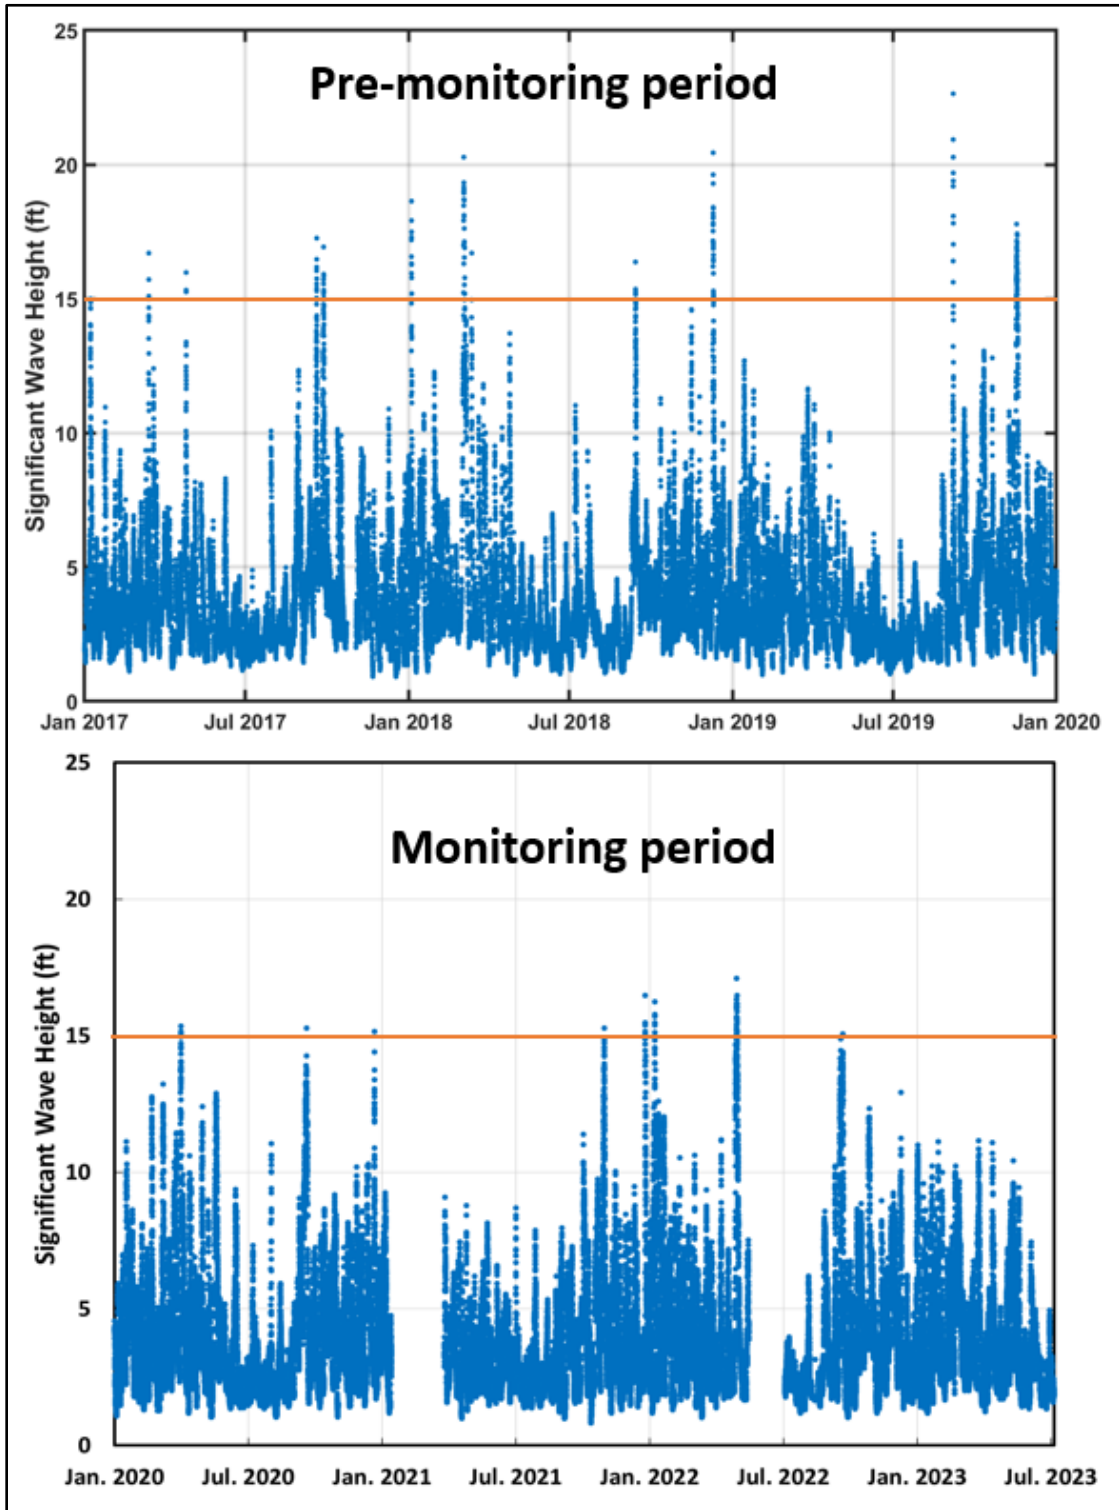
A general review of wave data reflective of conditions offshore Currituck County was conducted to evaluate whether the offshore wave climate prior to the study period (Jan. 2017 to Jan. 2020) differed significantly from the wave climate during the study period (May 2020 to June 2023). Figure 18 shows the measured significant wave heights from a waverider buoy located in approximately 26 m of water offshore of the Duck Field Research Facility pier.

Figure 18. Significant Wave Height data for waverider buoy located in 26 m of water offshore Duck, NC (Station 44100) prior to and during the monitoring period.

The upper panel shows the wave data for the three-year period prior to the commencement of the Currituck County Beach Monitoring and Beach Stability Assessment (January 2017 to January

The comparison of these wave data, coupled with the observations along beaches north and south of Currituck County, which experienced positive volumetric changes during this same period that varied from the typical negative volumetric changes observed, suggests that the positive volumetric changes experienced during the May 2020 to June 2023 monitoring period may be explained as a recovery following storm induced migration of sand into deeper depths offshore of the Assessment Area. Furthermore, if this explanation holds true, then negative volume change trends may follow this temporary period of recovery.
