2022 BEACH MONITORING AND BEACH STABILITY
ASSESSMENT
CURRITUCK COUNTY, NORTH CAROLINA

PREPARED FOR
CURRITUCK COUNTY

PREPARED BY
COASTAL PROTECTION ENGINEERING OF NORTH CAROLINA, INC.
ENGINEERING LICENCE CERTIFICATE #: C-2331

JANUARY 2023

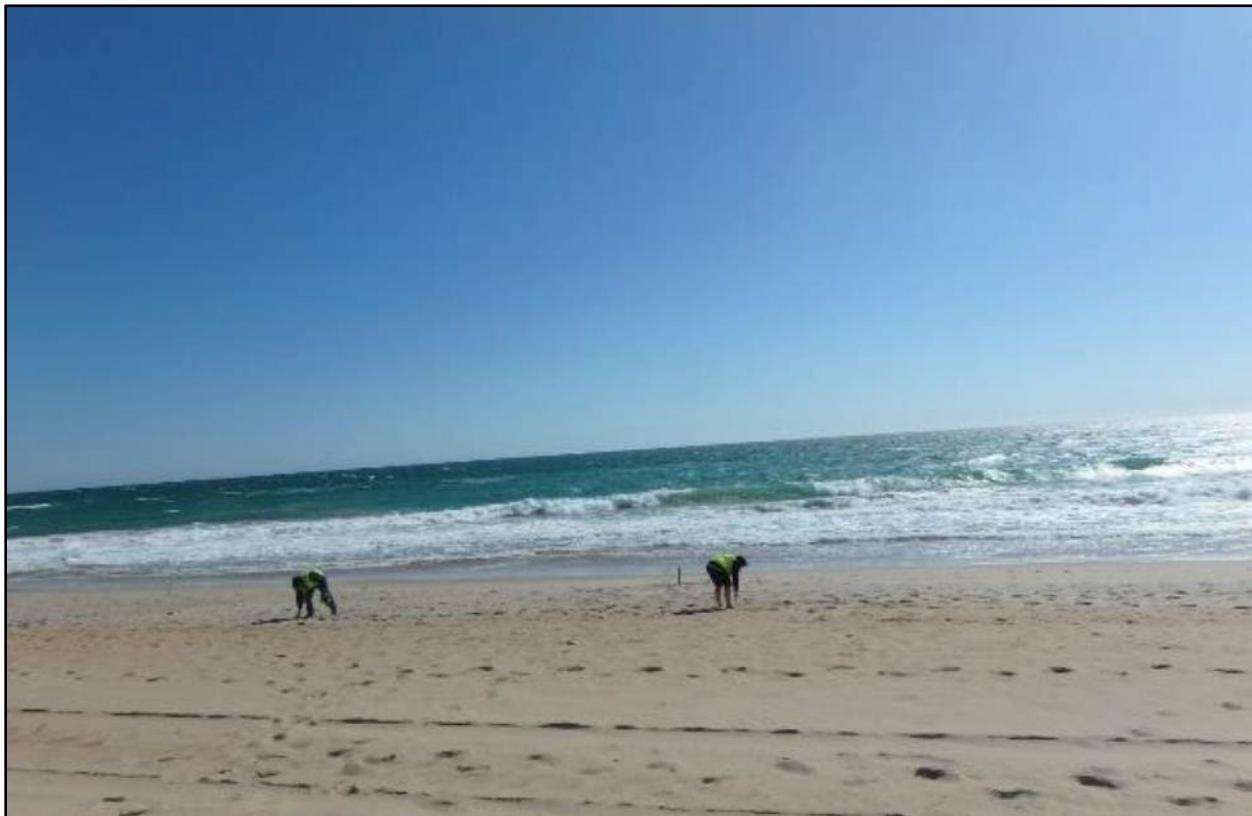
Figure 11. Photo of CPE Representatives Performing Large Clasts Survey

After the survey area was delineated, sediments greater than or equal to one inch and shell material greater than or equal to three inches in diameter were counted by a visual observation survey (Figure 11, Figure 12, and Figure 13). Upon completion of the surveys, an arithmetic mean was computed for both sediments and shells.

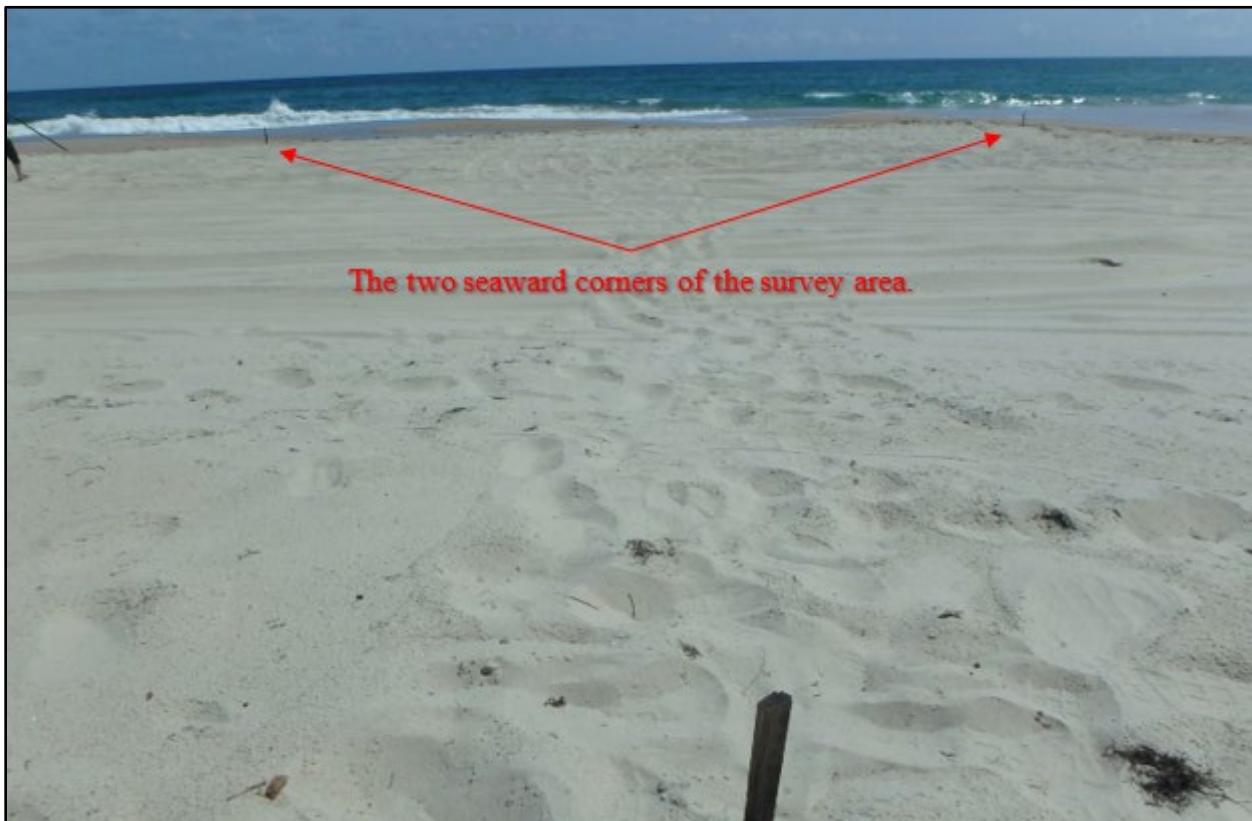
Figure 12. Photo of Large Clasts Survey Area

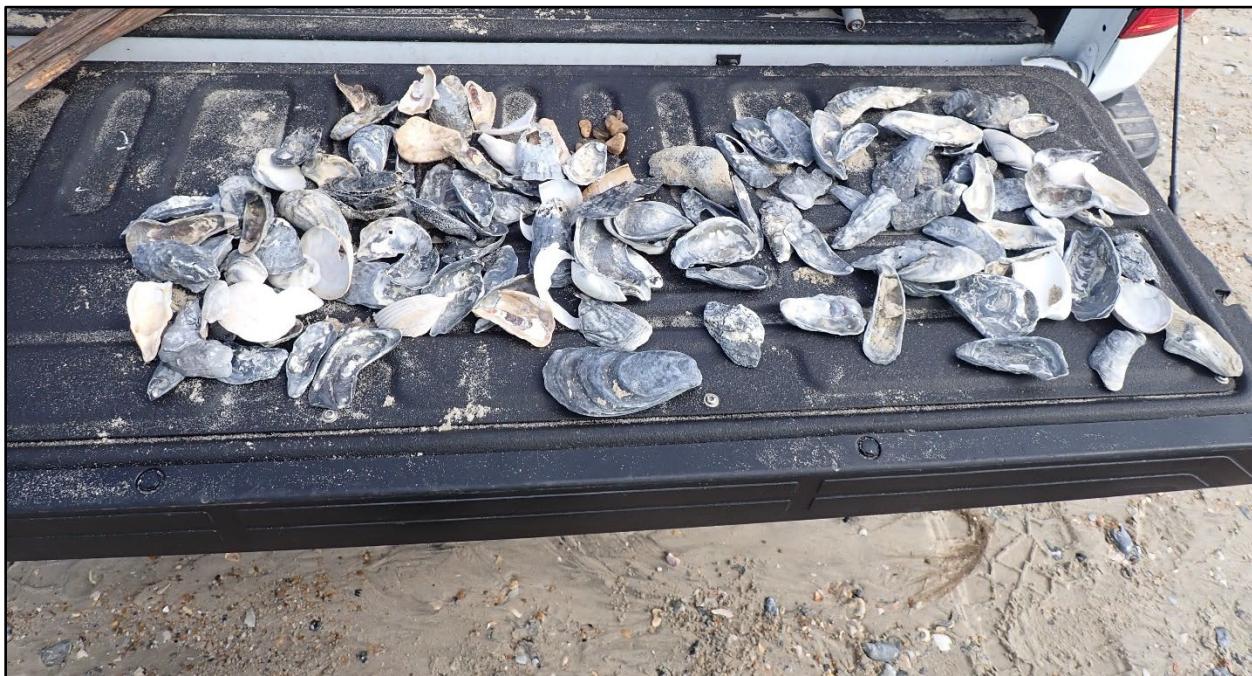
Figure 13. Photo of Shells and Rocks Counted at Sta. C-090

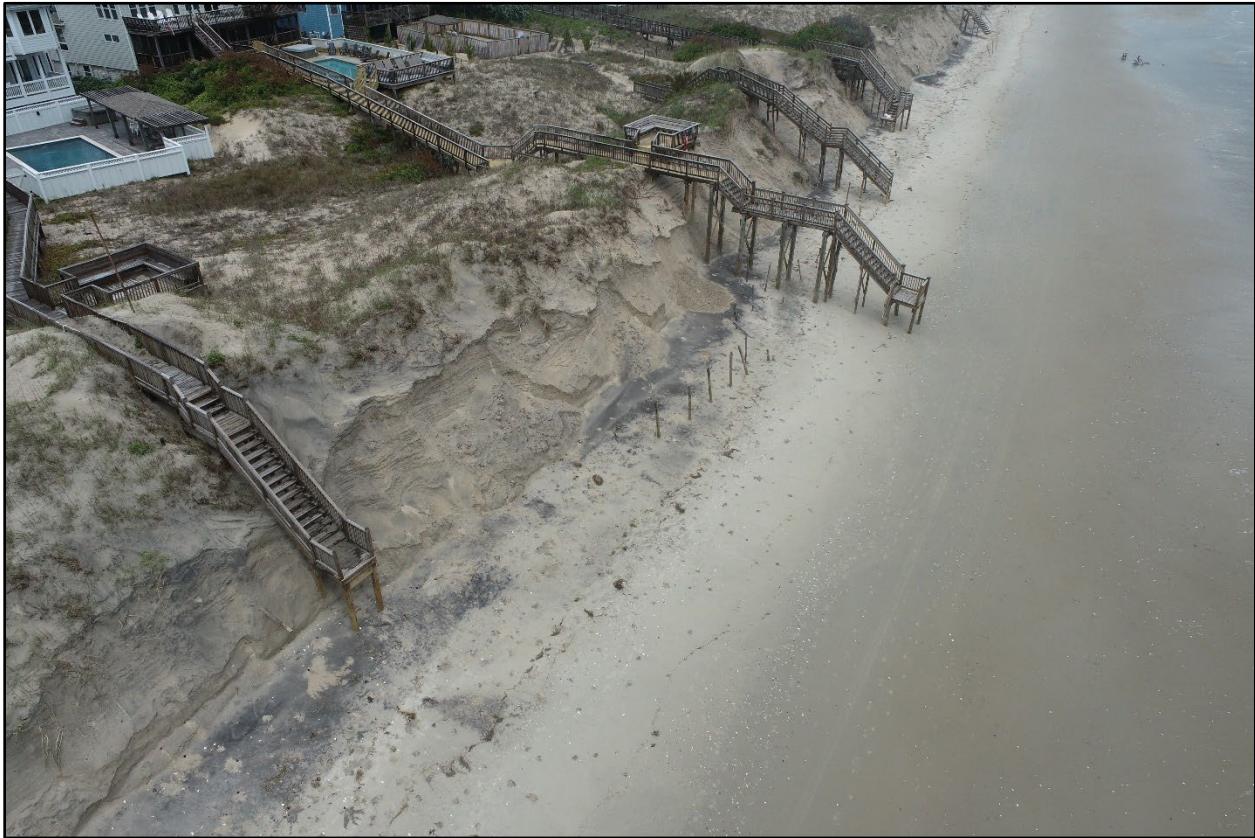
Figure 24. View of Dune Scarping approximately 500 feet north of Sta. C-060. (Photo date 5/15/22).
