DRAFT: BEACH MANAGEMENT PLAN CURRITUCK COUNTY, NORTH CAROLINA

PREPARED FOR
CURRITUCK COUNTY

PREPARED BY
COASTAL PROTECTION ENGINEERING OF NORTH CAROLINA, INC.
ENGINEERING LICENSE CERTIFICATE #: C-2331

June 2026

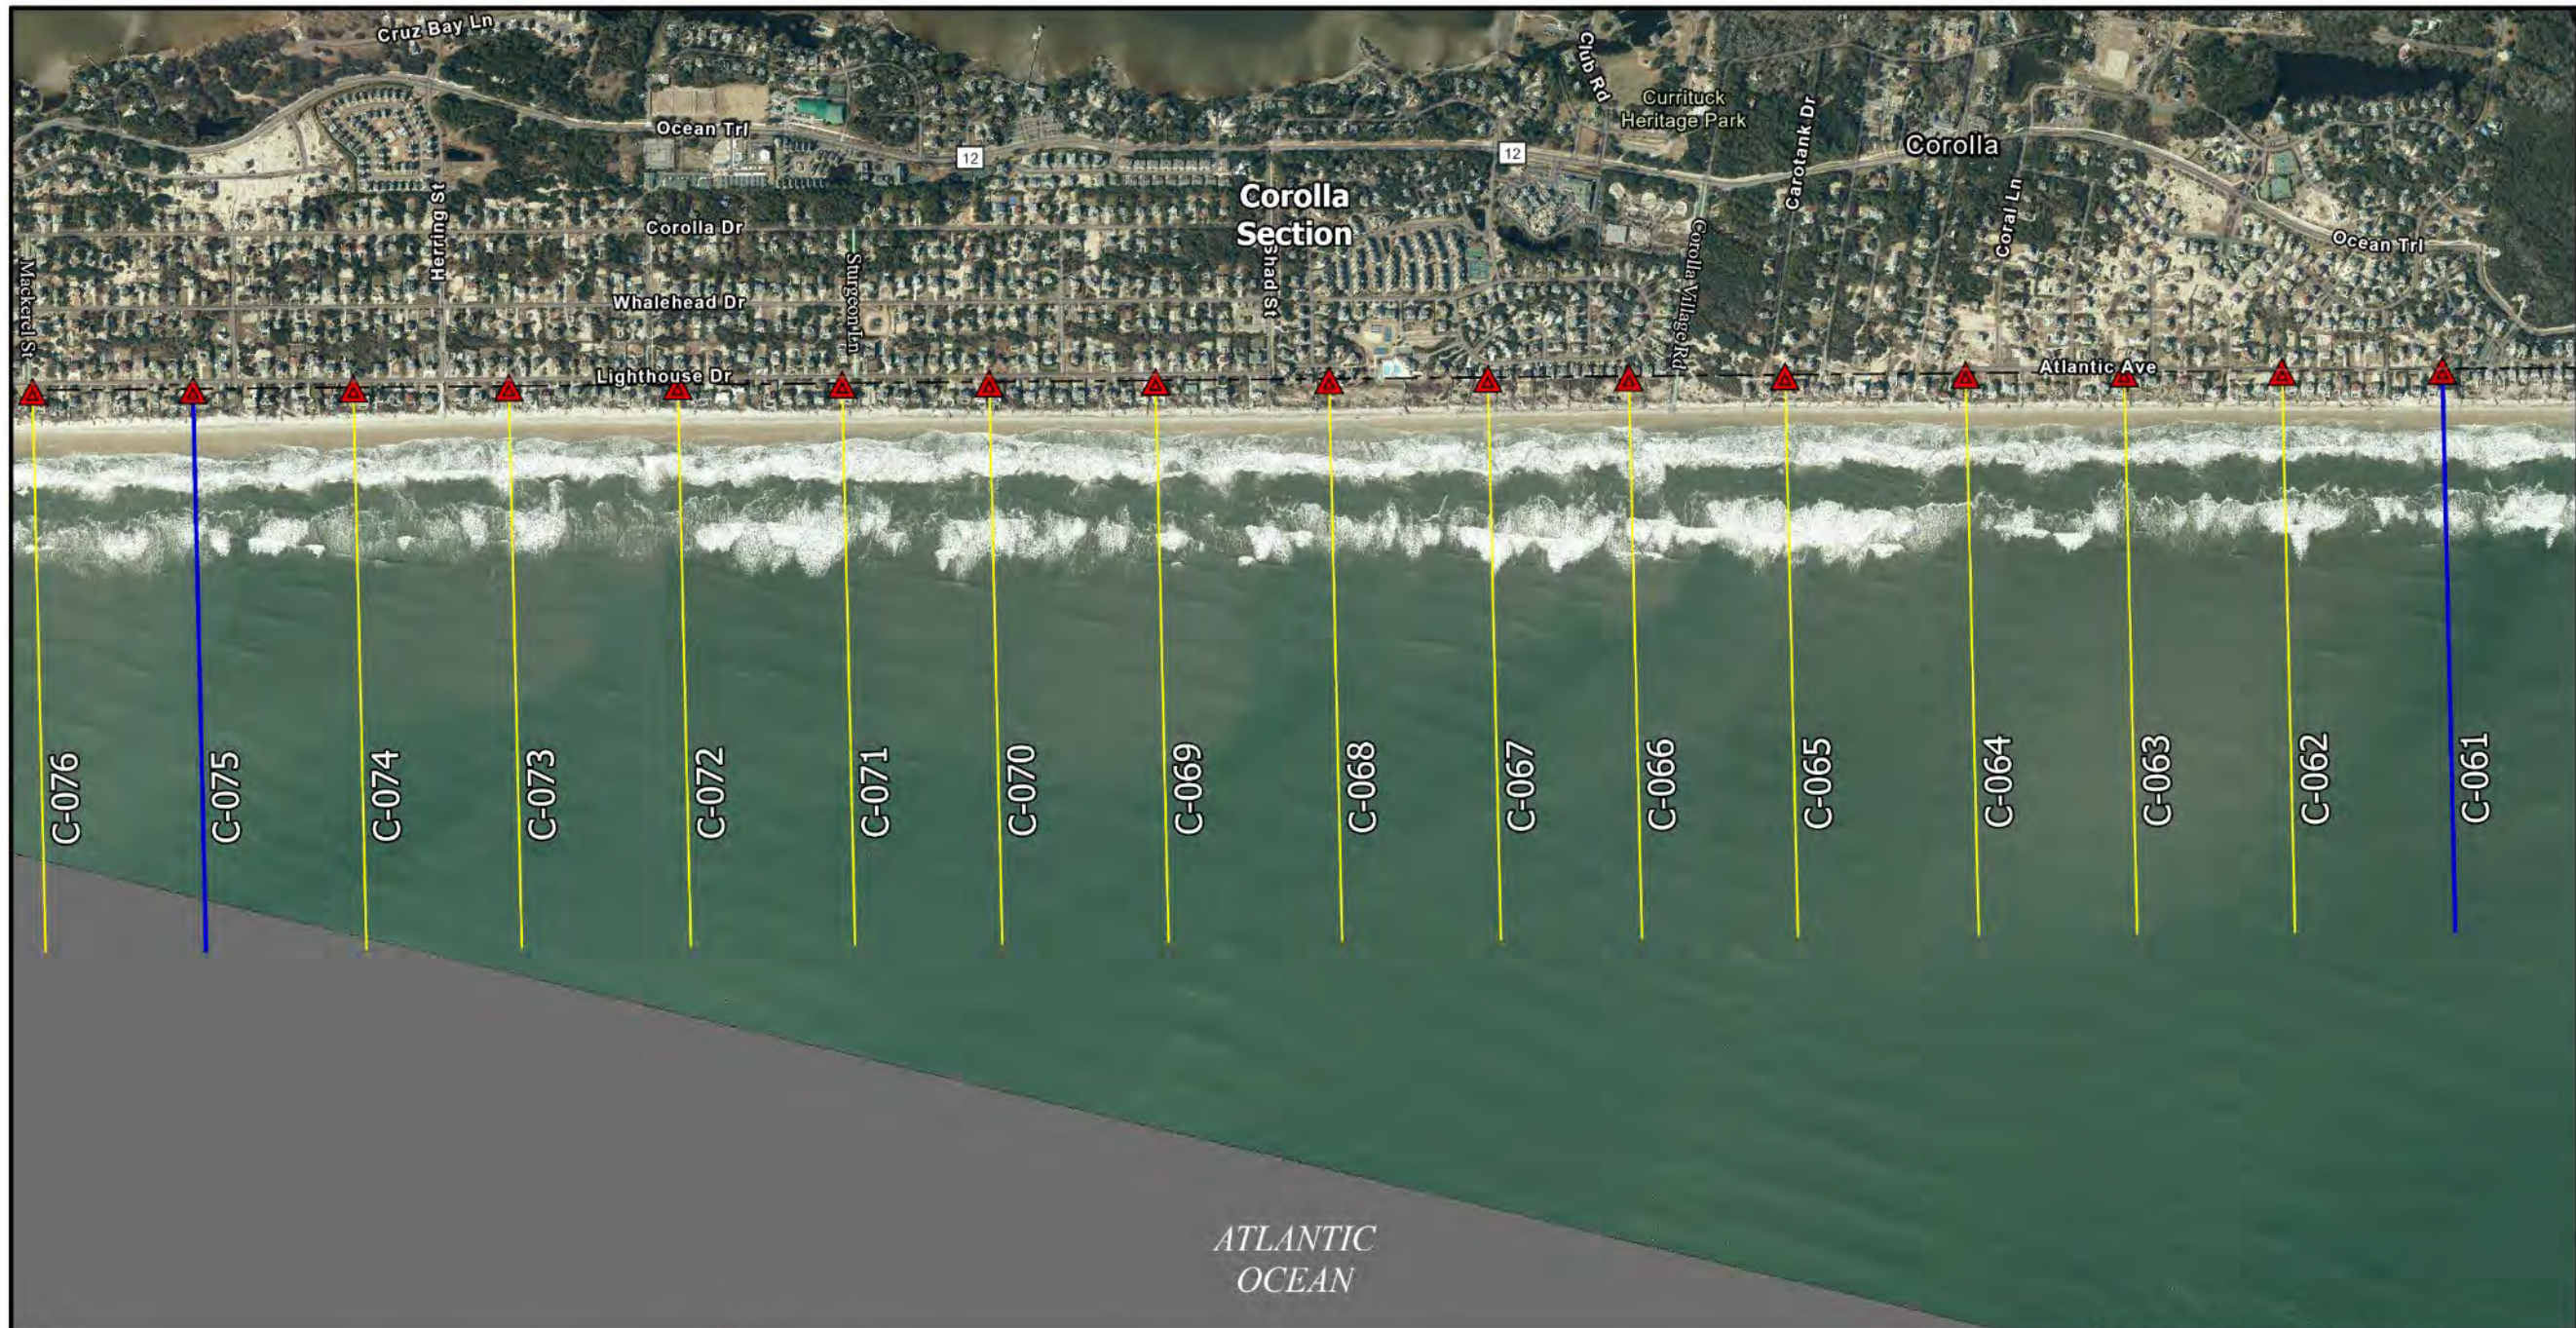
Figure 6. Monitoring Transects Map Station C-061 to C-076

1) Aerial imagery collected between February 2 and March 9, 2020 by the North Carolina Orthoimagery Program.

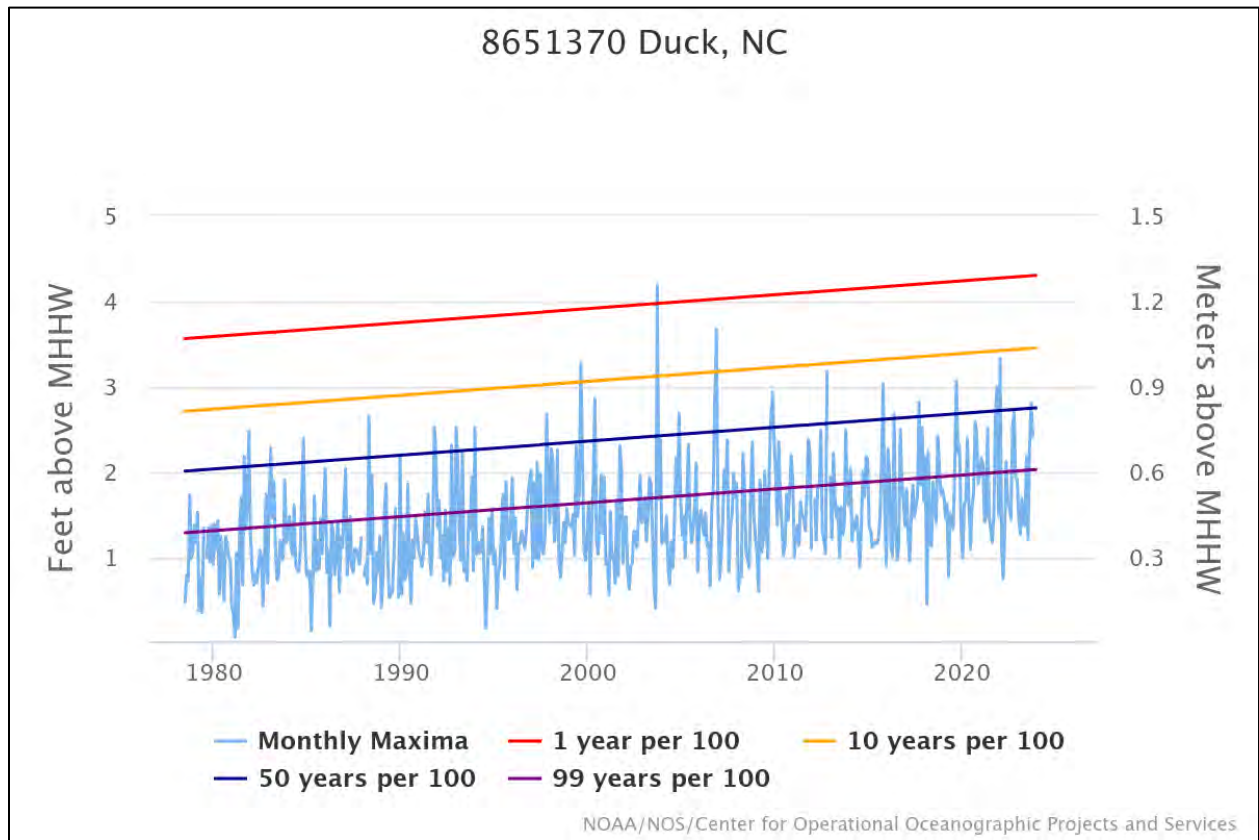
Figure 10. Monthly highest water levels at NOAA Station 8651370 at Duck, NC, along with 1%, 10%, 50%, and 99% annual exceedance probability levels shown in red, orange, blue, and purple, respectively.
 Source: <https://tidesandcurrents.noaa.gov/map/index.html?id=8651370>.

Water level return periods were derived from an extreme water level analysis using data from NOAA Station 8651370 at Duck, NC. This analysis includes the highest recorded monthly water levels from 1978 to 2024, as well as annual exceedance probability levels of 1%, 10%, 50%, and 99%. Water levels are provided in both meters and feet, referenced to Mean Higher High Water (MHHW) (Figure 10). By examining the peak values within this dataset, return periods were determined for all major storms occurring between 2000 and 2023.

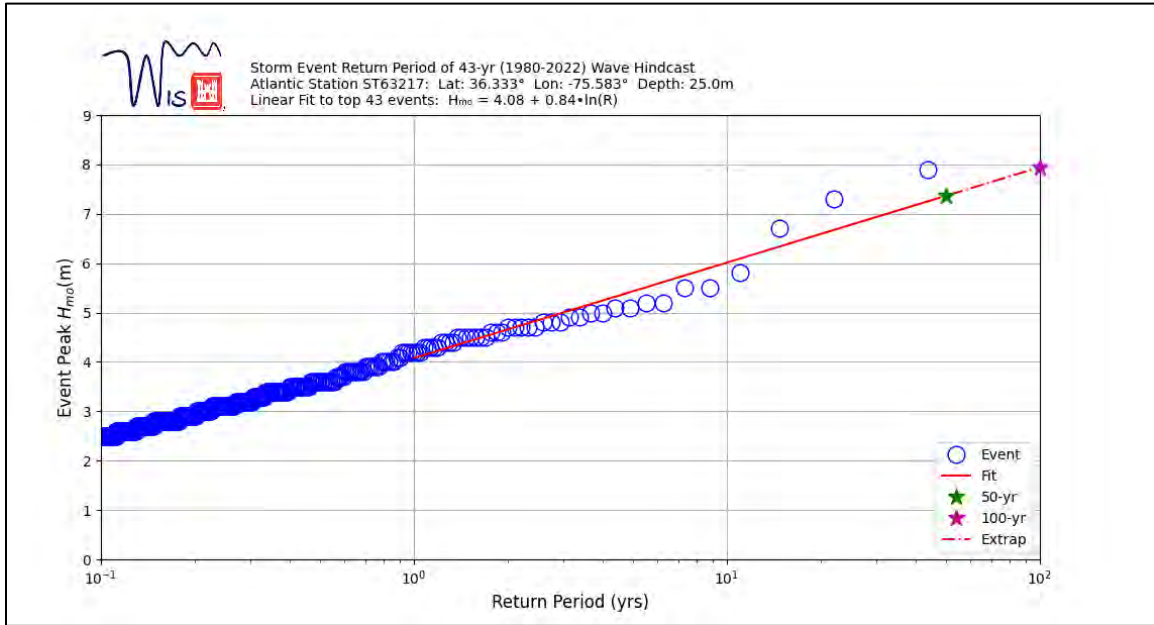
Figure 11. Peak wave heights (in meters) for extreme events plotted against wave return period (in years) for WIS Station ST63217. Source: <https://wisportal.erdc.dren.mil/>.

Hurricane Isabel (2003) had the highest peak wave height at 25.9 ft. with a 40-50-year return period and highest water level at 4.1 ft. (50-100 yr). Some storm events had higher return periods for wave heights than for water levels, indicating more extreme wave conditions relative to water level rise (e.g., Tropical Storm Ophelia). In contrast, other events, such as Hurricane Isabel and the November 2006 Nor’easter, had higher return periods for peak water levels, suggesting more significant coastal flooding despite less extreme wave conditions.

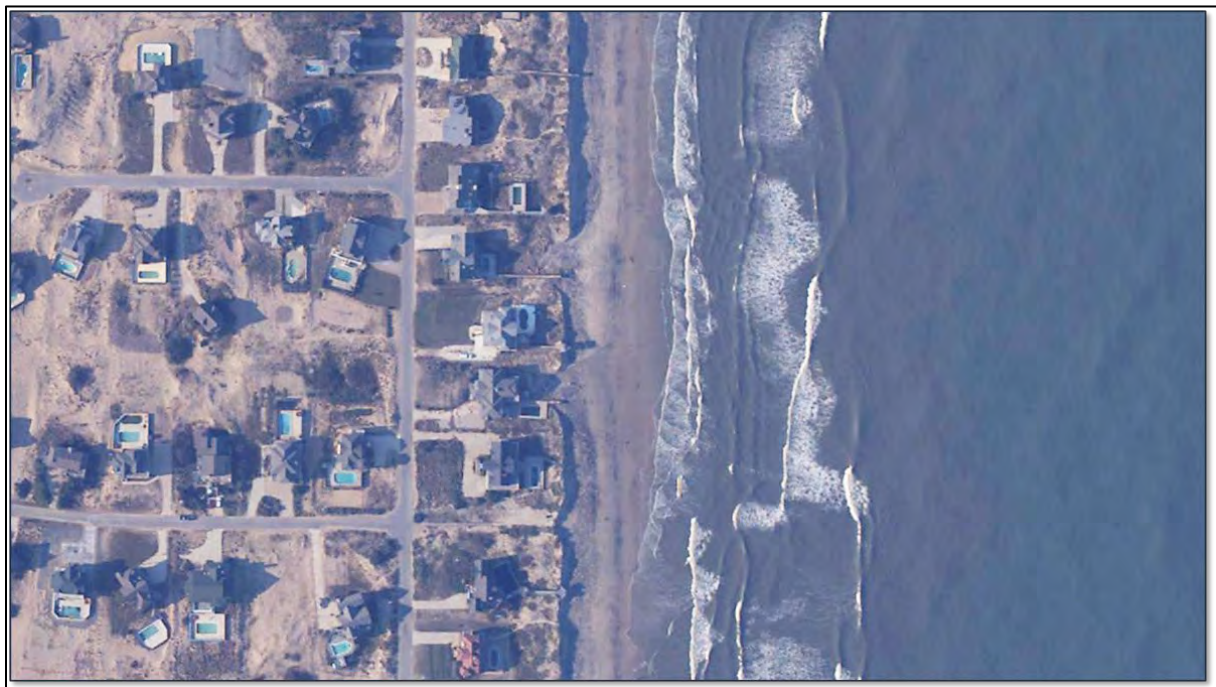
Figure 13. Post Hurricane Isabel Imagery showing severe scarping and dune washout along the Ocean Hills Community following Hurricane Isabel (2003). Source: [National Geodetic Survey - Emergency Response Imagery Index](#).

Hurricane Isabel presented the highest return periods for both wave height and water level. Although Hurricane Isabel (2003) made landfall approximately 110 miles south of Currituck County, as shown in Figure 12, the storm's indirect impact on Currituck County was exacerbated by its broad wind field, which drove storm surge and high waves into the region despite the storm's distant track. The prolonged period of strong onshore winds contributed to coastal flooding and severe beach erosion, causing damage to dunes and weakening the natural defenses of the shoreline. Figure 13 shows post-Hurricane Isabel imagery revealing severe scarping and dune washout along the Ocean Hills Community. The event highlighted vulnerabilities throughout the northern Outer Banks in local coastal infrastructure, necessitating long-term planning and investment in beach nourishment and dune restoration to prevent similar damage from future storms.

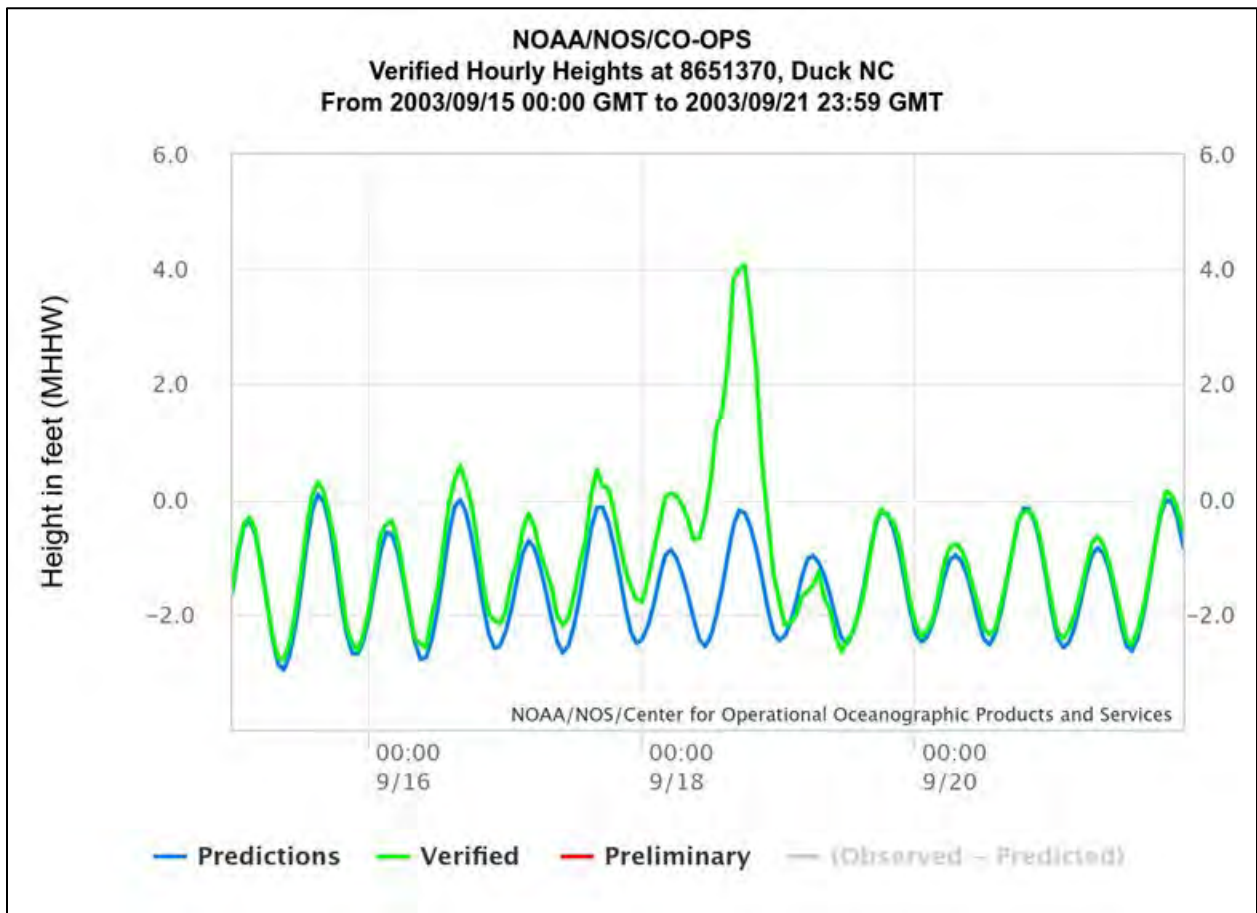
Figure 15. Water levels measured at NOAA Station 8651370 at Duck, NC during Hurricane Isabel (2003). Source: <https://tidesandcurrents.noaa.gov/map/index.html?id=8651370>.

During Hurricane Isabel, the peak wave height reached 25.9 feet (7.9 m) (Figure 14), corresponding to a return period of 40–50 years, while the peak water level was 4.1 feet, MHHW (Figure 15), with a return period of 50–100 years. The dominant wave direction was from E-SE, and the dominant wind direction was from NE which can be seen in the wave and wind roses (Figure 16).

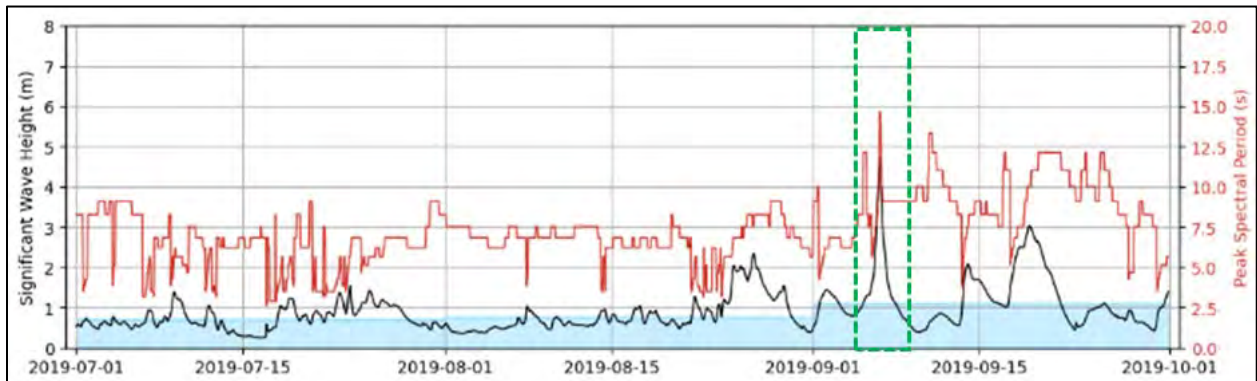
Figure 21. Significant wave height (in black) and peak period (in red) obtained from WIS Station ST63217 for the months of July to September 2019. The green box represents the Hurricane Dorian (2019) timeframe. Source: <https://wisportal.erdc.dren.mil/>.

For Hurricane Dorian (2019), the peak wave height reached 15.4 feet (4.7 m) (Figure 21), corresponding to a return period of 1–2 years, while the peak water level was 3.0 feet, MHHW (Figure 22), with a return period of 5–10 years. The dominant wave direction was from E-SE, and the dominant wind direction was from SE, observed in the wave and wind roses plots shown in Figure 23.

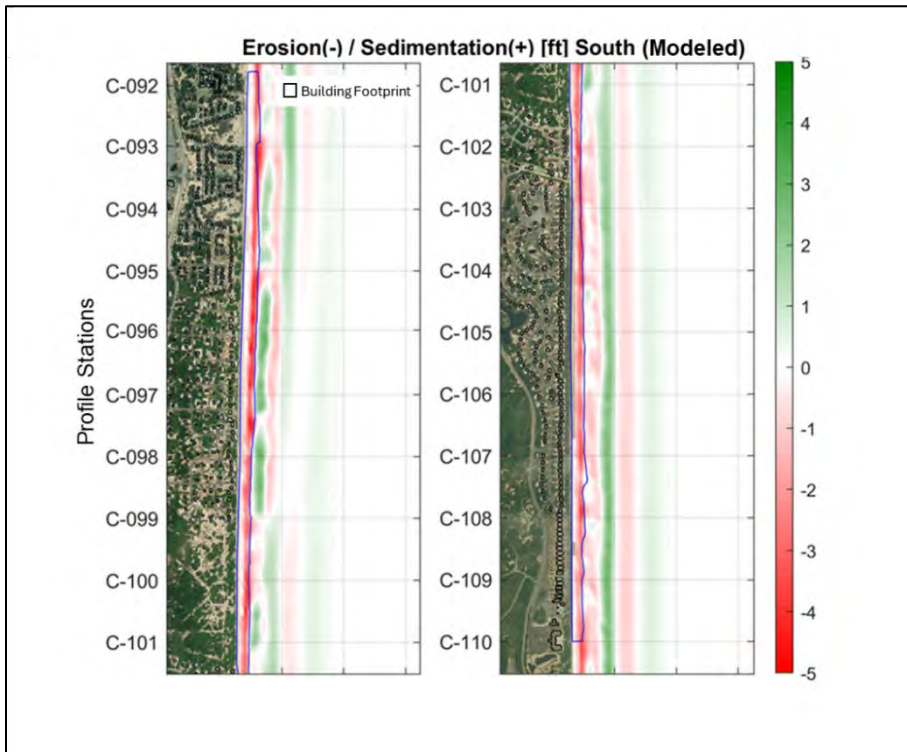
Figure 35. Modeled erosion and sedimentation for the south domain extent for Hurricane Matthew. The blue polygon represents the extents of the measured data.

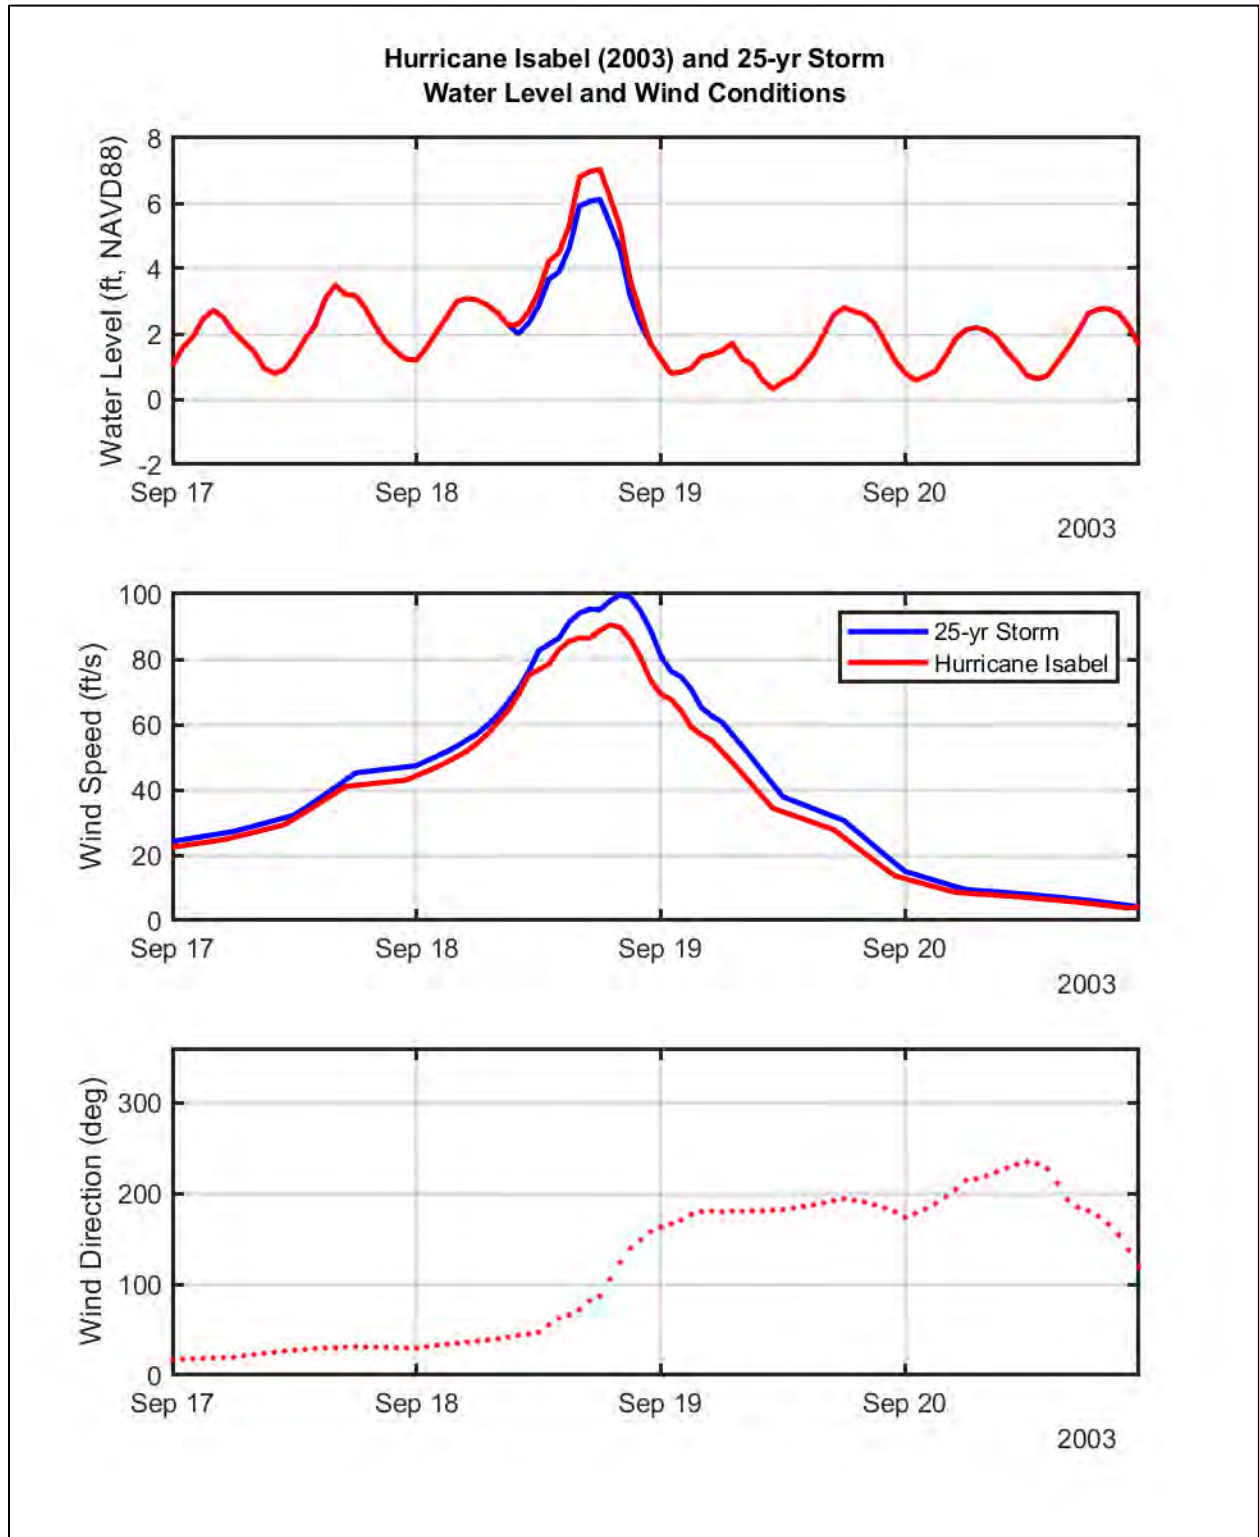
Figure 53. Hindcast meteorological and observed water level conditions used for XBeach during Hurricane Isabel (2003) and 25-yr Storm XBeach simulation (September 17–20, 2003): (top) water level (ft, NAVD88) at NOAA Station 8651370 (Duck, NC), (middle) wind speed (ft/s), and (bottom) wind direction (degrees).

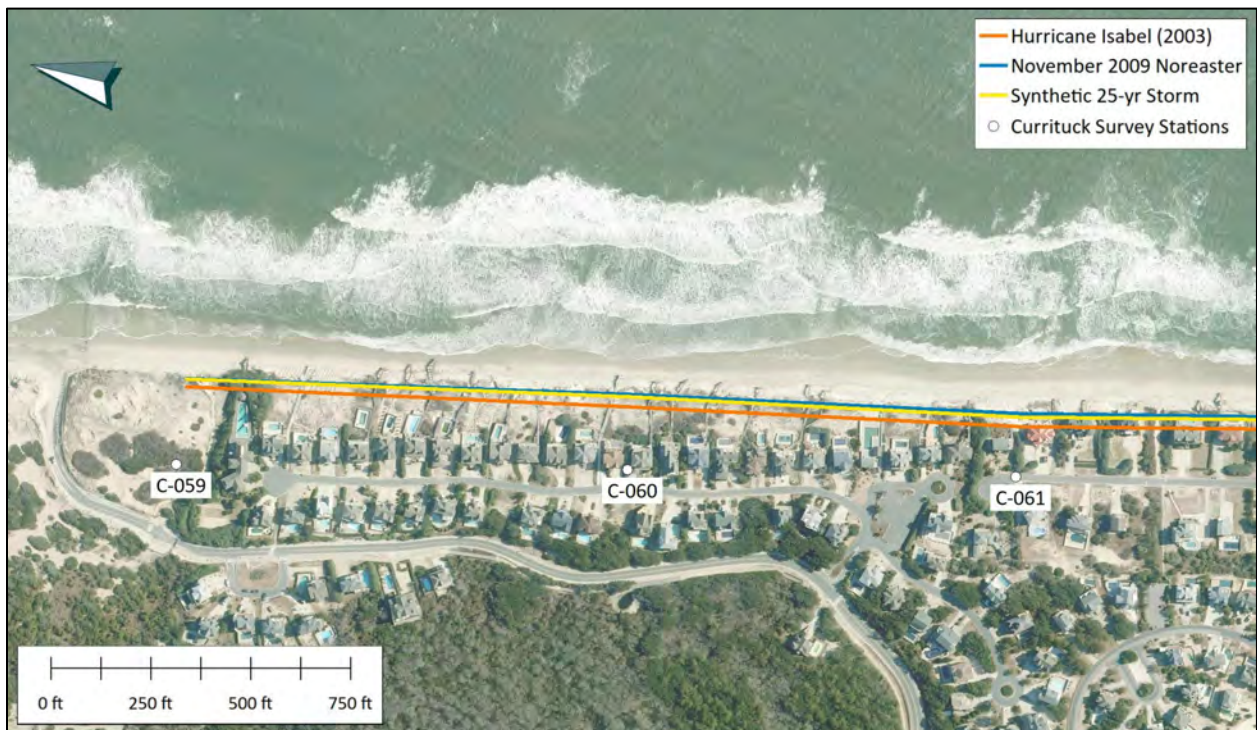
Figure 55. Vulnerability impact lines interpolated from 1-foot vertical recession points for simulated storm scenarios.

The 1-foot vertical recession point locations were connected to generate a continuous vulnerability impact line for each storm scenario. Maps showing these impact lines along the Corolla and Pine Island Sections are provided in Appendix B and an example is shown in Figure 55. This spatial representation helps to visualize areas with the greatest potential for storm vulnerability and may be an indication of locations that are more vulnerable to overwash and breaching. These are the primary processes of concern of the XBeach analysis and lead into the 2D XBeach Analysis discussed in Section 2.1.4.2. The vulnerability impact lines also provide additional context to the recession point locations relative to existing infrastructure, offering greater insight than recession location magnitudes alone. Full profile and recession point plots for all profiles are provided in Appendix C.

After overlaying the vulnerability impact lines onto aerial imagery, the proximity of recession extents to existing infrastructure was evaluated to identify areas with the greatest potential threat to developed spans of the barrier island. These impact lines were used in the development of the vulnerability matrices described in Section 2.4 (Vulnerability Matrix). While some profiles exhibited only moderate recession magnitudes, the limited setback distance between the dune

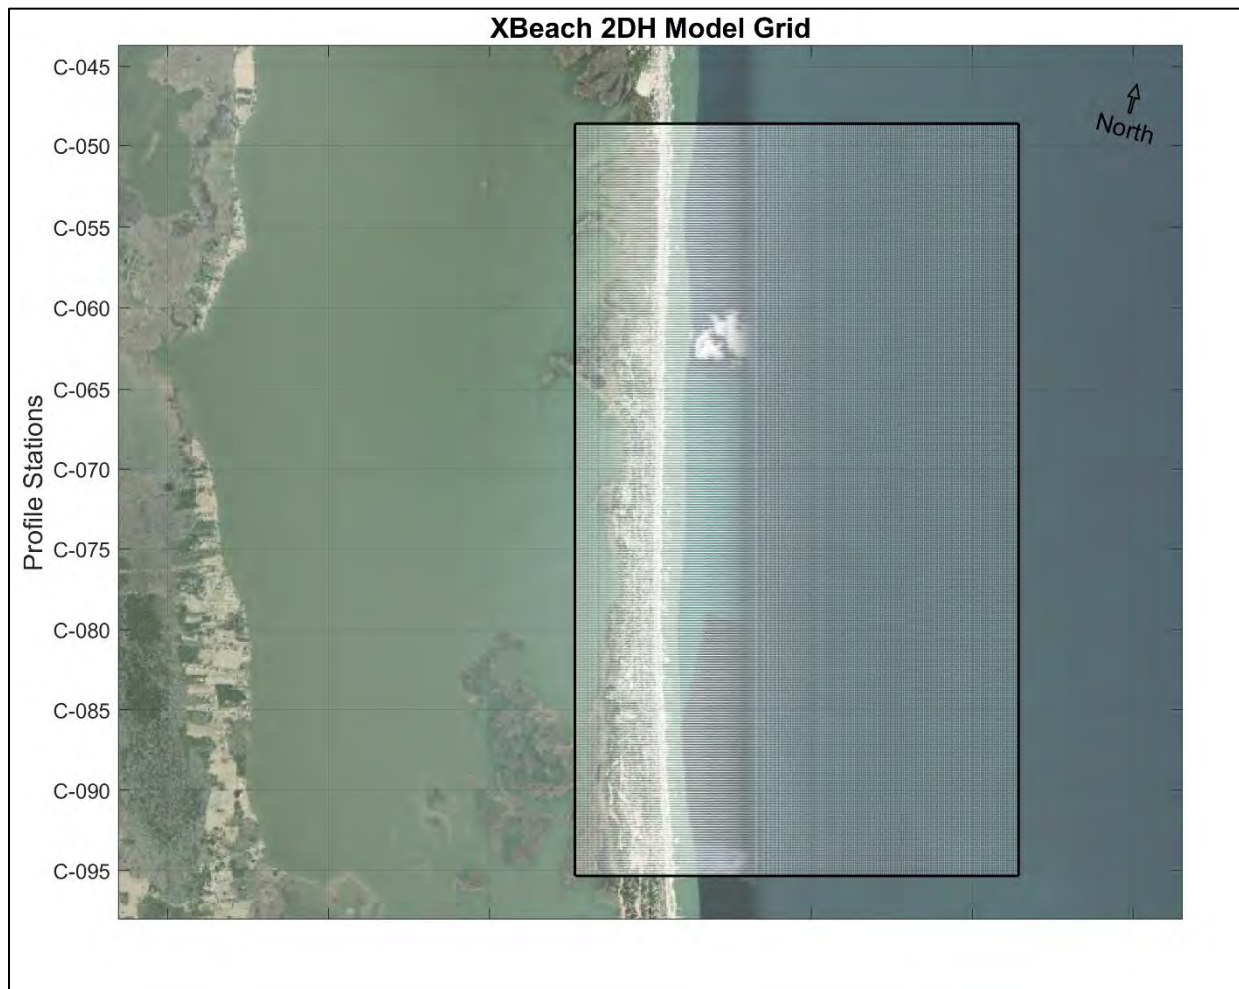
Figure 56. XBeach 2D computational grid showing the model domain extent from Station C-048 to C-096.

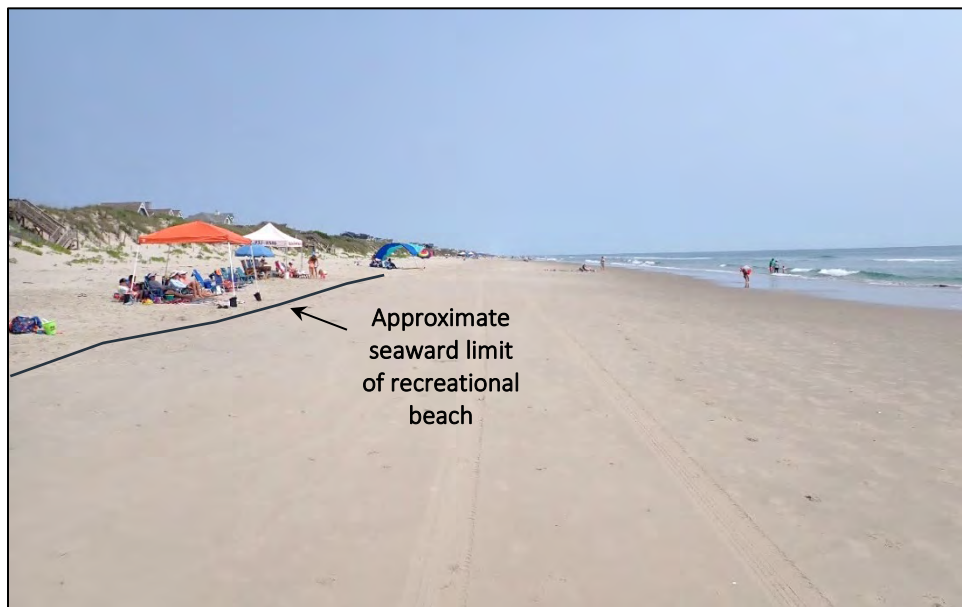
Figure 72. Photograph of the beach near Station C-076 (approximately 1,200 feet south of Perch Street) taken in June 2025 (CPE) illustrating the dry sand beach width.

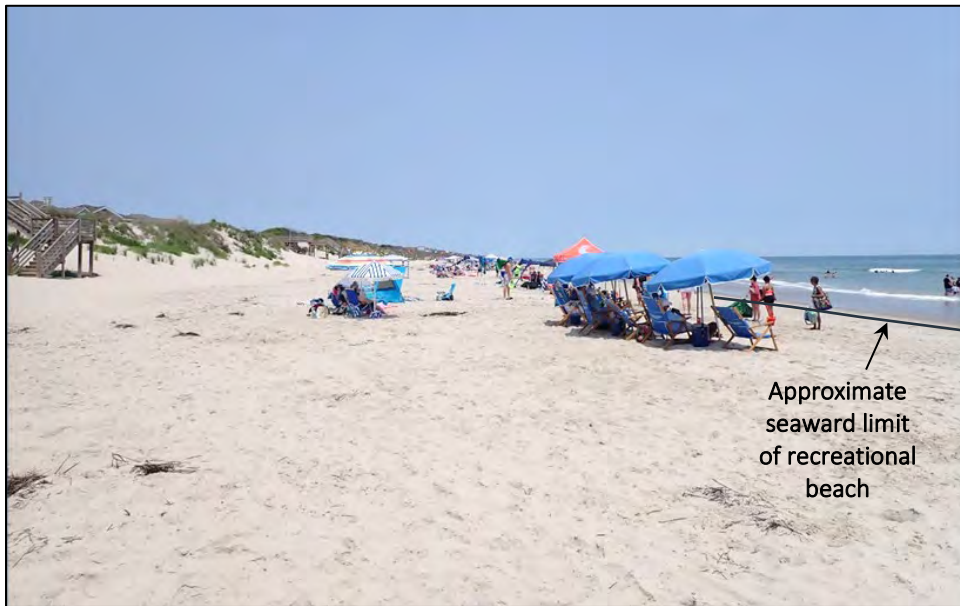
Figure 73. Photograph of the beach near Station C-086 (just south of Crown Point Circle) taken in June 2025 (CPE) illustrating the dry sand beach width.

During the 2025 beach profile surveys, a coastal engineer was onsite to evaluate beach width and beach usage. Figure 72, Figure 73, Figure 74, and Figure 75 show various examples of the recreational beach as observed in June 2025. Each photograph includes a hand digitized indicator (solid black line) of the approximate seaward limit of the recreational beach. Figure 72 shows the beach near Station C-076 (approximately 1,200 feet south of Perch Street), which was measured to have a recreational beach width of 73 feet in June 2025. Figure 73 shows the beach near Station C-086 (just south of Crown Point Circle), which was measured to have a recreational beach width of 94 feet in June 2025. Figure 74 shows the beach near Station C-098 (North end of Breaker Arch), which was measured to have a recreational beach width of 57 feet in June 2025. Figure 75 shows the beach near Station C-102 (Spindrift Community), which was measured to have a recreational beach width of 58 feet in June 2025.

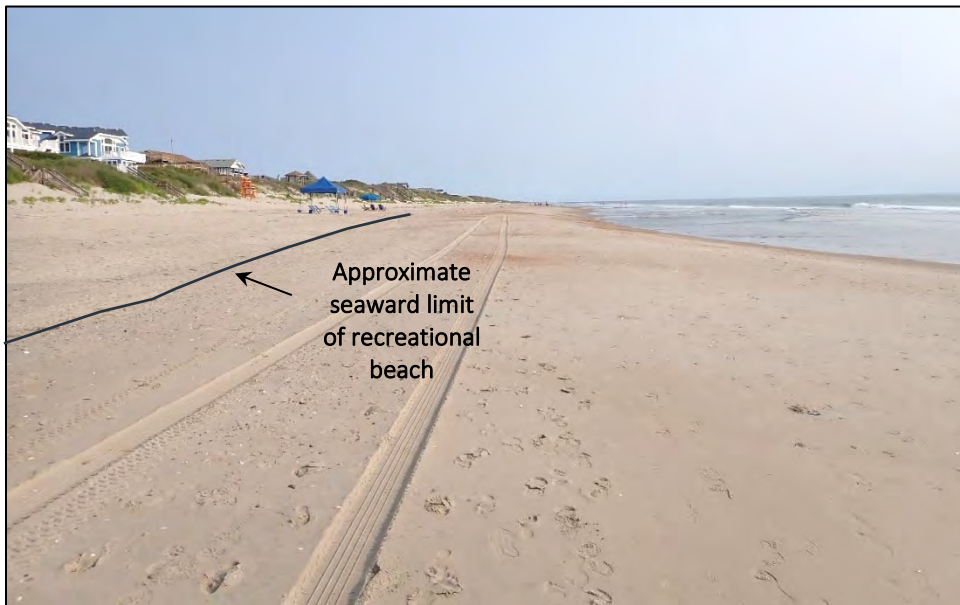
Figure 74. Photograph of the beach near Station C-098 (North end of Breaker Arch) taken in June 2025 (CPE) illustrating the dry sand beach width.

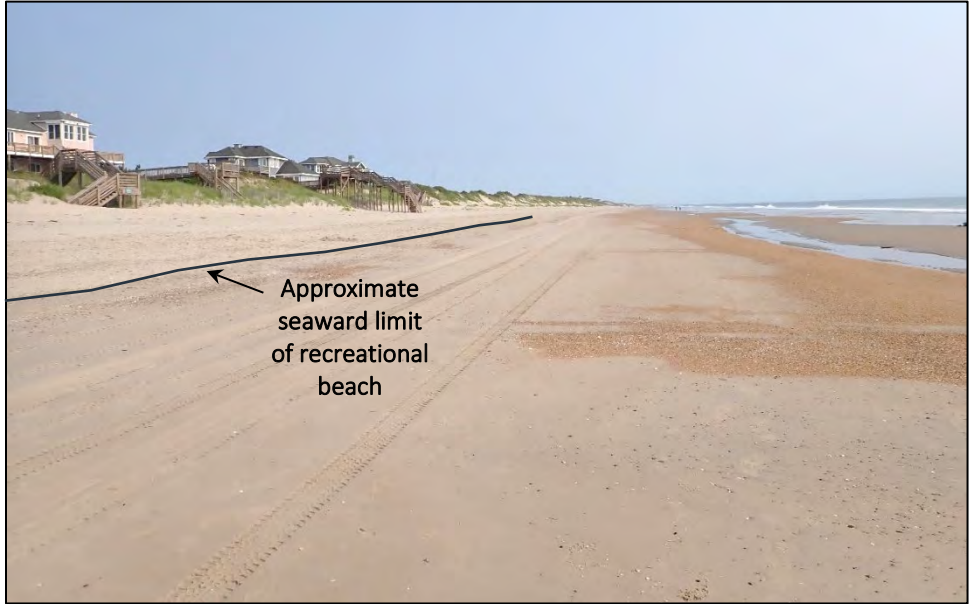
Figure 75. Photograph of the beach near Station C-102 (Spindrif Community) taken in June 2025 (CPE) illustrating the dry sand beach width.

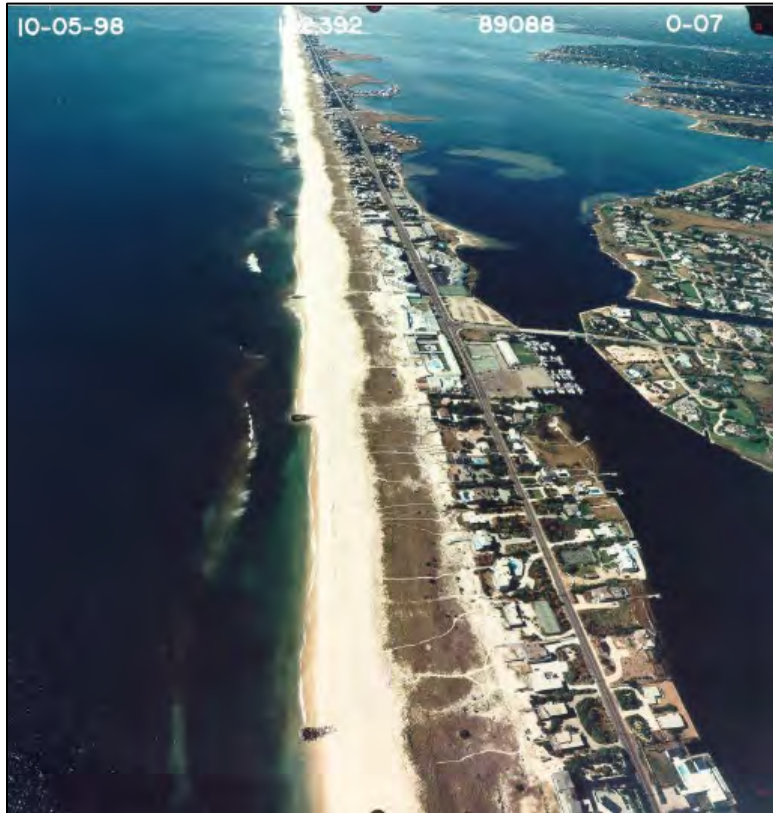
Figure 89. Example of groin field and renourished beach at Westhampton Beach, New York, 1998 (Courtesy USAED, New York).

The incorporation of sand retention structures into coastal programs must consider that these structures do not add sand to the system that would increase coastal protection and/or mitigate erosion, they retain sand that is part of the littoral system. Therefore, if these structures are the only aspect of a coastal management strategy, the retention of sand in front of one section of beach is likely to result in adverse downdrift effects on an adjacent section of beach. For this reason, coastal engineers typically use these structures in conjunction with beach nourishment projects to reduce the rate of sediment loss along a specific section of beach, often referred to as a “hot spot.” Figure 89 and Figure 90 show examples of groin fields and breakwater fields being incorporated into beach nourishment projects.

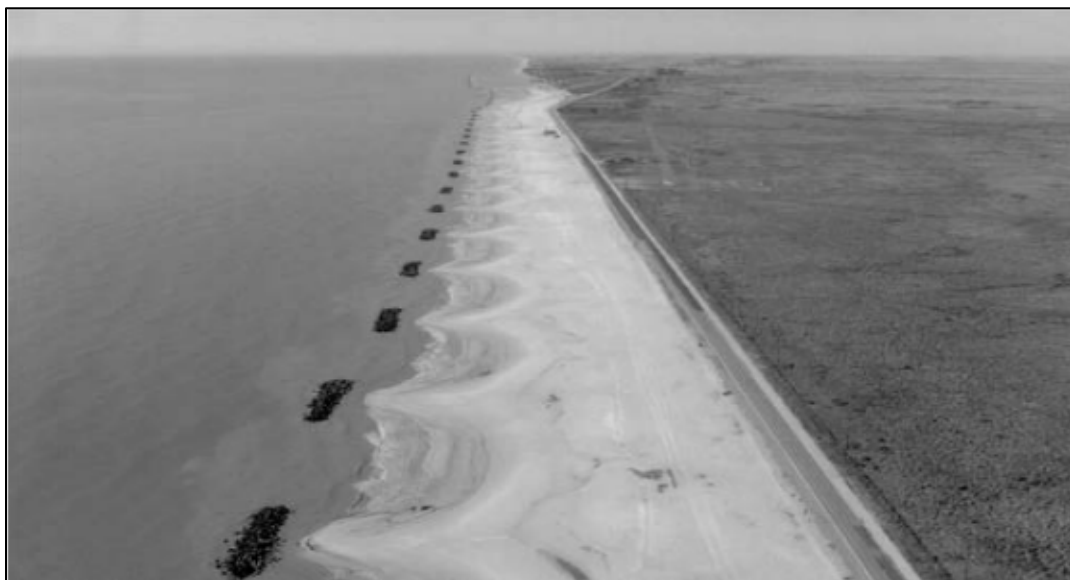
Figure 90. Example of a breakwater field and a renourished beach at Holly Beach, Louisiana (Mann and Thomson, 2003)

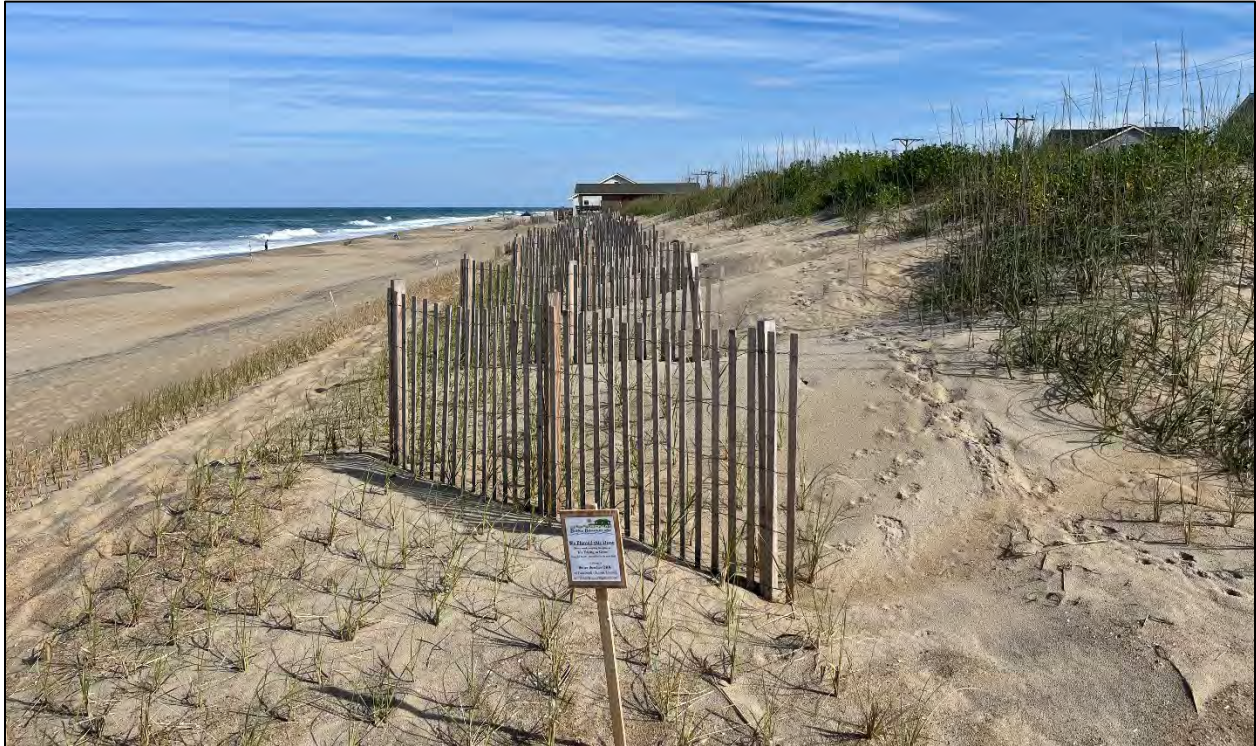
Figure 91. A constructed dune in the Town of Kitty Hawk, NC where dune vegetation was planted along the seaward dune slope and crest and sand fence was installed along the crest (May, 2023).

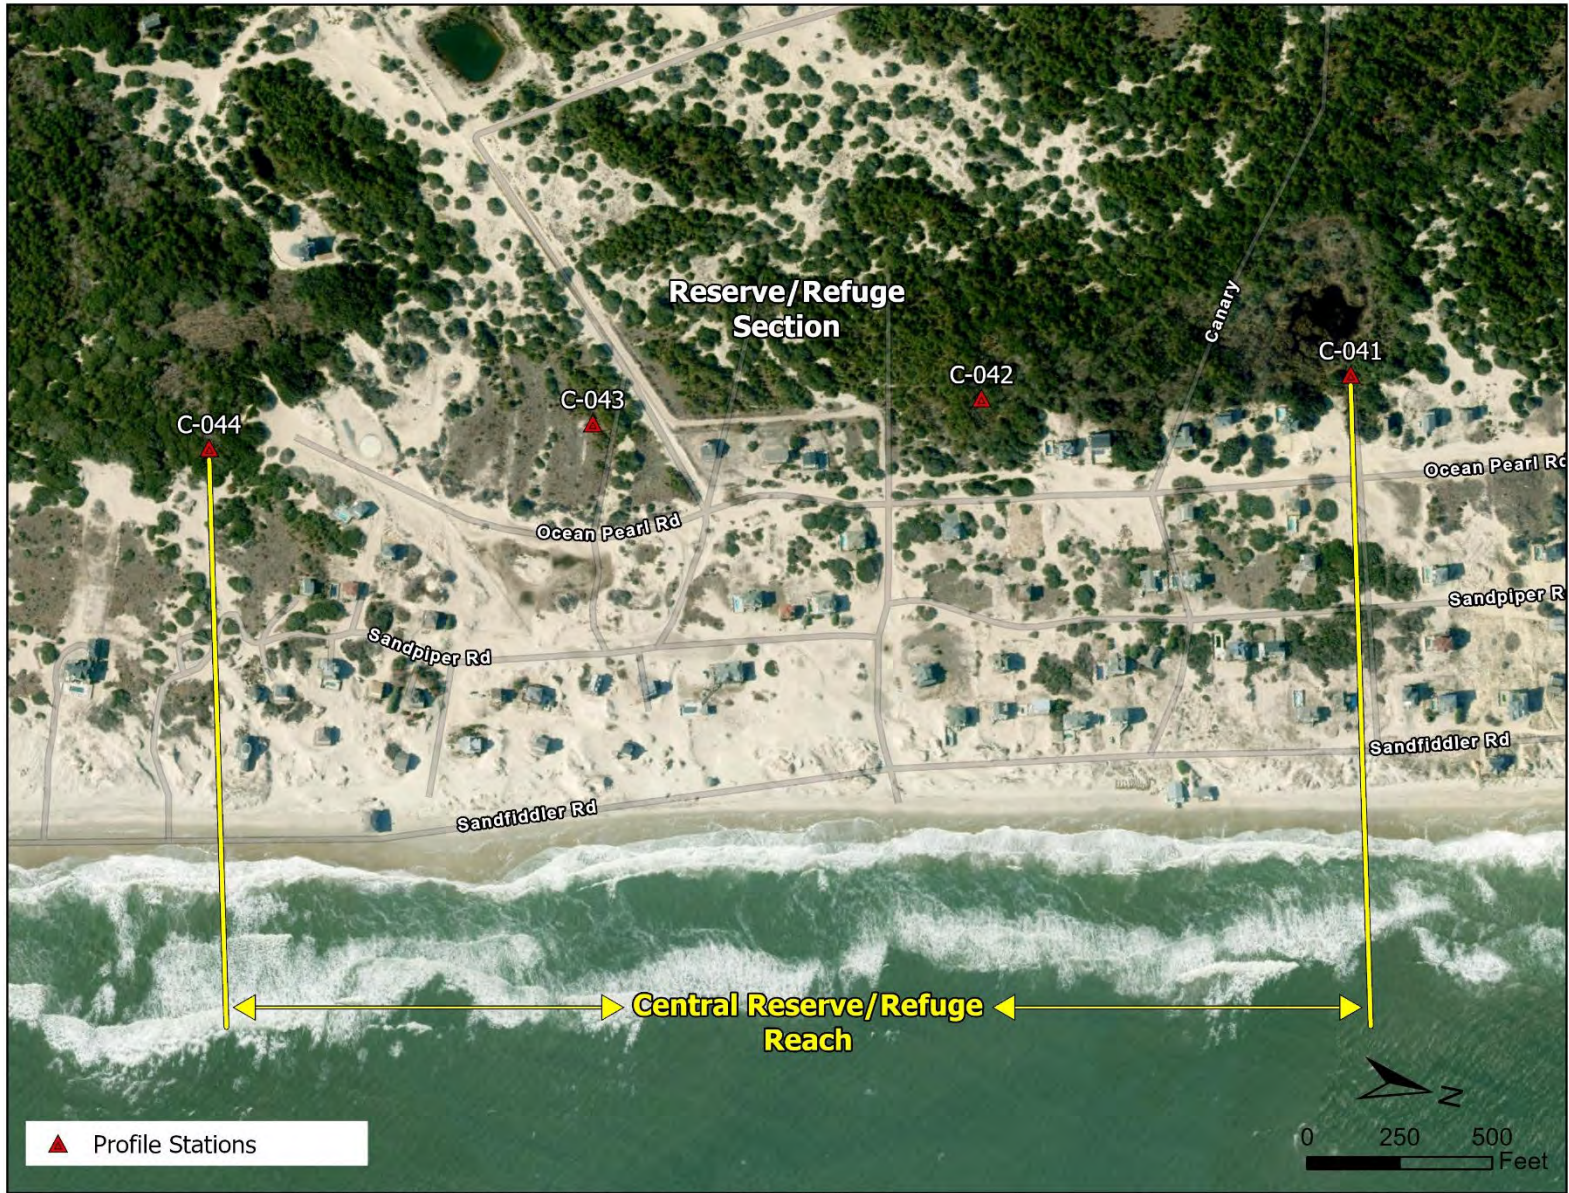
Figure 92. Map showing the extent of the Central Reserve/Refuge Reach.

Three alternatives were evaluated as part of the feasibility assessment for the Sections north of the Horse Gate: 1) the No Action Alternative; 2) Buyout and Removal of Threatened Oceanfront Structures; and 3) Beach Nourishment Program. These alternatives focus on the portion of shoreline located between Stations C-041 and C-044 shown in Figure 92 and is referred to as the Central Reserve/Refuge Reach.
