DRAFT: BEACH MANAGEMENT PLAN CURRITUCK COUNTY, NORTH CAROLINA

PREPARED FOR
CURRITUCK COUNTY

PREPARED BY
COASTAL PROTECTION ENGINEERING OF NORTH CAROLINA, INC.
ENGINEERING LICENSE CERTIFICATE #: C-2331

June 2026

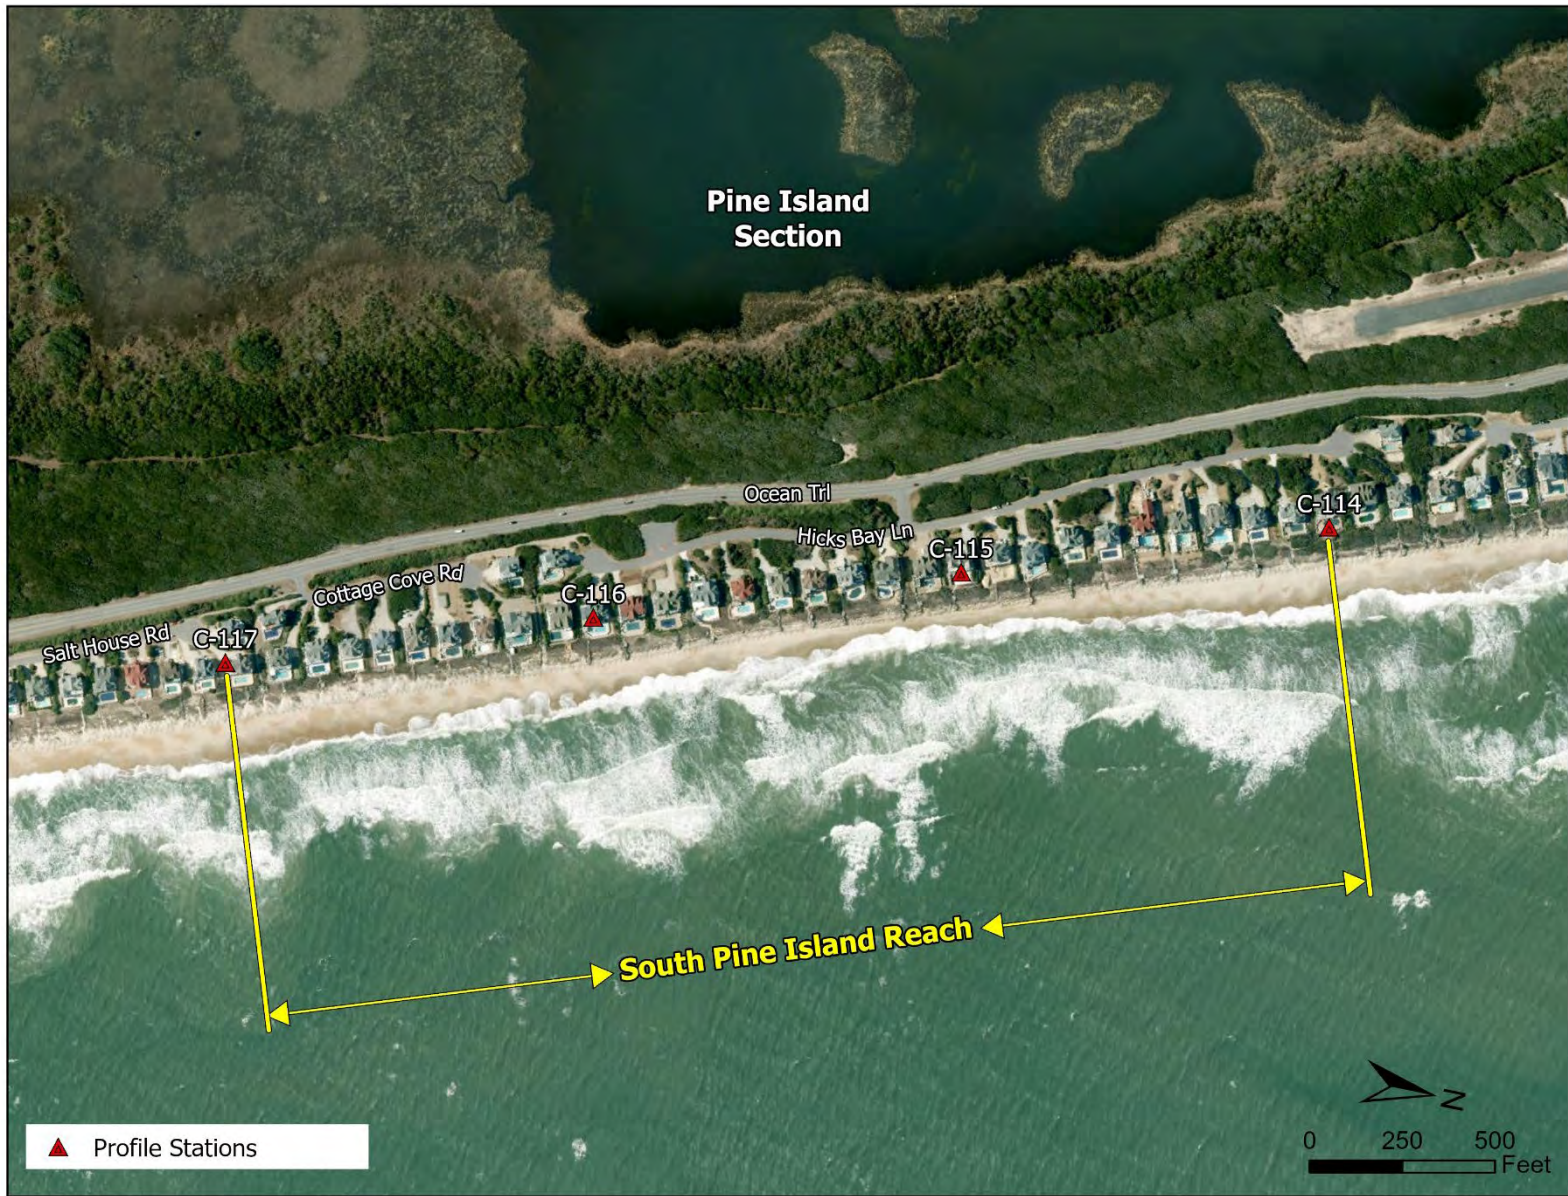
Figure 98. Map showing the extent of the South Pine Island Reach

The South Pine Island Reach, which is shown in Figure 98, includes an approximately 3,000 foot long portion of the Pine Island Section, south of the Hampton Inn. The Reach covers the oceanfront from Station C-014 to C-017, east of Hicks Bay Lane and Cottage Cove Road. Of the three different design storms considered, the South Pine Island Reach was only identified as vulnerable to storm damage under the Hurricane Isabel design storm. The impacts observed through simulations of the 25-year return interval and 2009 Nor'easter design storms did not rise to the level that warranted active beach management.
