**ENGINEERING REPORT
FOR
HIDDEN OAKS SUBDIVISION
FOR
COMMON AREA TURNOVER**

Updated March 24 & May 23, 2023

HIDDEN OAKS COMMON AREAS

PURPOSE OF THE REPORT

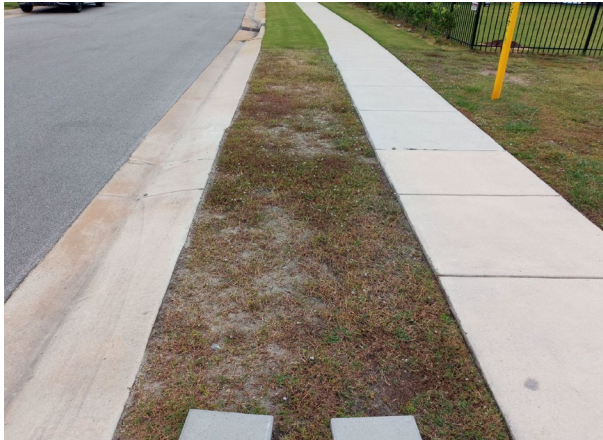
Photo #1 - Sidewalk on North side of Lot 67, Facing East

Sidewalks: Photos 1 thru 23 show various sections of sidewalk throughout the subdivision

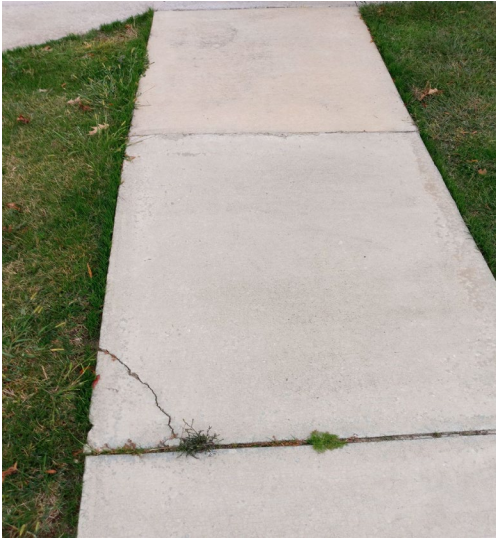
Photo #16 - Sidewalk in front of Lot 21, Facing North with cracked corner

- Repair of cracked concrete sidewalk and pedestrian crossing ramp tapers
- Removal of excess swale vegetation where noted
- Seeding of eroded areas at BMP 1
- Supplemental seeding of 2 cul-de-sac islands

March 24, 2023 Update: Repairs have been made and inspected, and the common areas and facilities appear to be ready for turnover to the HOA.

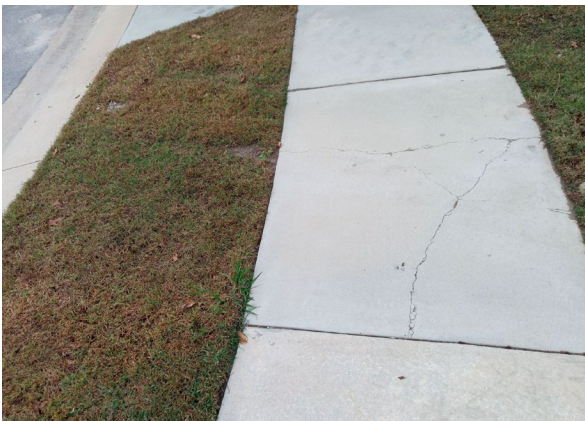
Photo #22 – Cracked sidewalk in front of Lot 10, Facing South

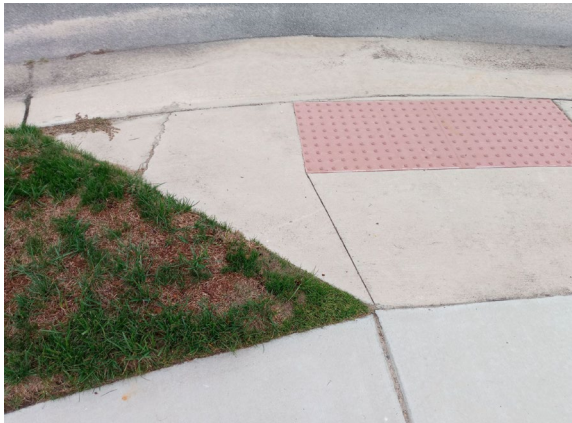
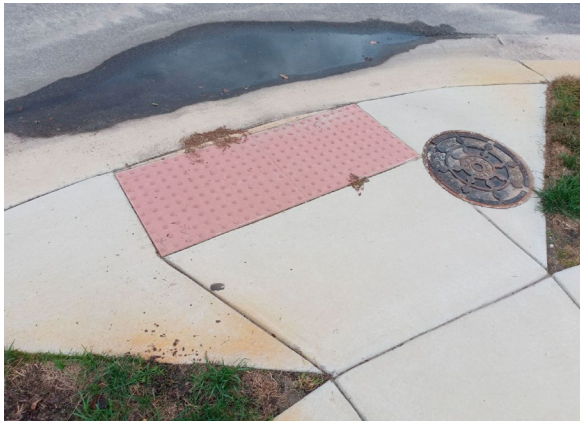
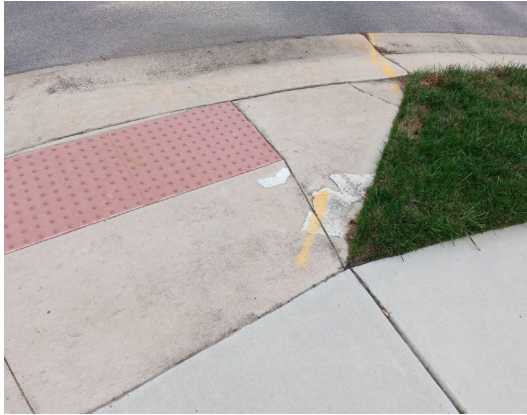
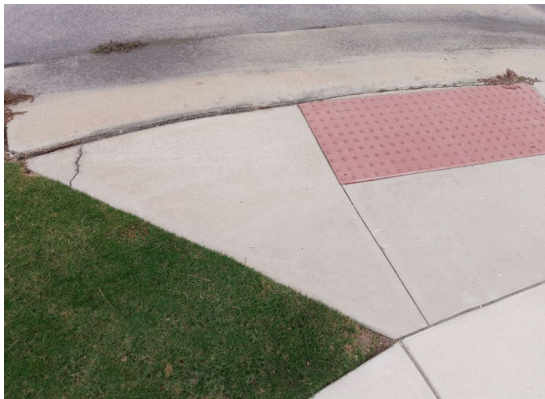
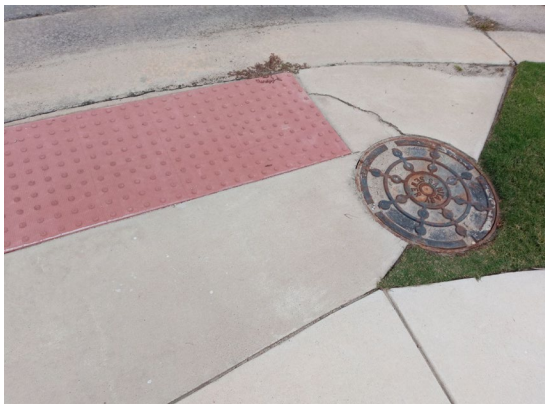
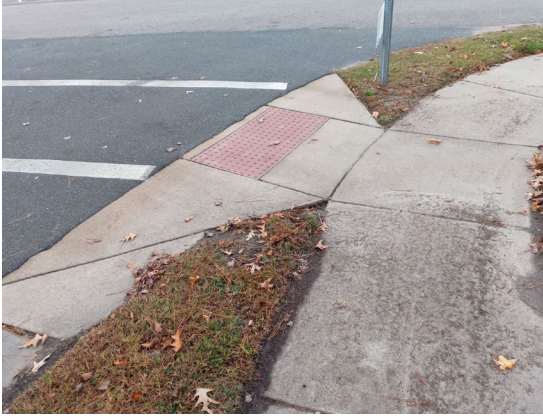
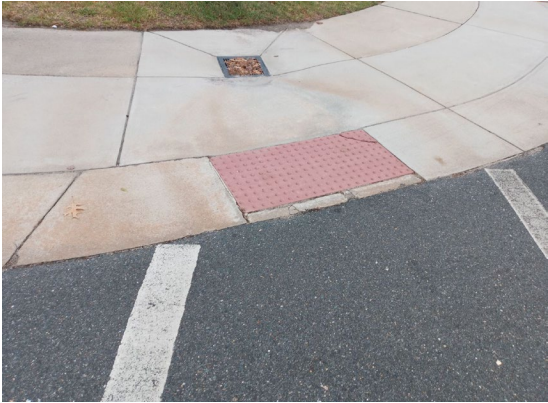
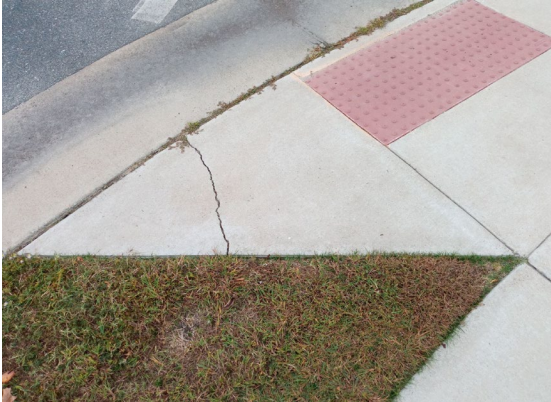
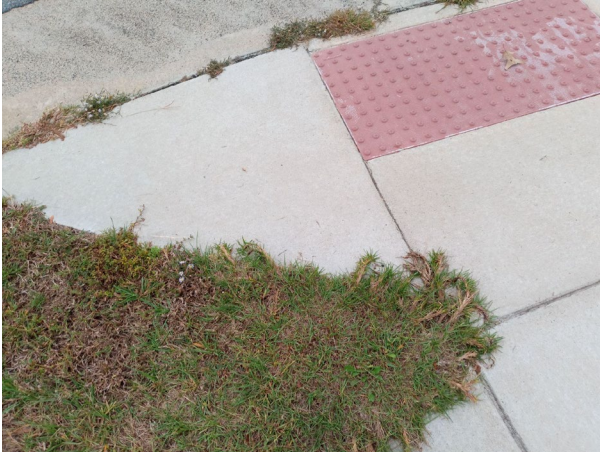
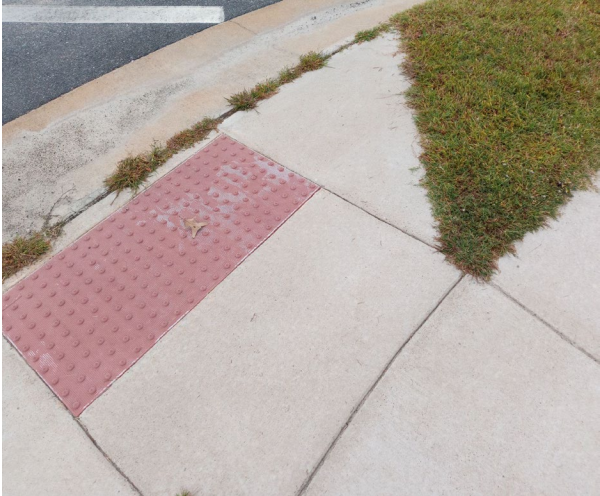
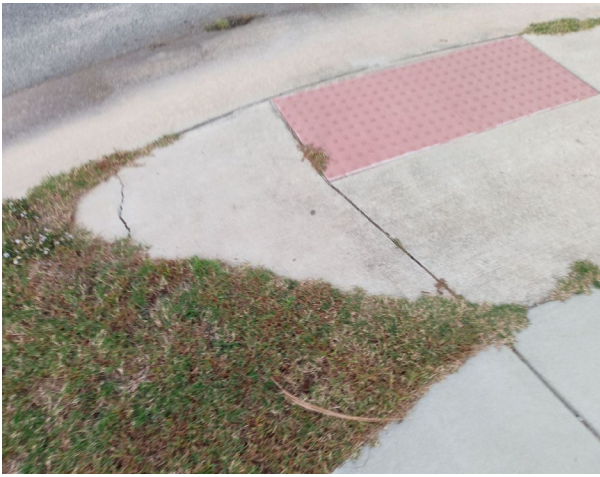
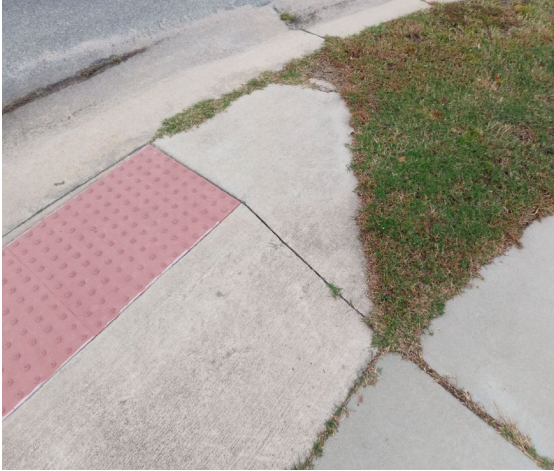
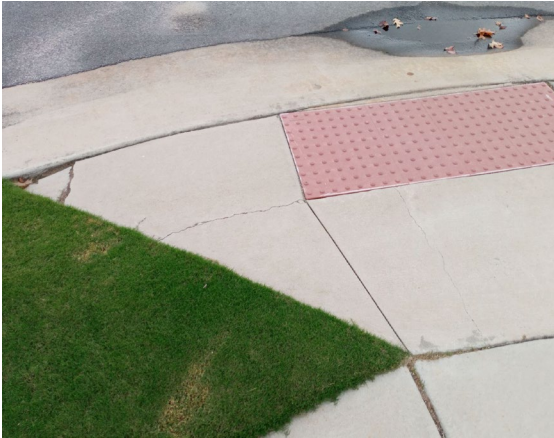
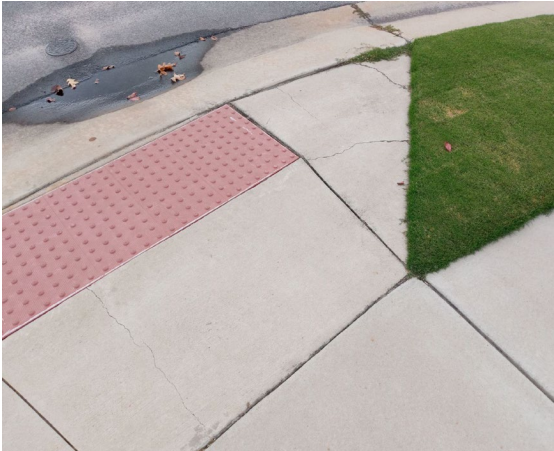
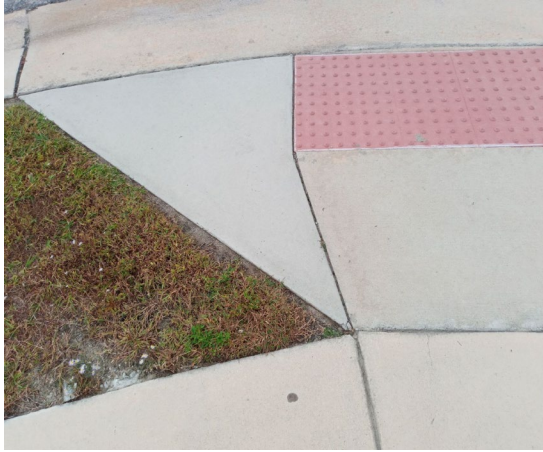
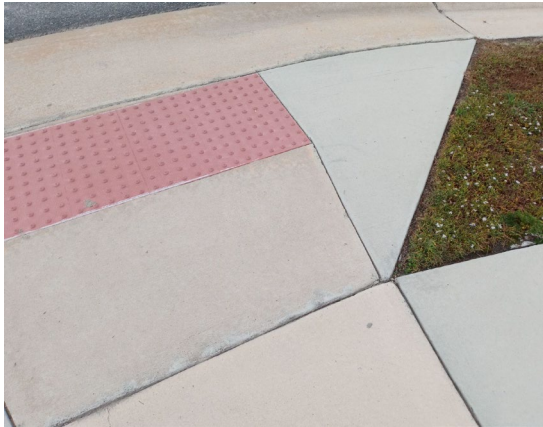
Pedestrian Crossings: Photos 24 thru 39 show the pedestrian crossings within Hidden Oaks. The majority of the crossing pavements have at least one crack. Generally the cracks are on the taper sections nearest to the grass and road. The cracks should be either be repaired or small taper sections of concrete replaced.

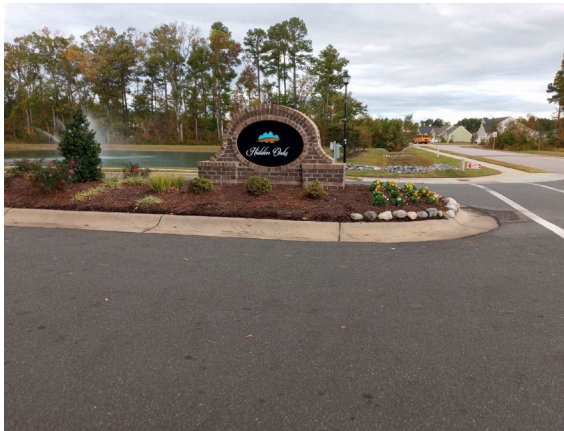
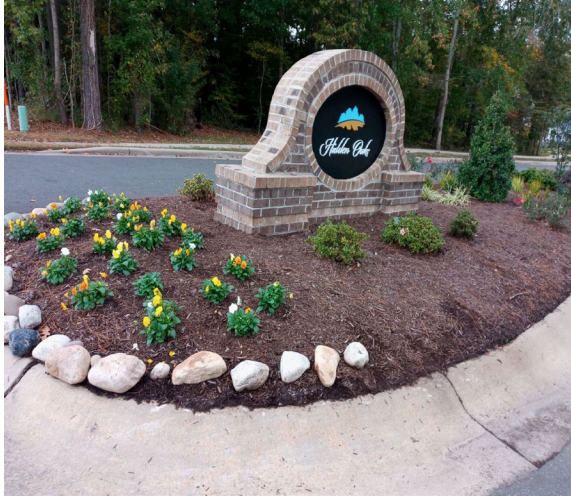
Entrance Sign: Photos 40 and 41 show the condition of the Hidden Oaks entrance sign. The sign is in like new condition, with no staining, bleaching, or rusting.

Photo #40 - South side of the Entrance sign, Facing North

Photo #41 - North side of the Entrance Sign, Facing Southwest

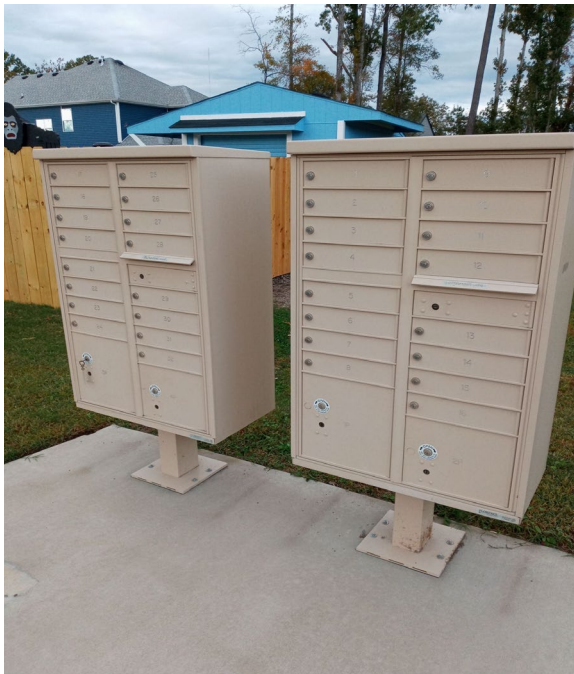
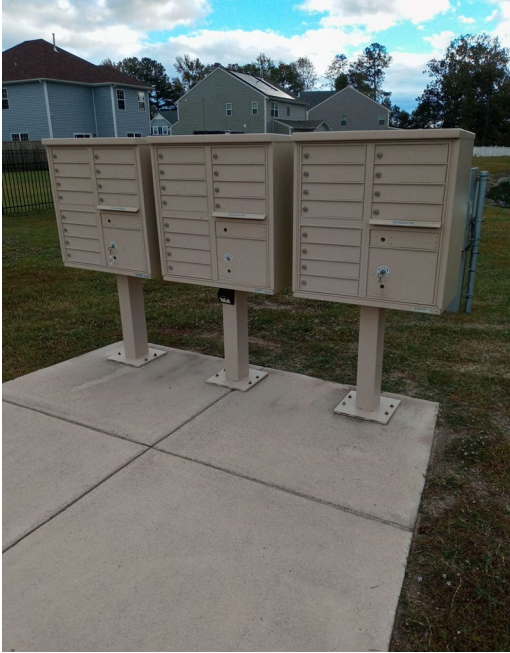
Mail Area: Photos 42 and 43 show the two sets of mail boxes within Hidden Oaks. Both sets of boxes are in good condition, with no indentations or fading of colors.

Photo #42 - Mailboxes between Lot 22 and Lot 23, Facing North

Photo #43 - Western Mailboxes, Facing South

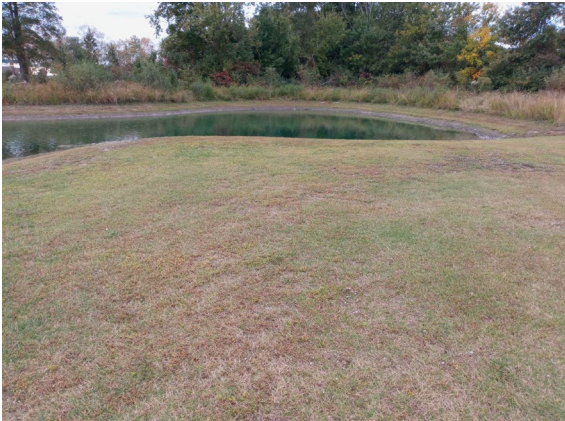
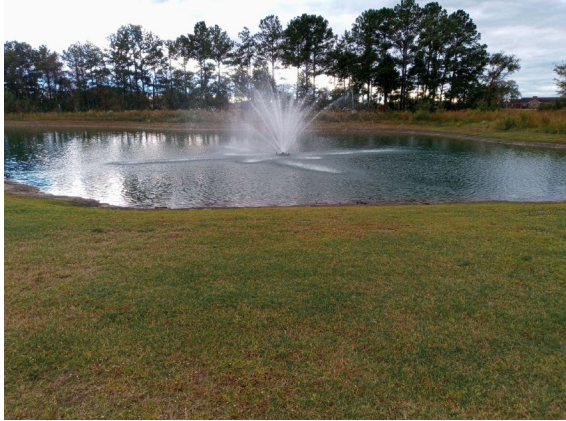
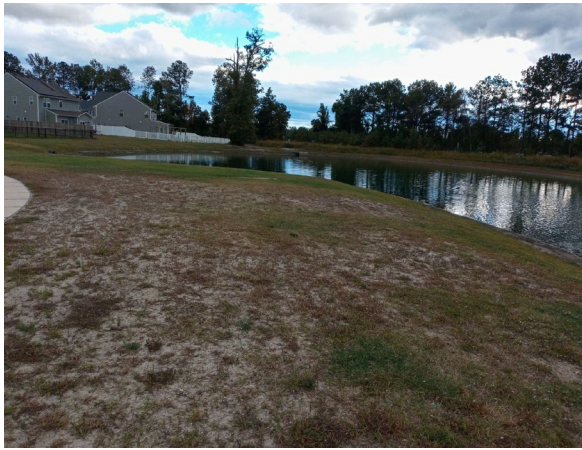
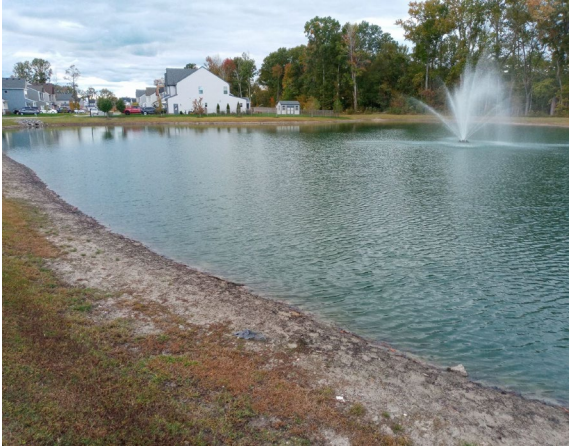
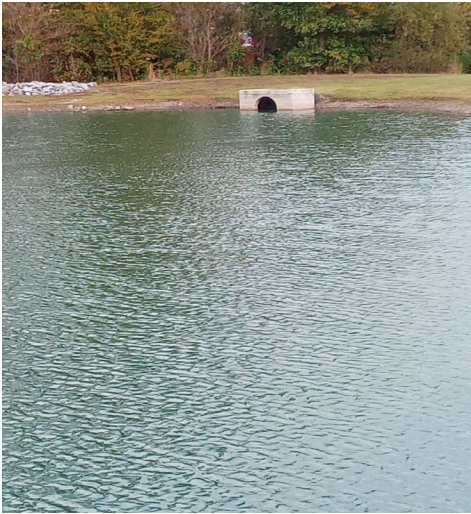
Stormwater Management Ponds: Photos 44 thru 49 show the two stormwater ponds, both of which appear to be well-maintained, with proper water levels and mostly good vegetative cover around the edges of the ponds.

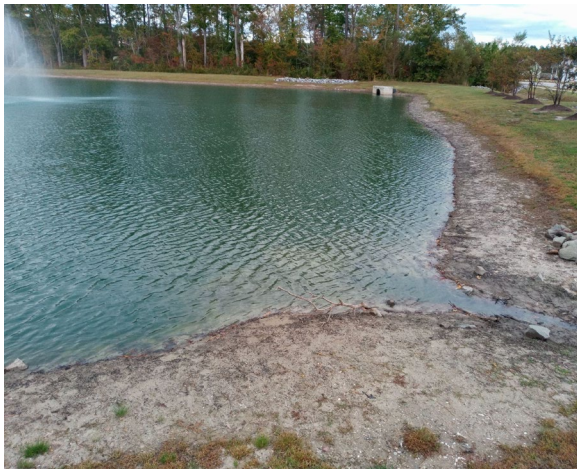
Photo #47 - East side of Stormwater BMP 1, Facing North. Some additional stabilization appears to me needed here.

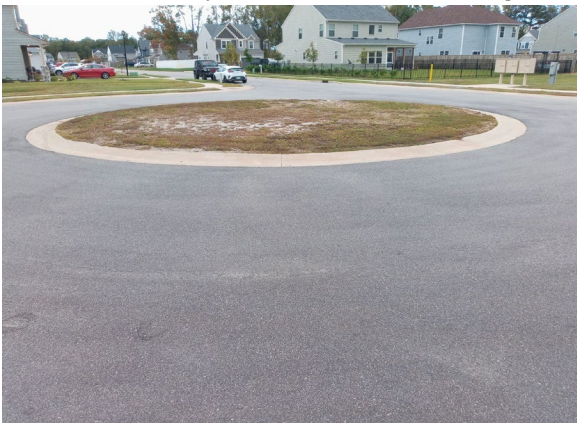
Cul De Sac Islands: Photos 50 thru 54 show all five cul de sacs of the Hidden Oaks Estates. The islands in the North and Sout Gumberry Trace, and S Heritage Tree Manor are well vegetated. It appears that the Shady Oak and the Oak Bend Cul de sacs each need some additional ground cover.

Photo #50 - Shady Oaks Cul-de-sac, Facing East

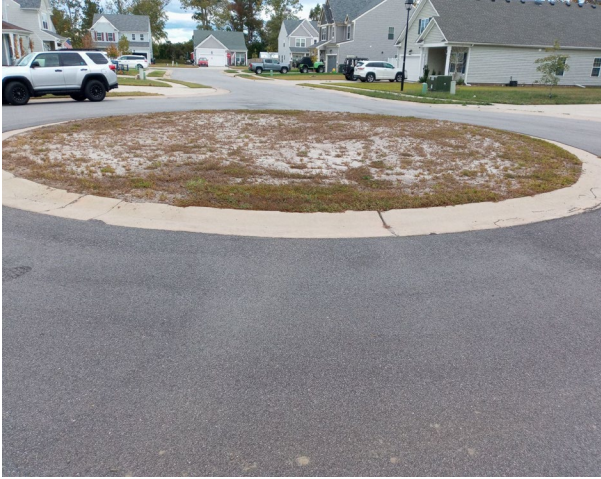
Photo #51 - Oak Bend Cul-de-sac, Facing North

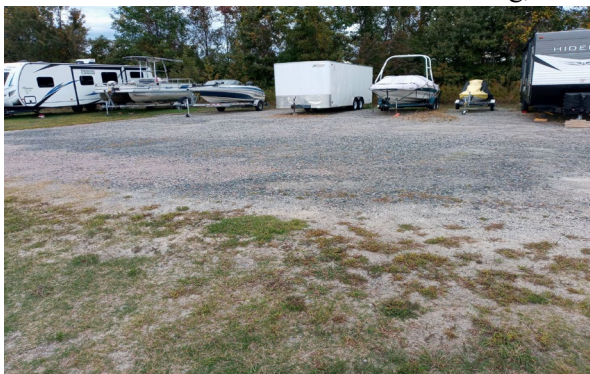
Photo #55 - West side of the Trailer Parking, Facing Northwest

Trailer/RV Parking Area : Photos 55 and 56 show the gravel area where trailers and RVs are parked.

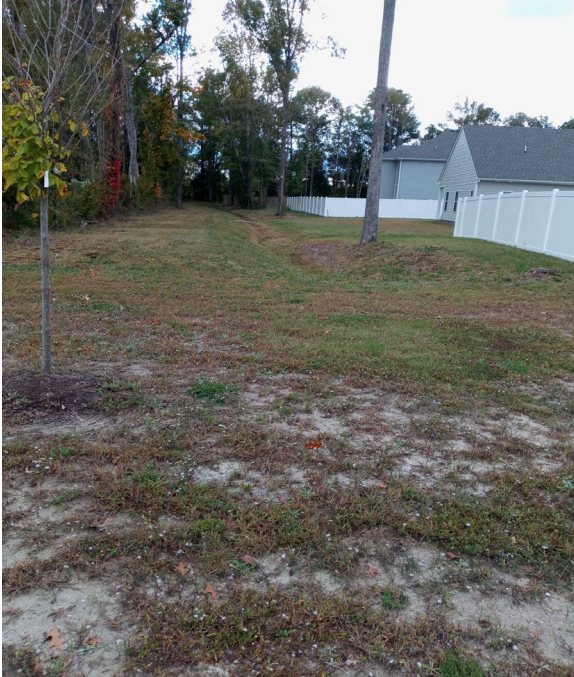
Photo #57 - Swale between lot 57 and Lot 58, Facing South

Swales and Culverts: Photos 57 thru 66 show the swales and culverts within Hidden Oak that are not subject to NCDOT maintenance. Most of the swales and culverts of Hidden Oaks are in excellent condition, with no excess ponding noticeable and the proper vegetative cover.

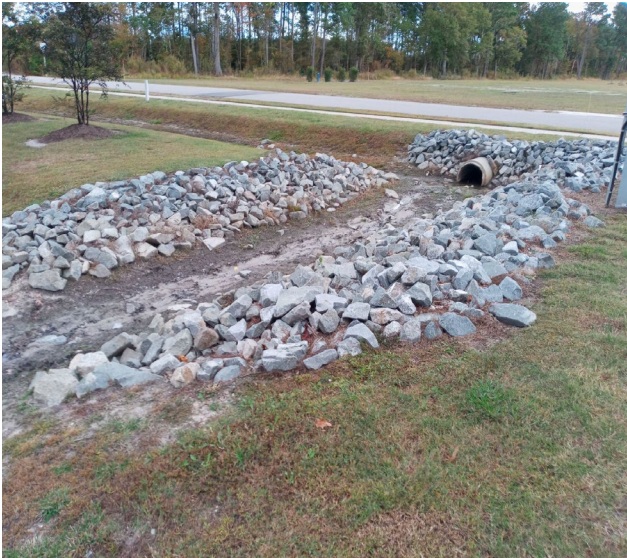
Photo #61 – Riprap lined channel and Inlet Culvert into Stormwater BMP 1, Facing Northeast

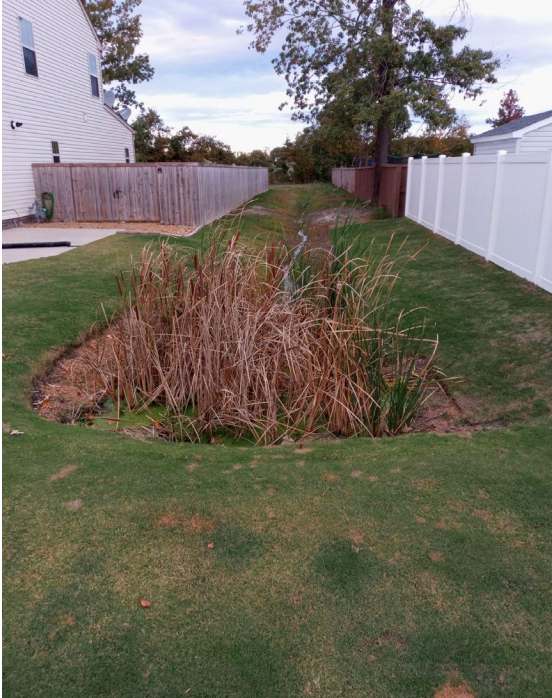
Photo #63 - Swale between Lot 8 and Lot 9, Facing North has some extra vegetation that should be cut
