CONDITION STUDY FOR
CURRITUCK COUNTY

**CURRITUCK COUNTY COURTHOUSE
CURRITUCK COUNTY
NORTH CAROLINA**

MARCH 1993

CONDITION STUDY
FOR THE
RENOVATION AND REPAIR OF THE
ORIGINAL CURRITUCK COUNTY COURTHOUSE

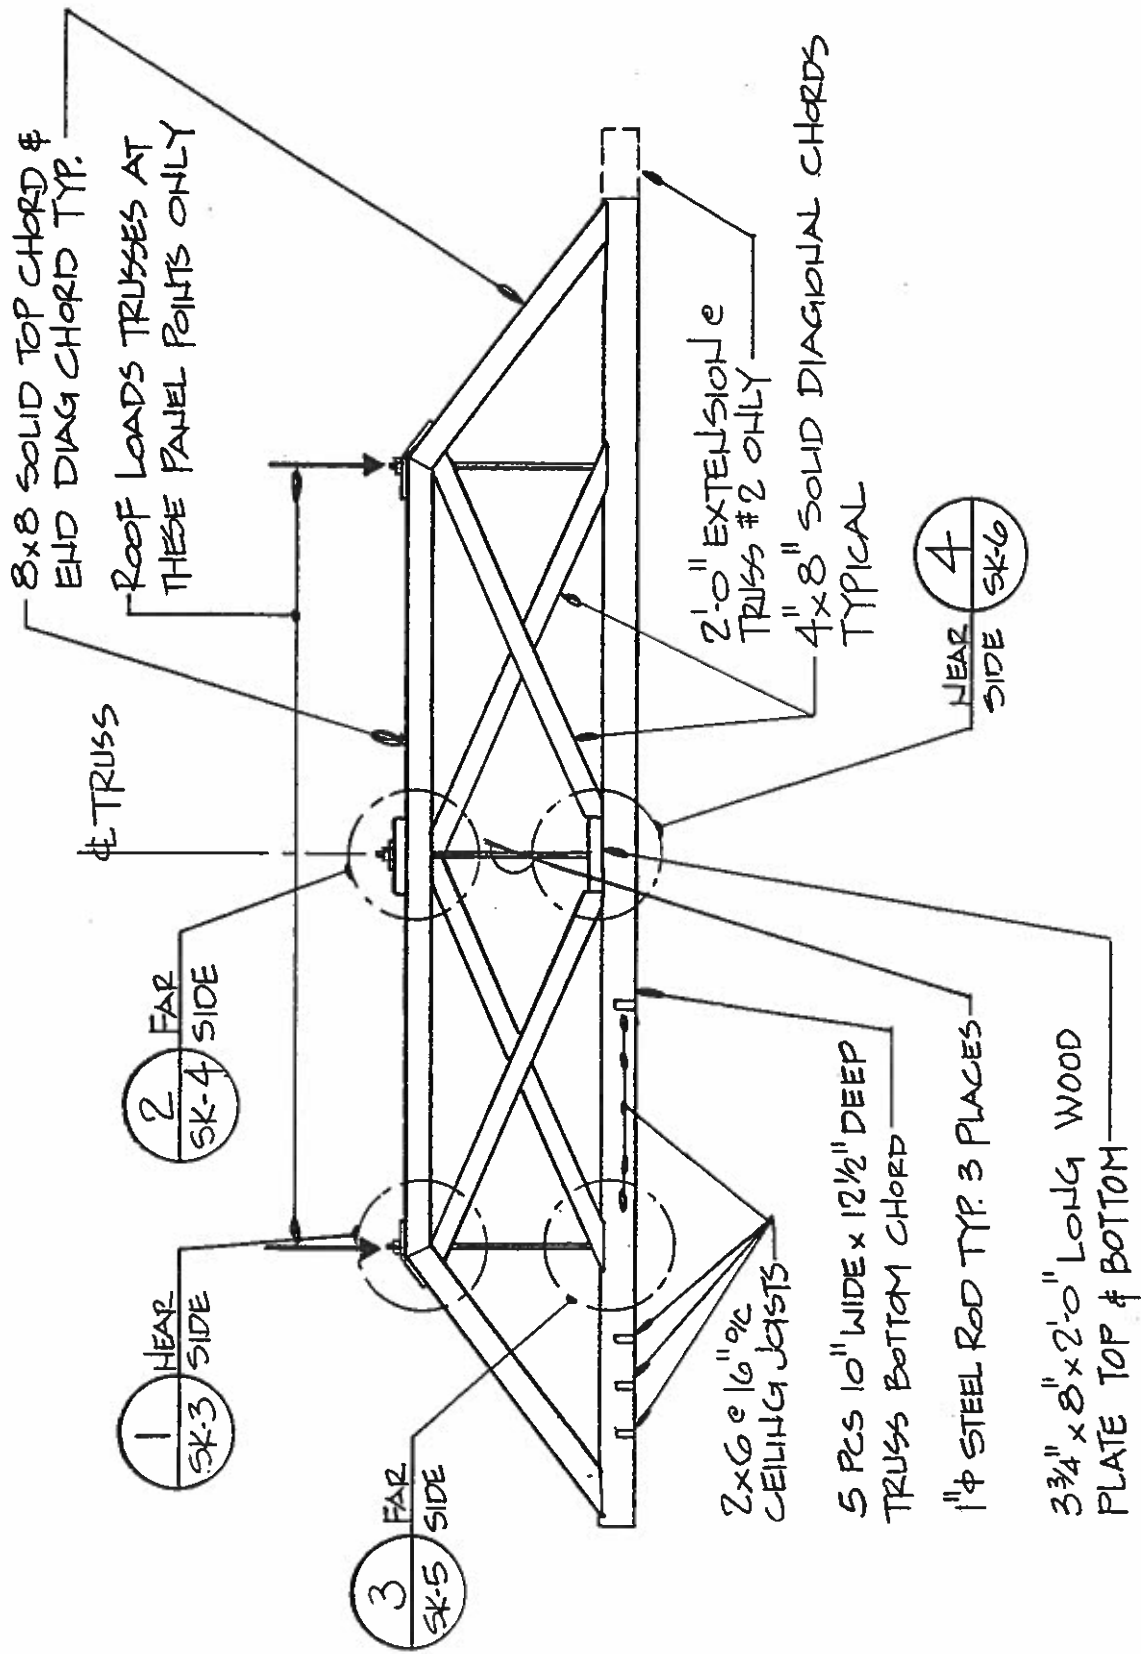
TRUSS ELEVATION

The trusses overall are in excellent condition considering their age. There is some checking or splitting in the top chord and diagonals, however it is our opinion that the checking in these members is not detrimental to the load carrying capacity of the trusses and replacement or repairs to the checks is unnecessary.

Where diagonals adjoining the top and bottom chords have separated, we recommend that the separations be closed on all three trusses.
