<b>TITLE</b>		
Impact Line and Projected Shoreline Maps 2022 Beach Monitoring and Stability Assessment Currituck County, NC		
COASTAL PROTECTION ENGINEERING OF NORTH CAROLINA, INC. 4038 Masonboro Loop Road Wilmington, NC 28409 PH (910) 399-1905		
Date: 1/2/2023	By: FMM	Page 1 of 23

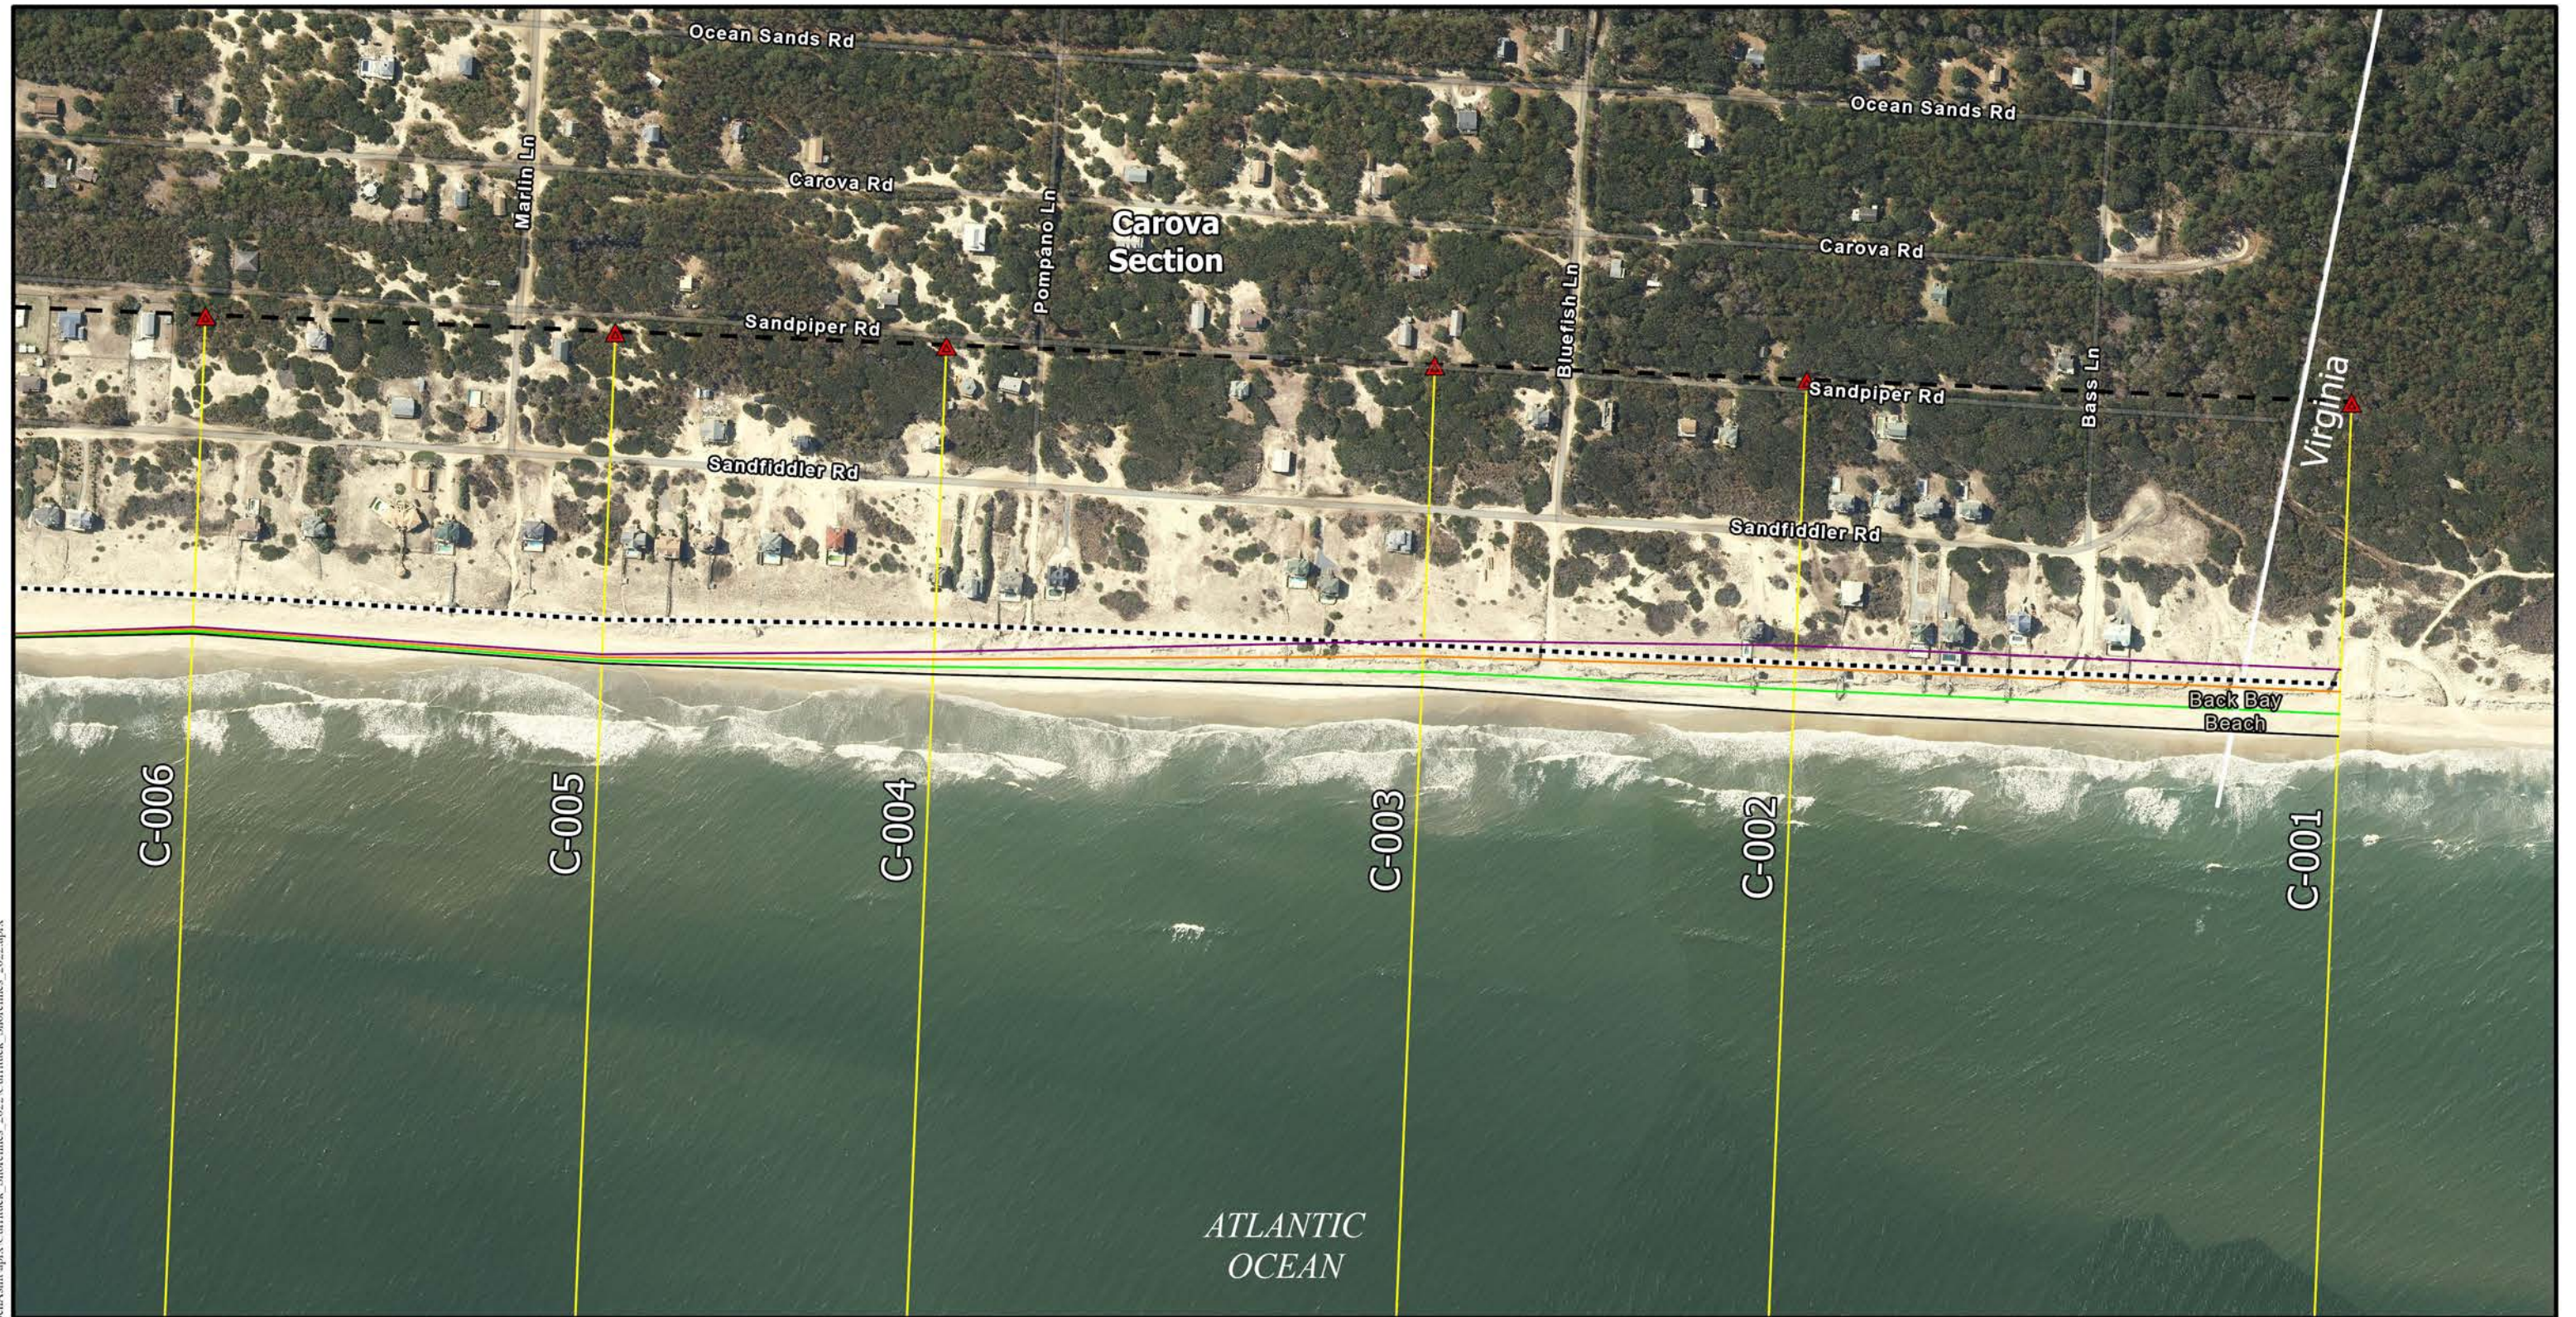
- 1) Aerial imagery collected between February 2 and March 9, 2020 by the North Carolina Orthoimagery Program.
- 2) Shoreline position based on data collected in May 2022 by Coastal Protection Engineering of North Carolina, Inc.

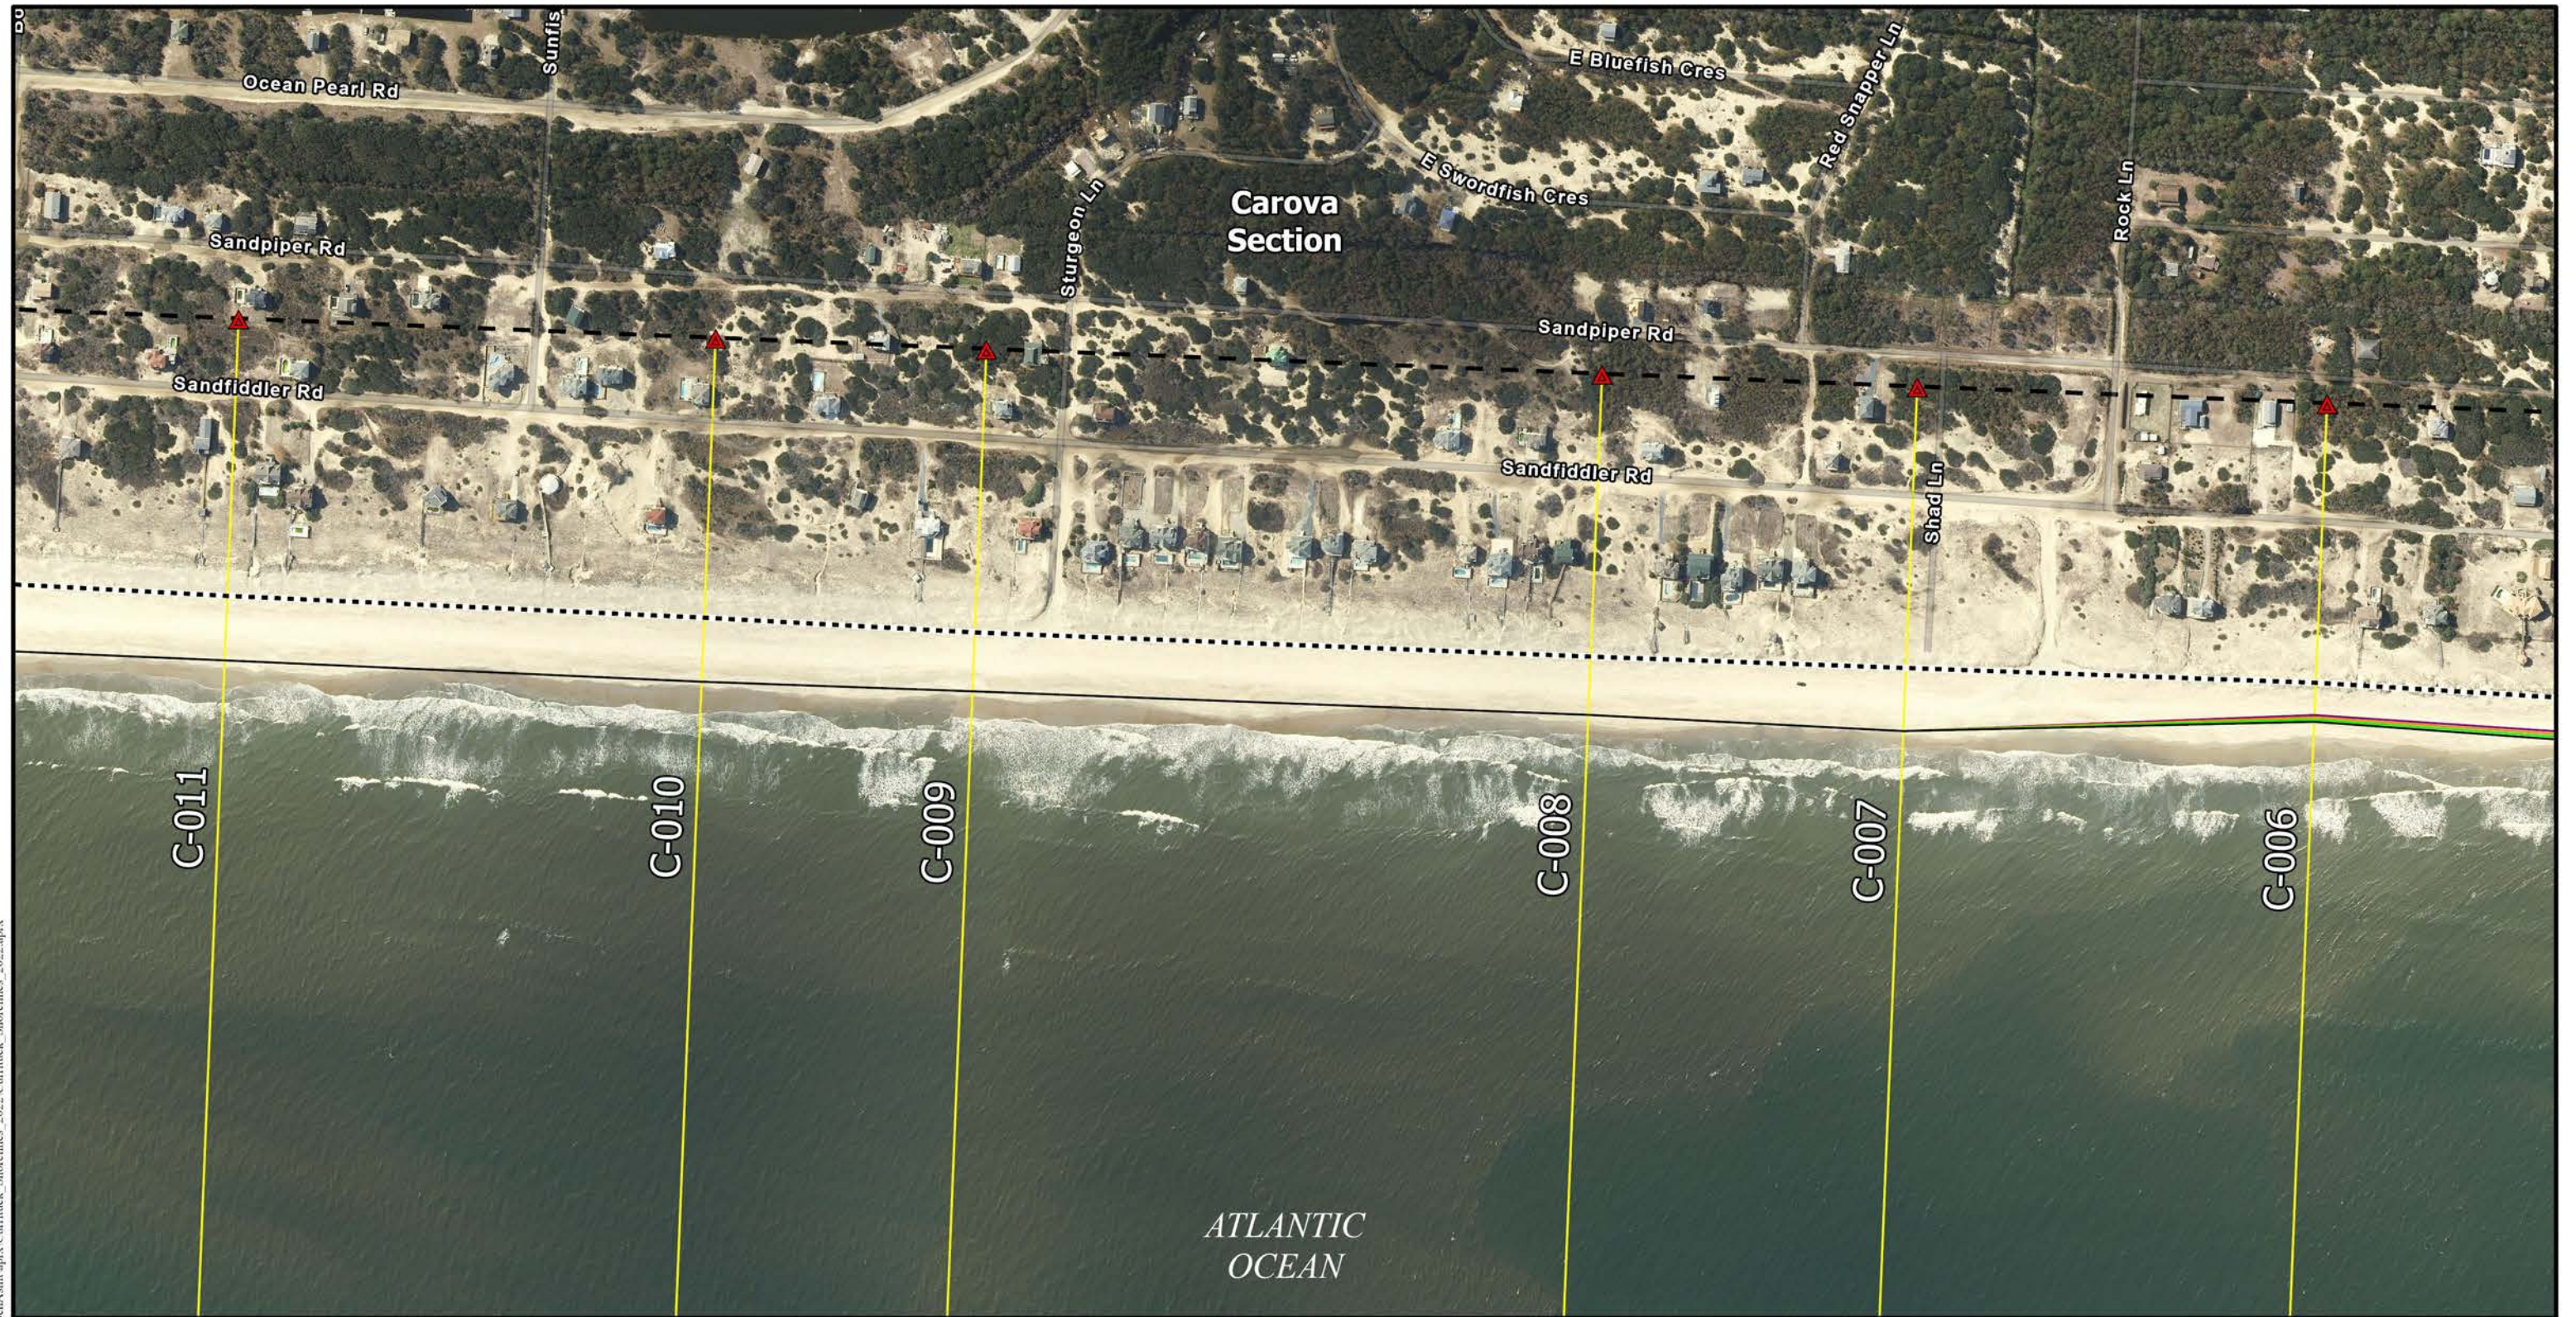
<b>TITLE</b>		
Impact Line and Projected Shoreline Maps 2022 Beach Monitoring and Stability Assessment Currituck County, NC		
COASTAL PROTECTION ENGINEERING OF NORTH CAROLINA, INC. 4038 Masonboro Loop Road Wilmington, NC 28409 PH (910) 399-1905		
Date: 1/2/2023	By: FMM	Page 2 of 23

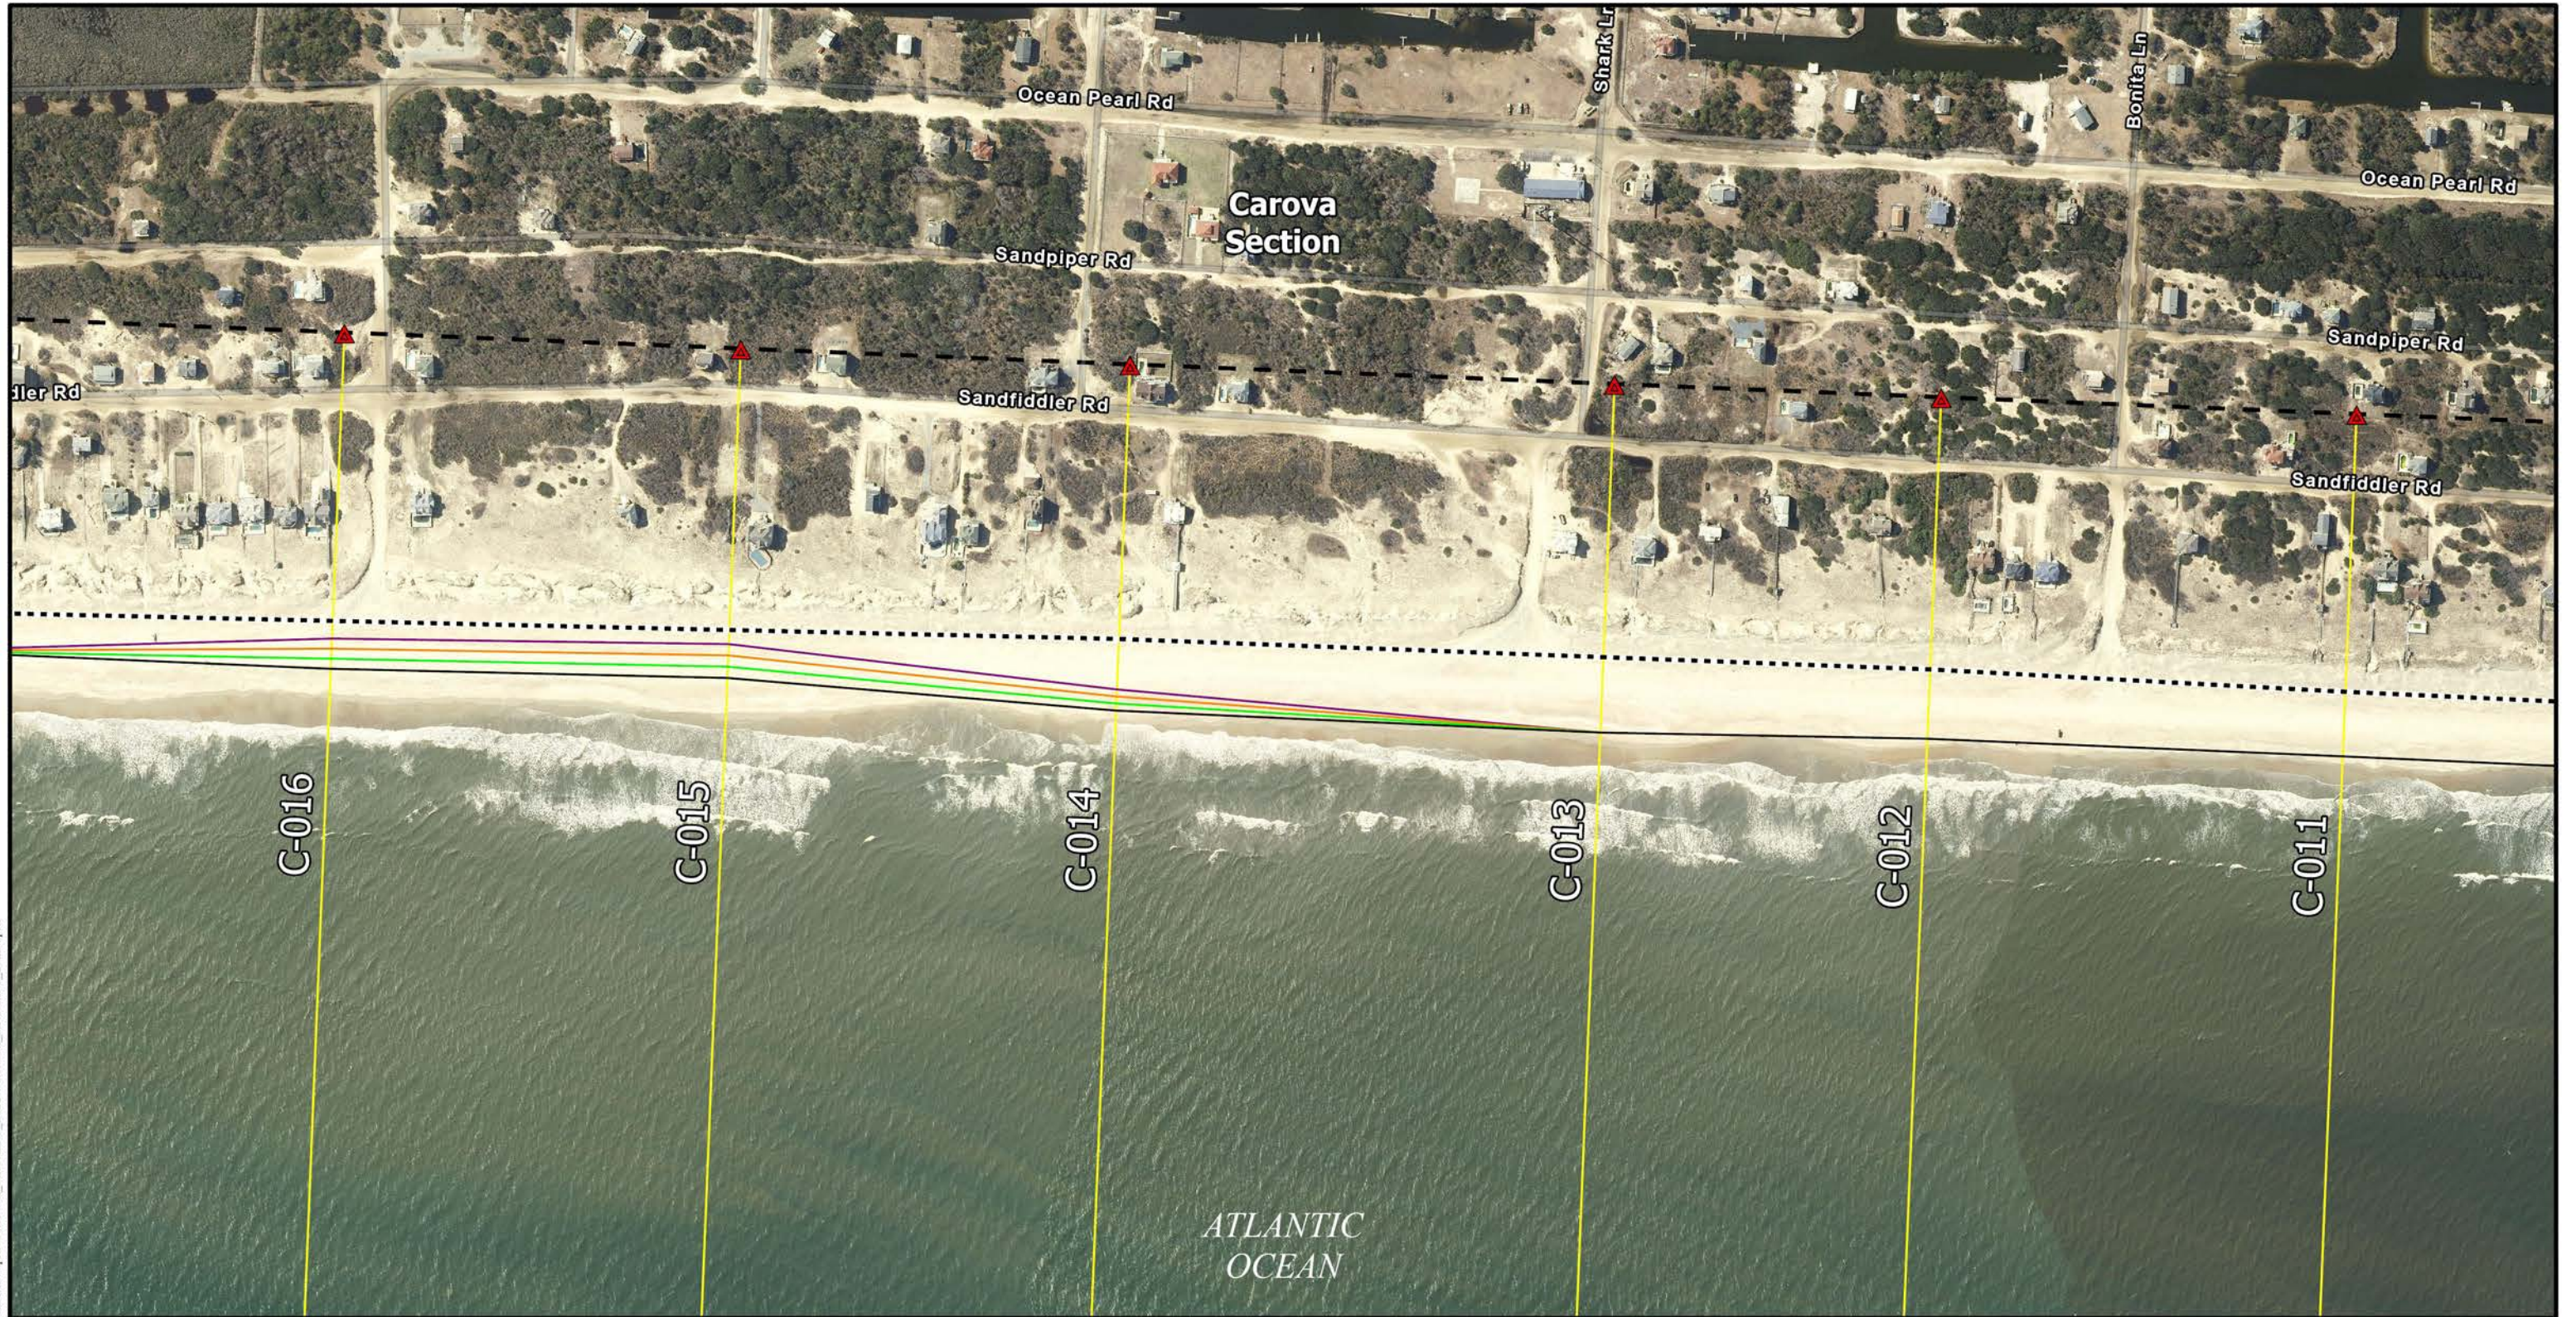
Date: 1/2/2023 By: FMM Page 3 of 23

**TITLE** Impact Line and Projected Shoreline Maps  
2022 Beach Monitoring and Stability Assessment  
Currituck County, NC

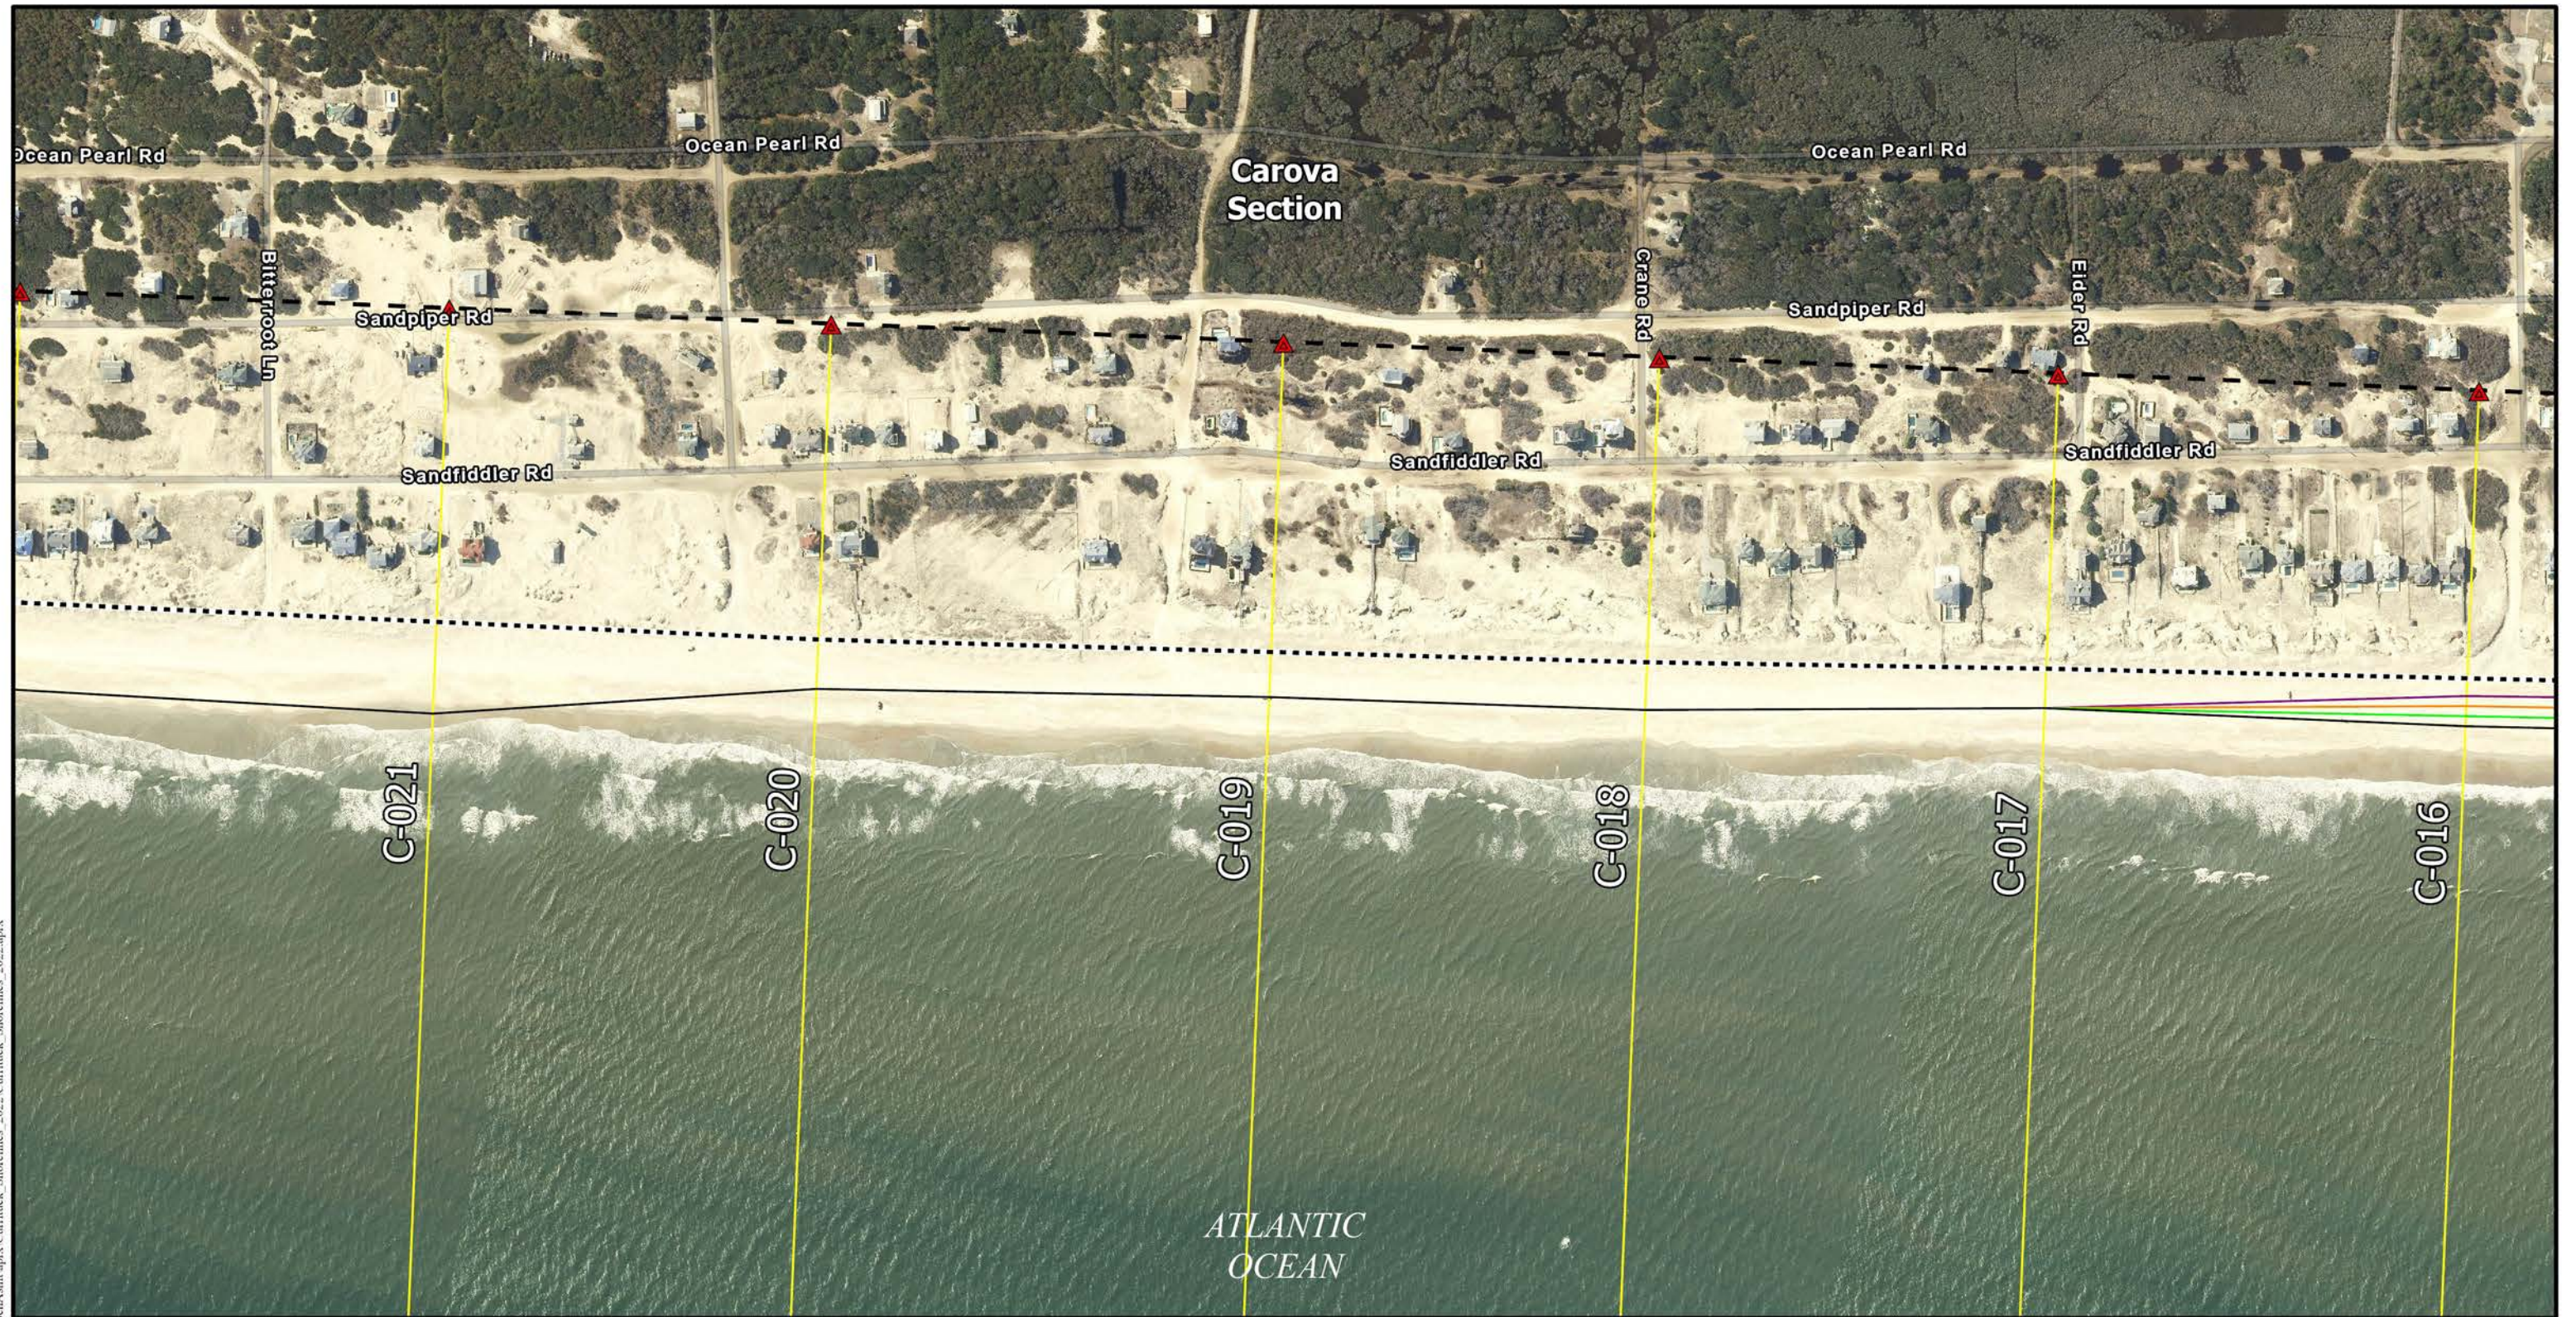
<b>TITLE</b>		
<b>Impact Line and Projected Shoreline Maps</b> 2022 Beach Monitoring and Stability Assessment Currituck County, NC		
<b>COASTAL PROTECTION ENGINEERING OF NORTH CAROLINA, INC.</b> 4038 Masonboro Loop Road Wilmington, NC 28409 PH (910) 399-1905		
Date: 1/2/2023	By: FMM	Page 4 of 23

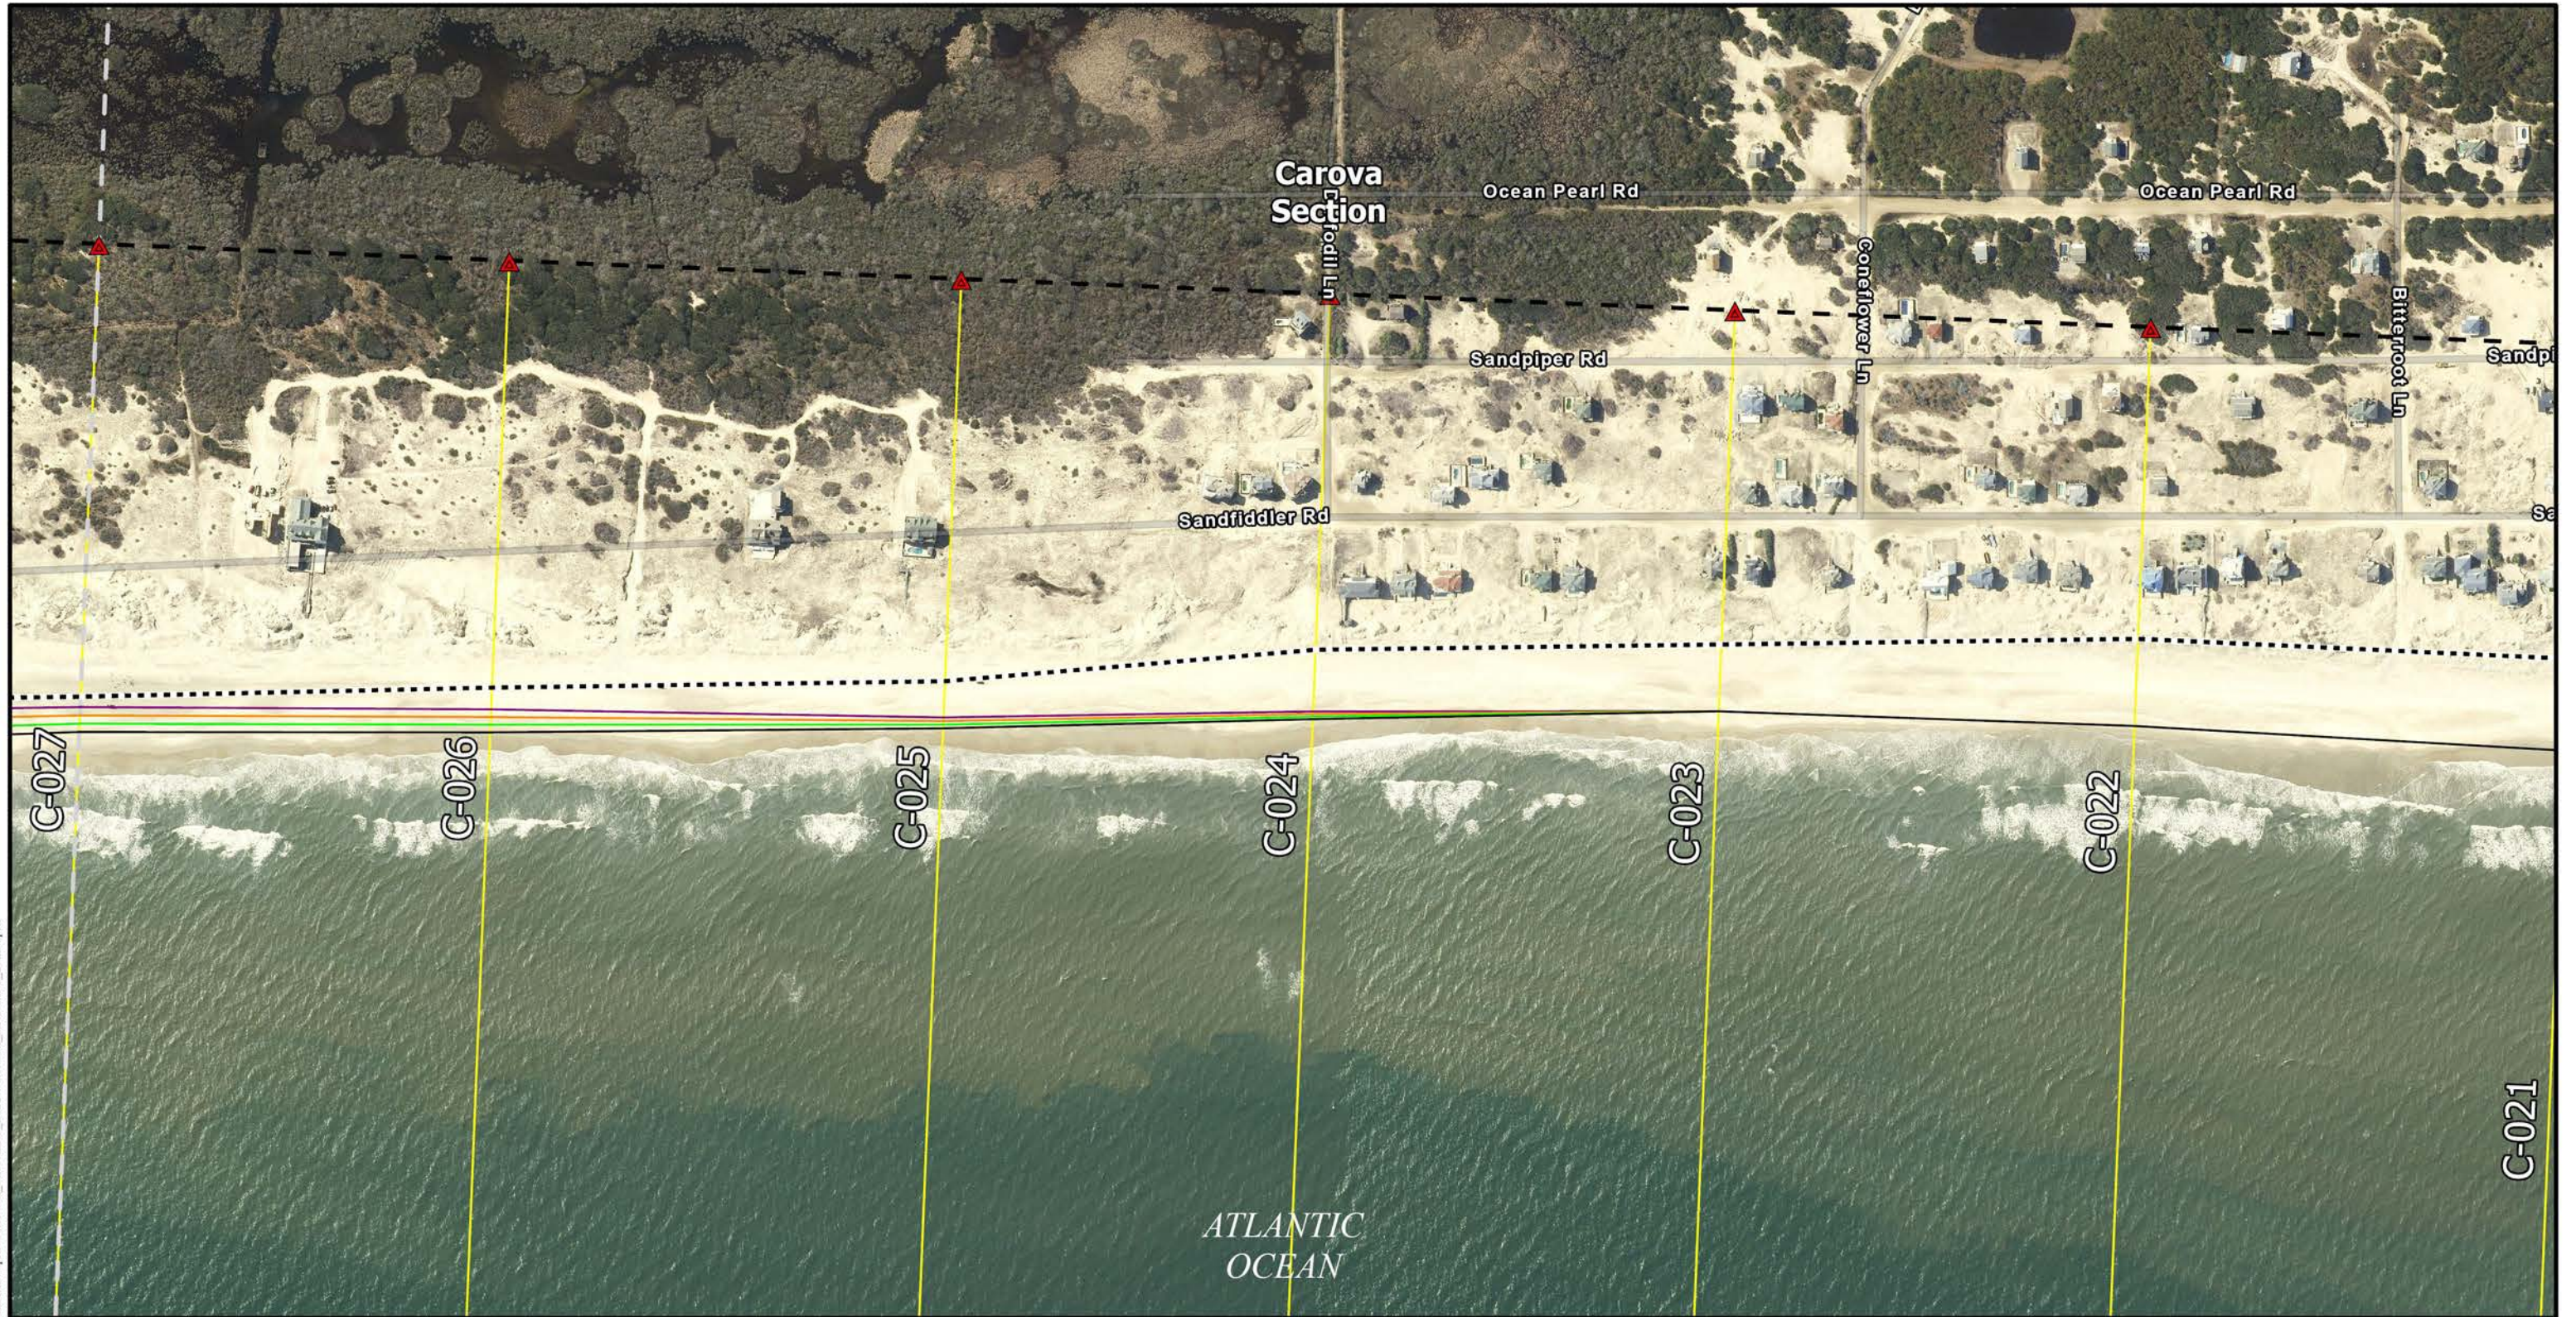
Date: 1/2/2023      By: FMM      Page 5 of 23

**TITLE**  
 Impact Line  
 and Projected Shoreline Maps  
 2022 Beach Monitoring and Stability Assessment  
 Currituck County, NC

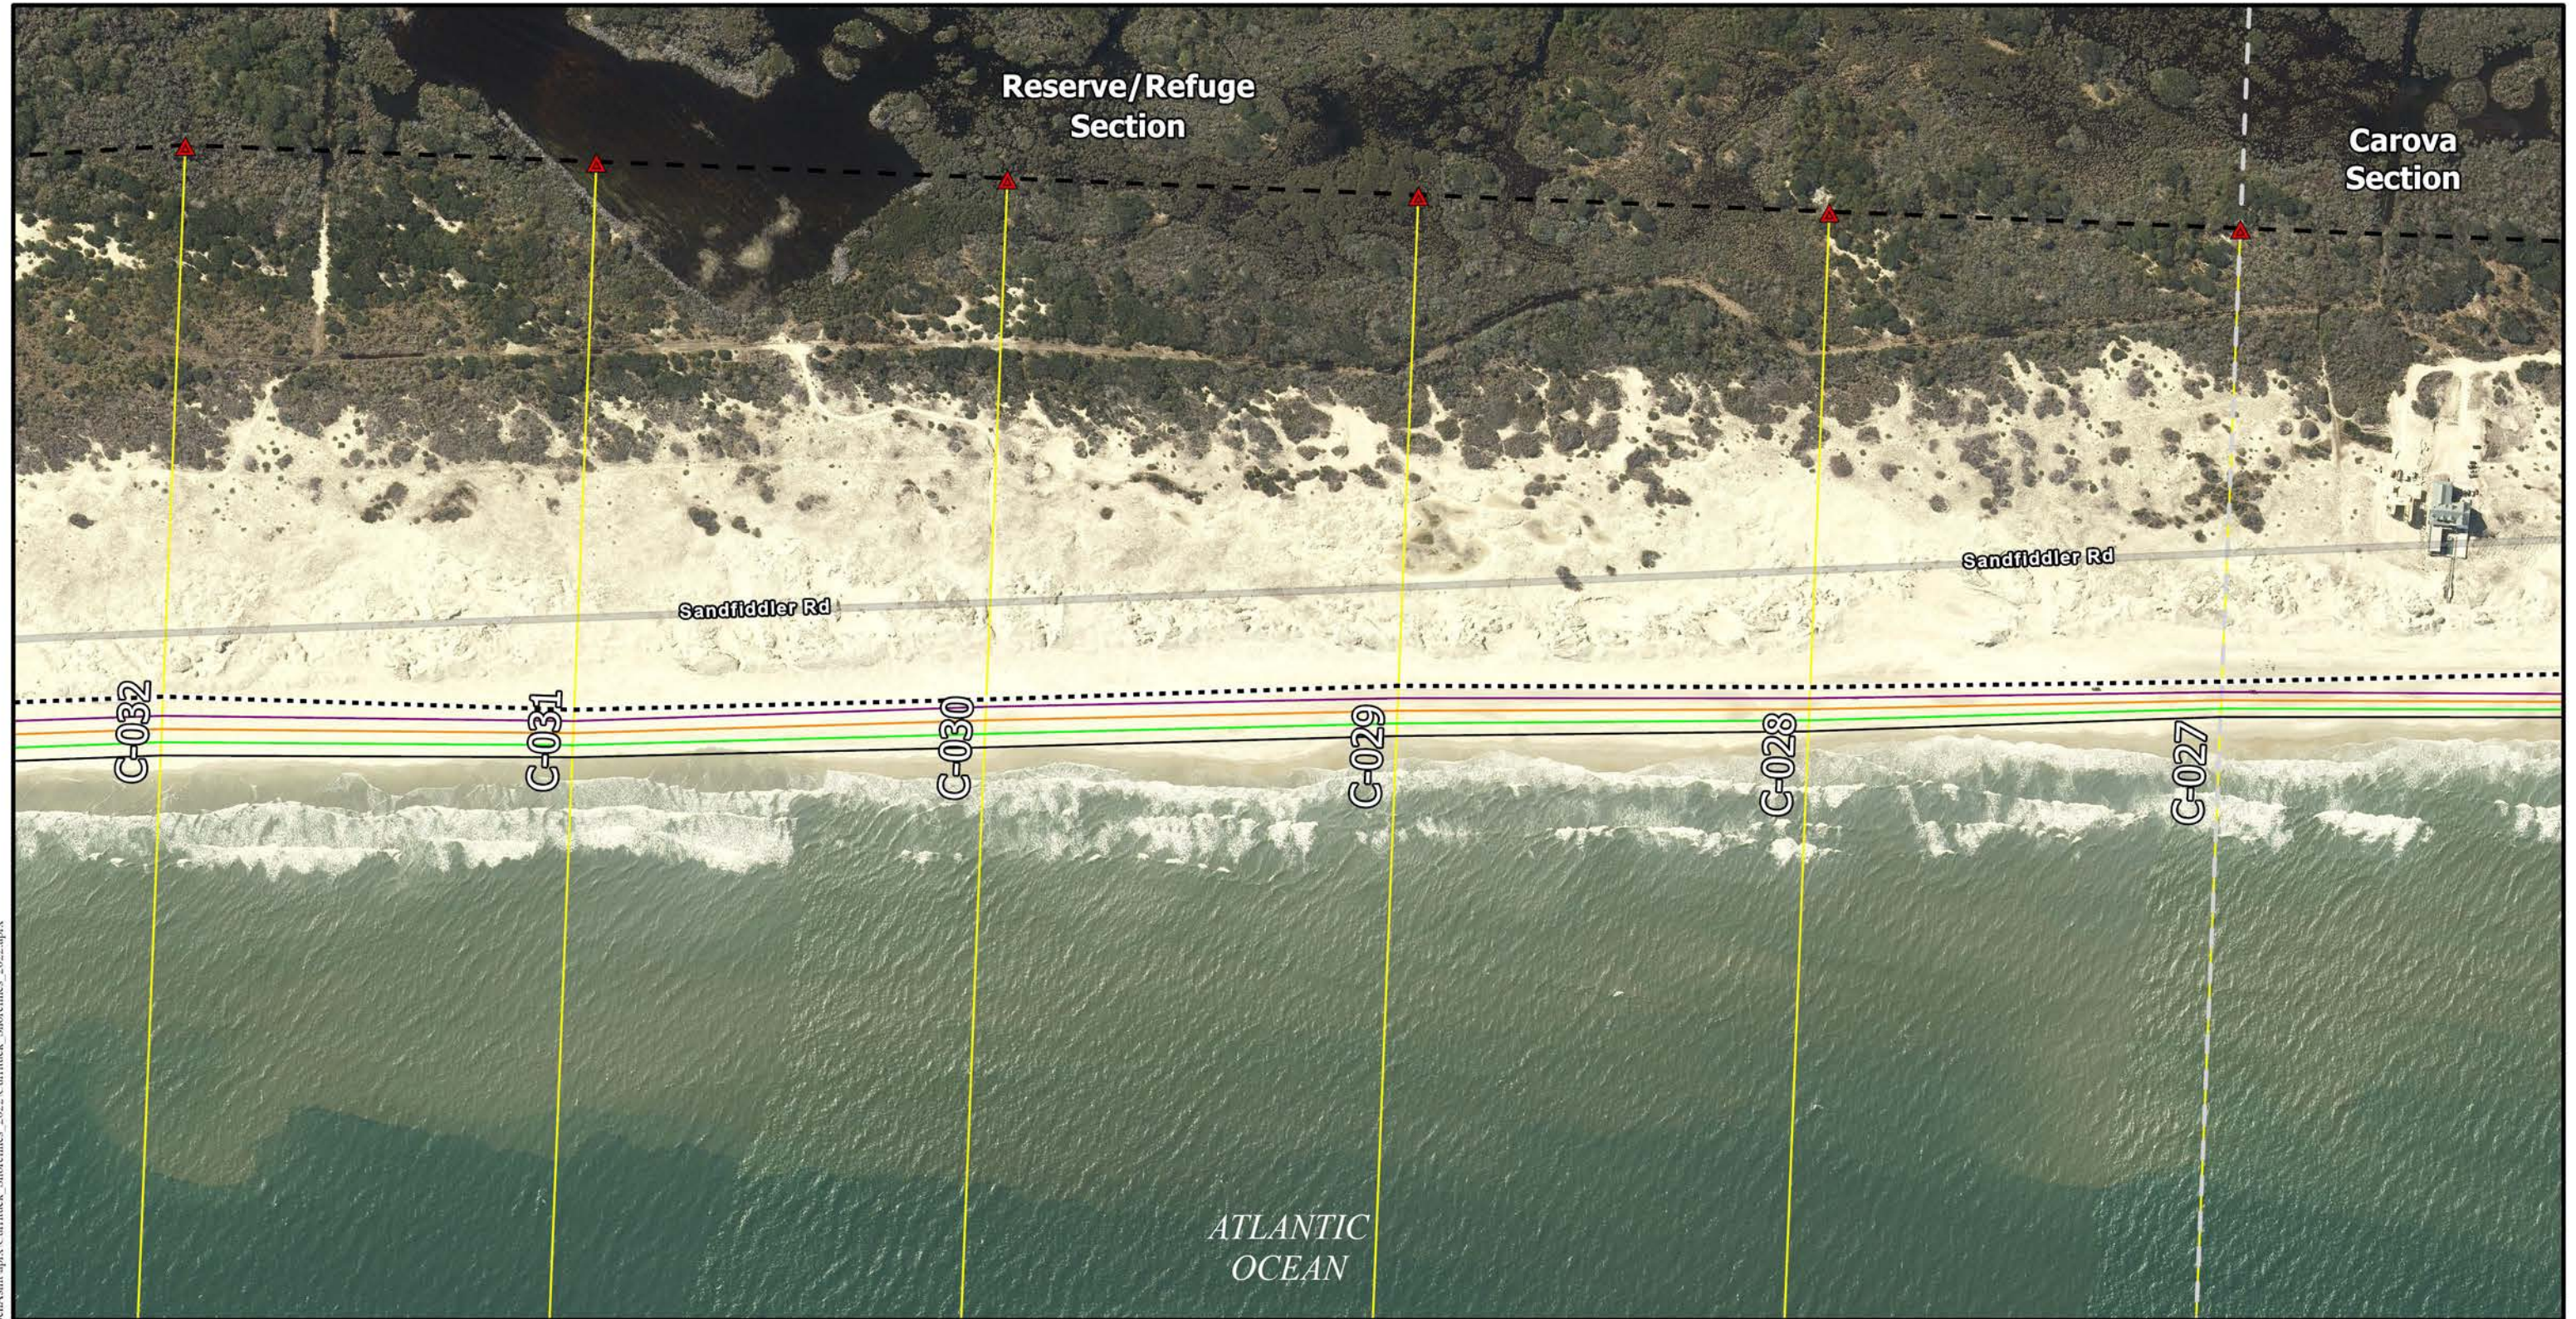
<b>TITLE</b>		
Impact Line and Projected Shoreline Maps 2022 Beach Monitoring and Stability Assessment Currituck County, NC		
COASTAL PROTECTION ENGINEERING OF NORTH CAROLINA, INC. 4038 Masonboro Loop Road Wilmington, NC 28409 PH (910) 399-1905		
Date: 1/2/2023	By: FMM	Page 6 of 23
