<b>TITLE</b>		
Impact Line and Projected Shoreline Maps 2022 Beach Monitoring and Stability Assessment Currituck County, NC		
COASTAL PROTECTION ENGINEERING OF NORTH CAROLINA, INC. 4038 Masonboro Loop Road Wilmington, NC 28409 PH (910) 399-1905		
Date: 1/2/2023	By: FMM	Page 1 of 23

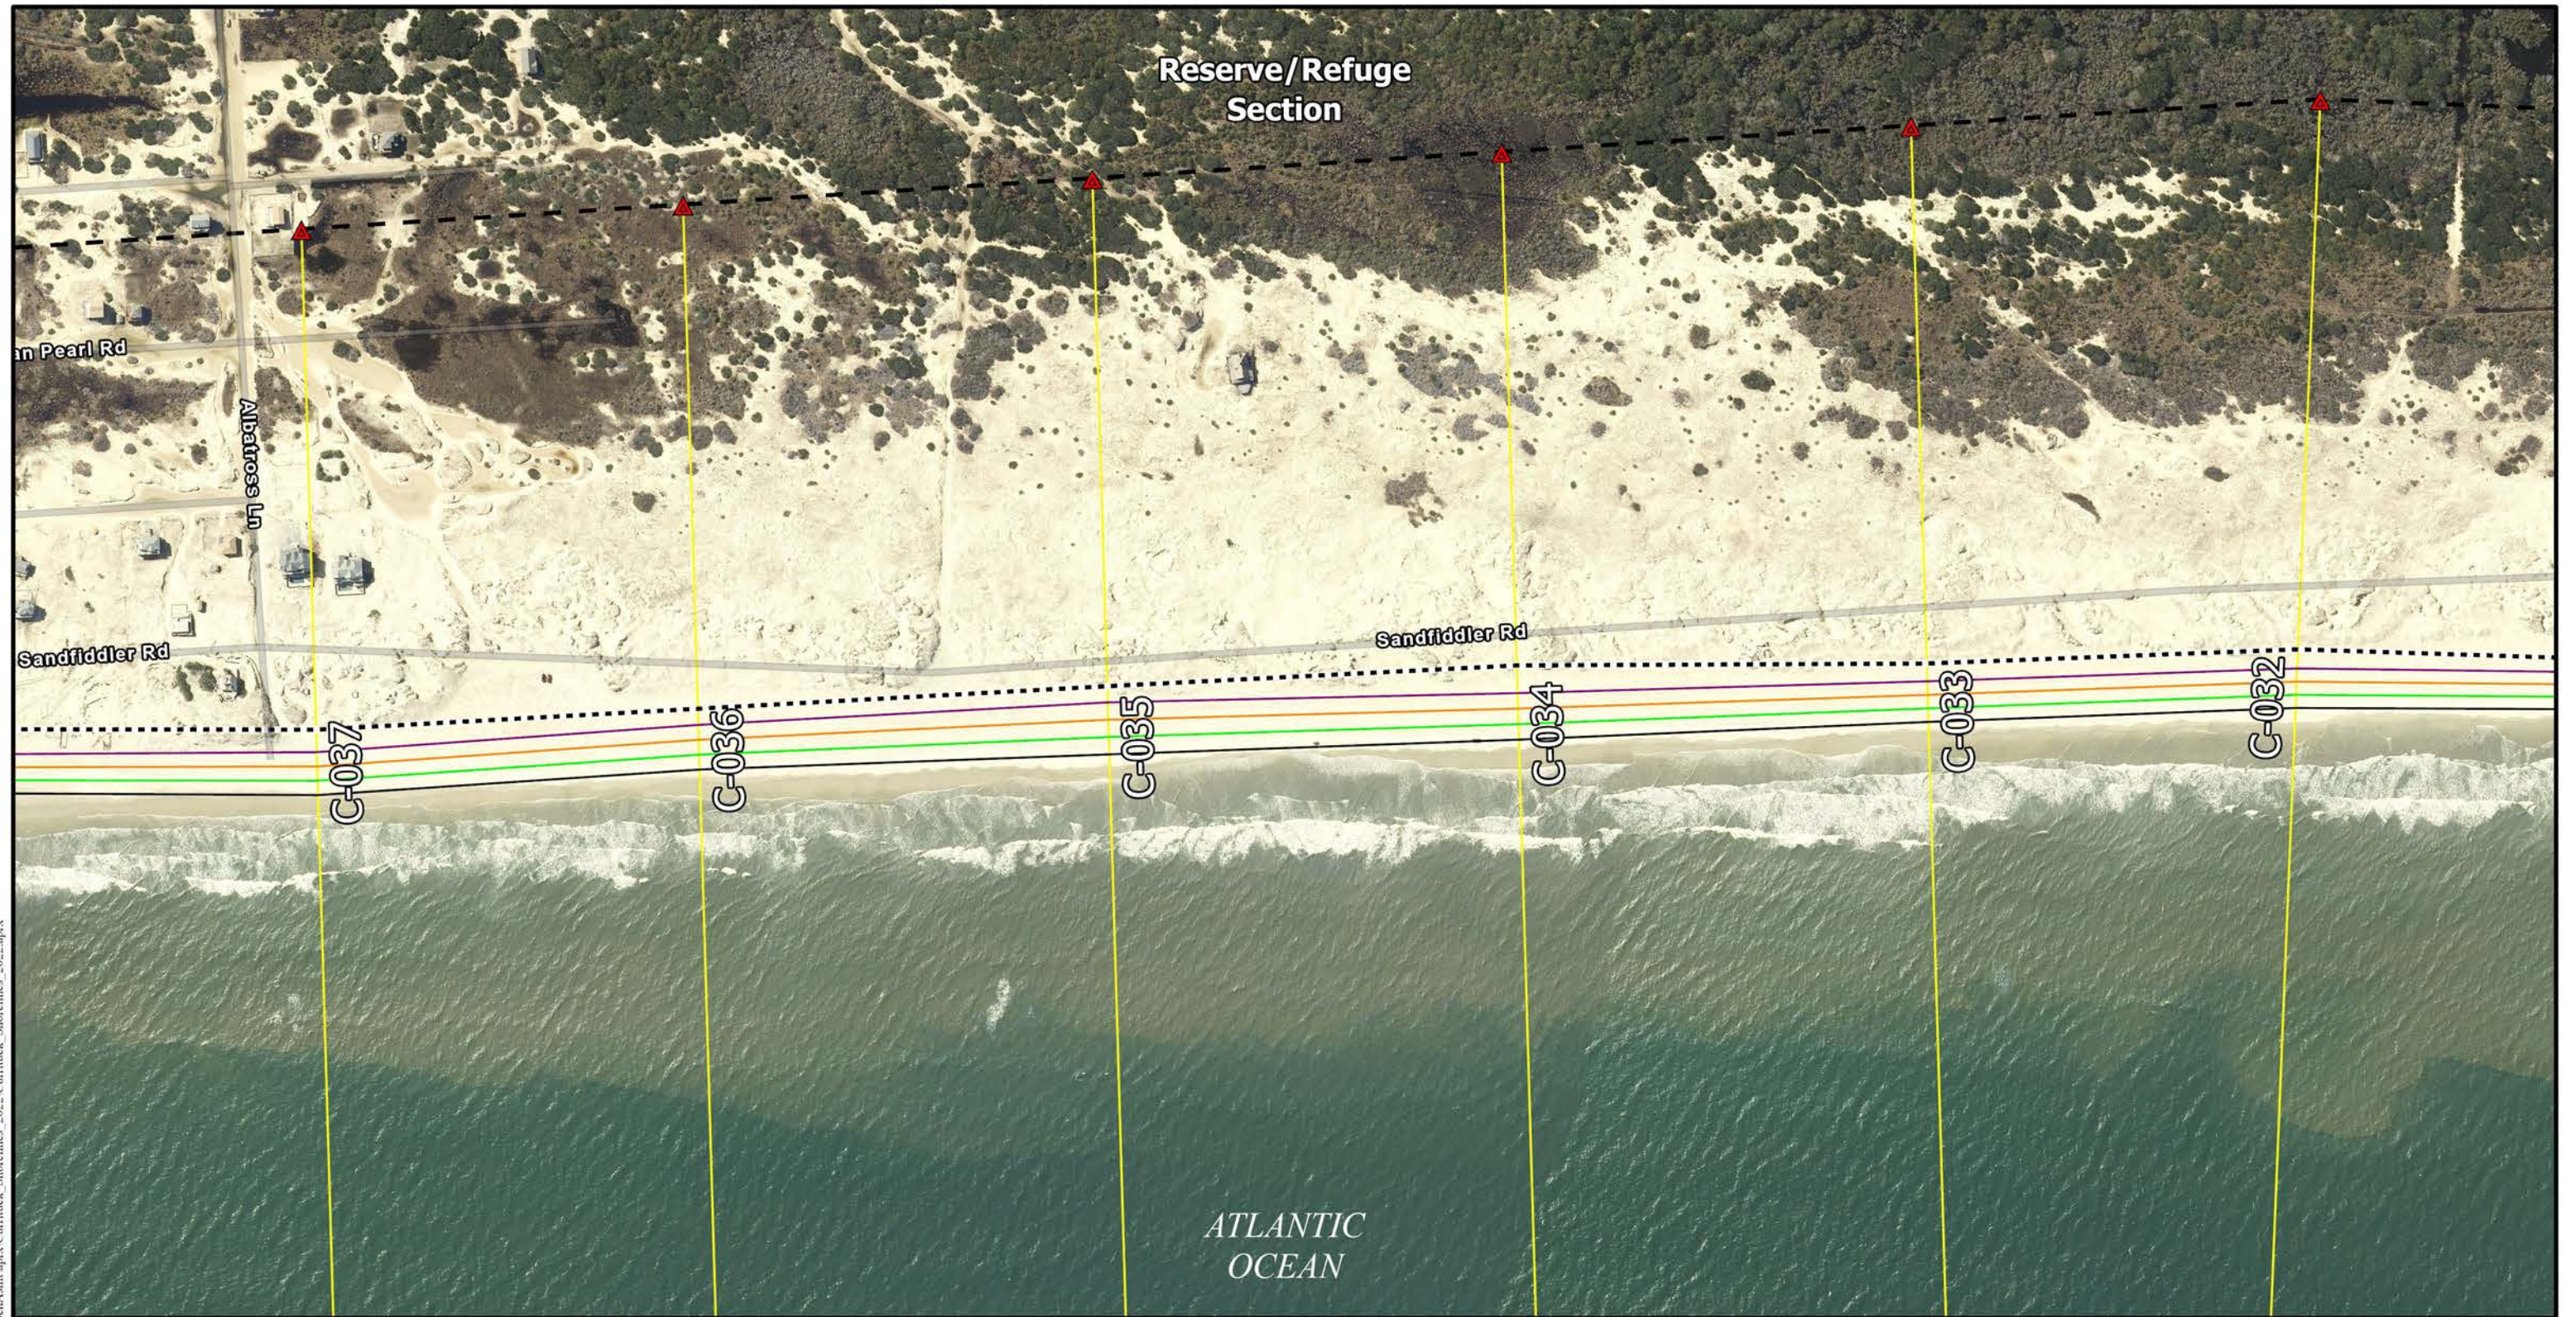
<b>TITLE</b>		
Impact Line and Projected Shoreline Maps 2022 Beach Monitoring and Stability Assessment Currituck County, NC		
COASTAL PROTECTION ENGINEERING OF NORTH CAROLINA, INC.		
4038 Masonboro Loop Road Wilmington, NC 28409 PH (910) 399-1905		
Date: 1/2/2023	By: FMM	Page 7 of 23

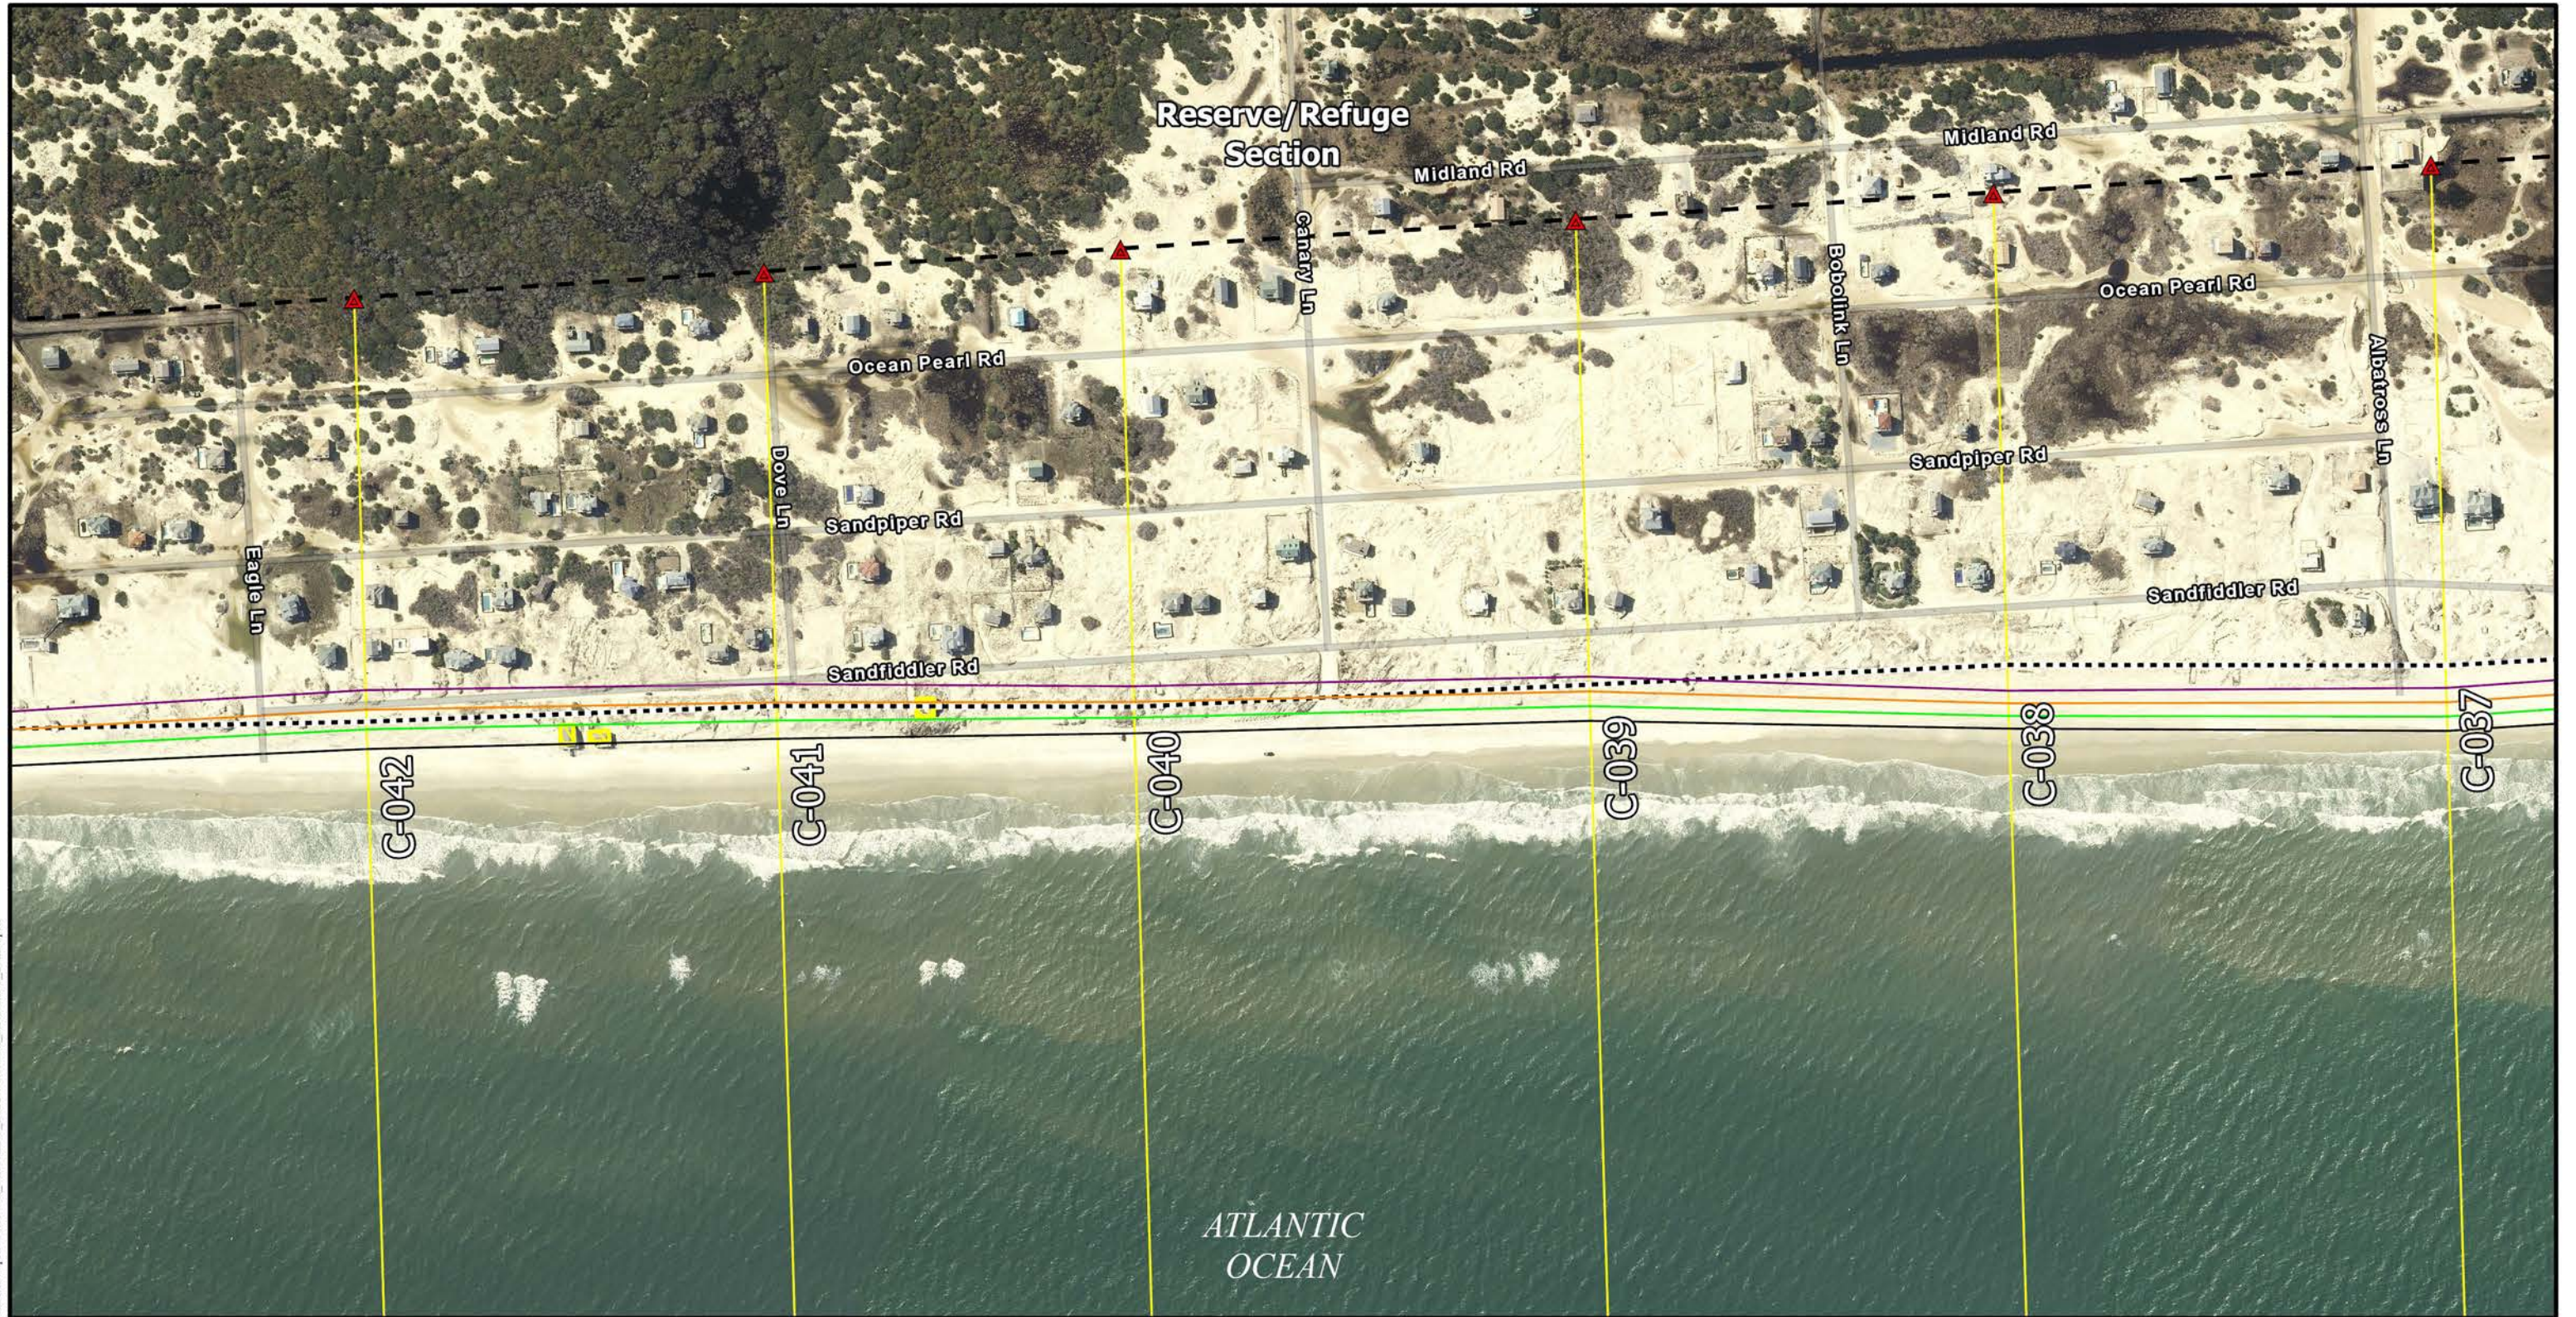
<b>TITLE</b>		
Impact Line and Projected Shoreline Maps 2022 Beach Monitoring and Stability Assessment Currituck County, NC		
COASTAL PROTECTION ENGINEERING OF NORTH CAROLINA, INC. 4038 Masonboro Loop Road Wilmington, NC 28409 PH (910) 399-1905		
Date: 1/2/2023	By: FMM	Page 8 of 23

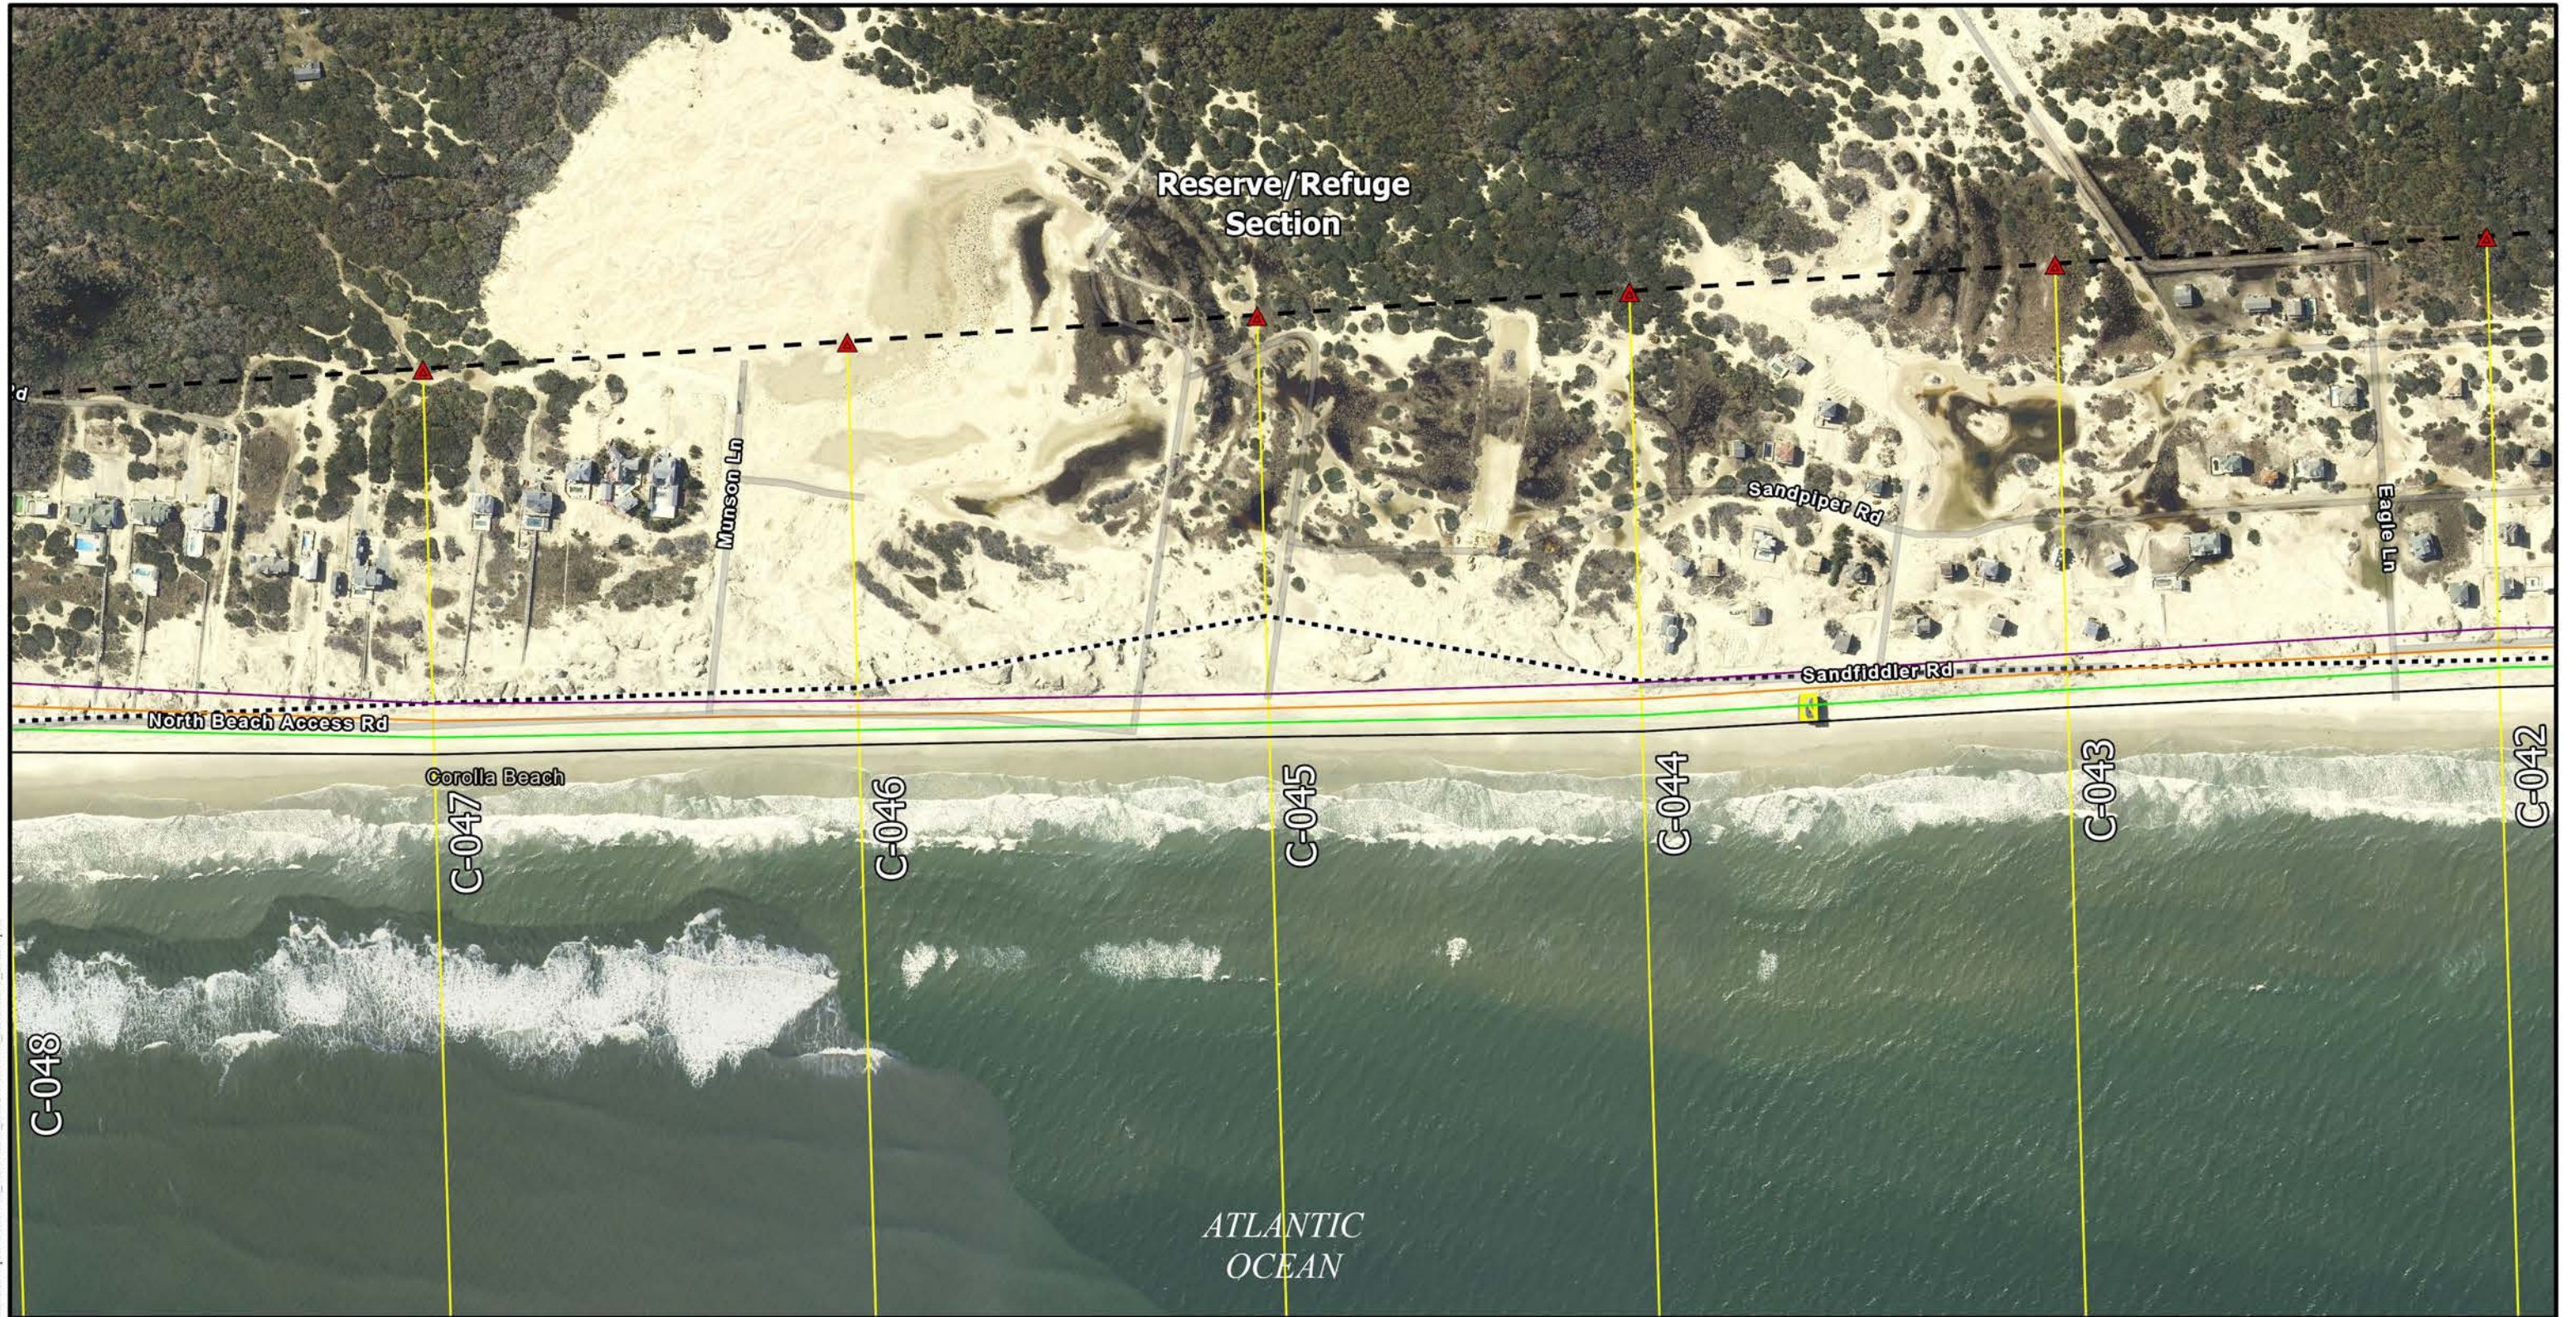
Date: 1/2/2023 By: FMM Page 9 of 23

**TITLE**  
 Impact Line  
 and Projected Shoreline Maps  
 2022 Beach Monitoring and Stability Assessment  
 Currituck County, NC

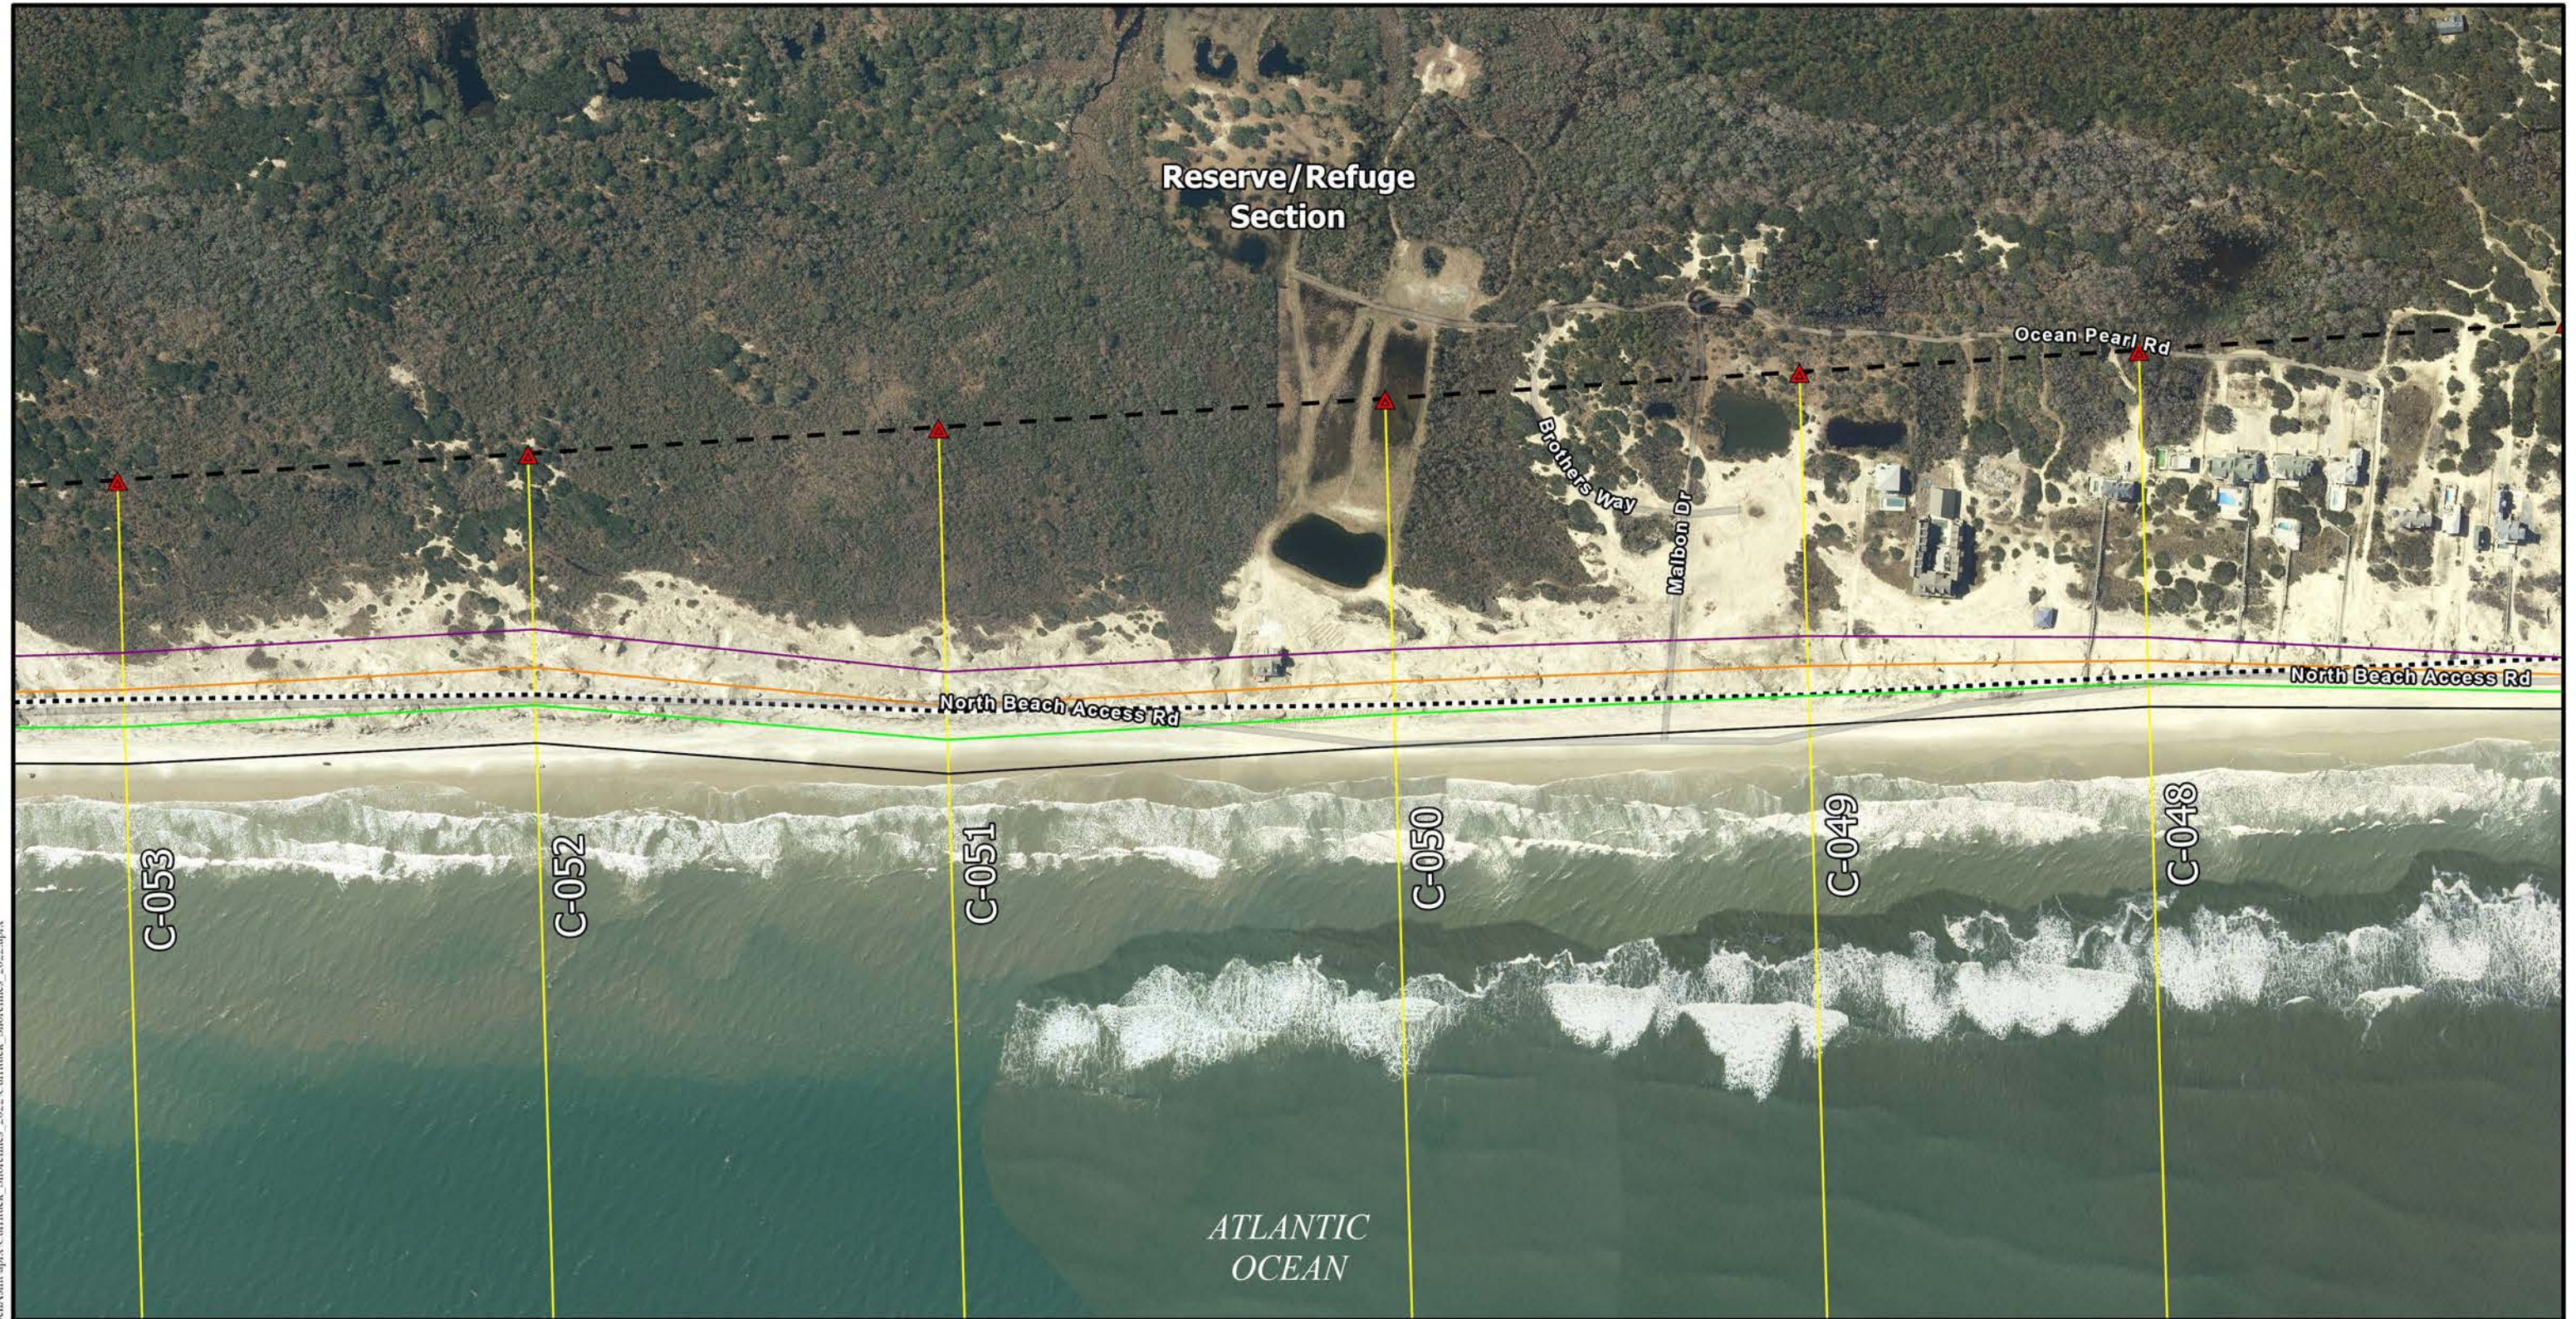
<b>TITLE</b>		
Impact Line and Projected Shoreline Maps 2022 Beach Monitoring and Stability Assessment Currituck County, NC		
COASTAL PROTECTION ENGINEERING OF NORTH CAROLINA, INC. 4038 Masonboro Loop Road Wilmington, NC 28409 PH (910) 399-1905		
Date: 1/2/2023	By: FMM	Page 10 of 23

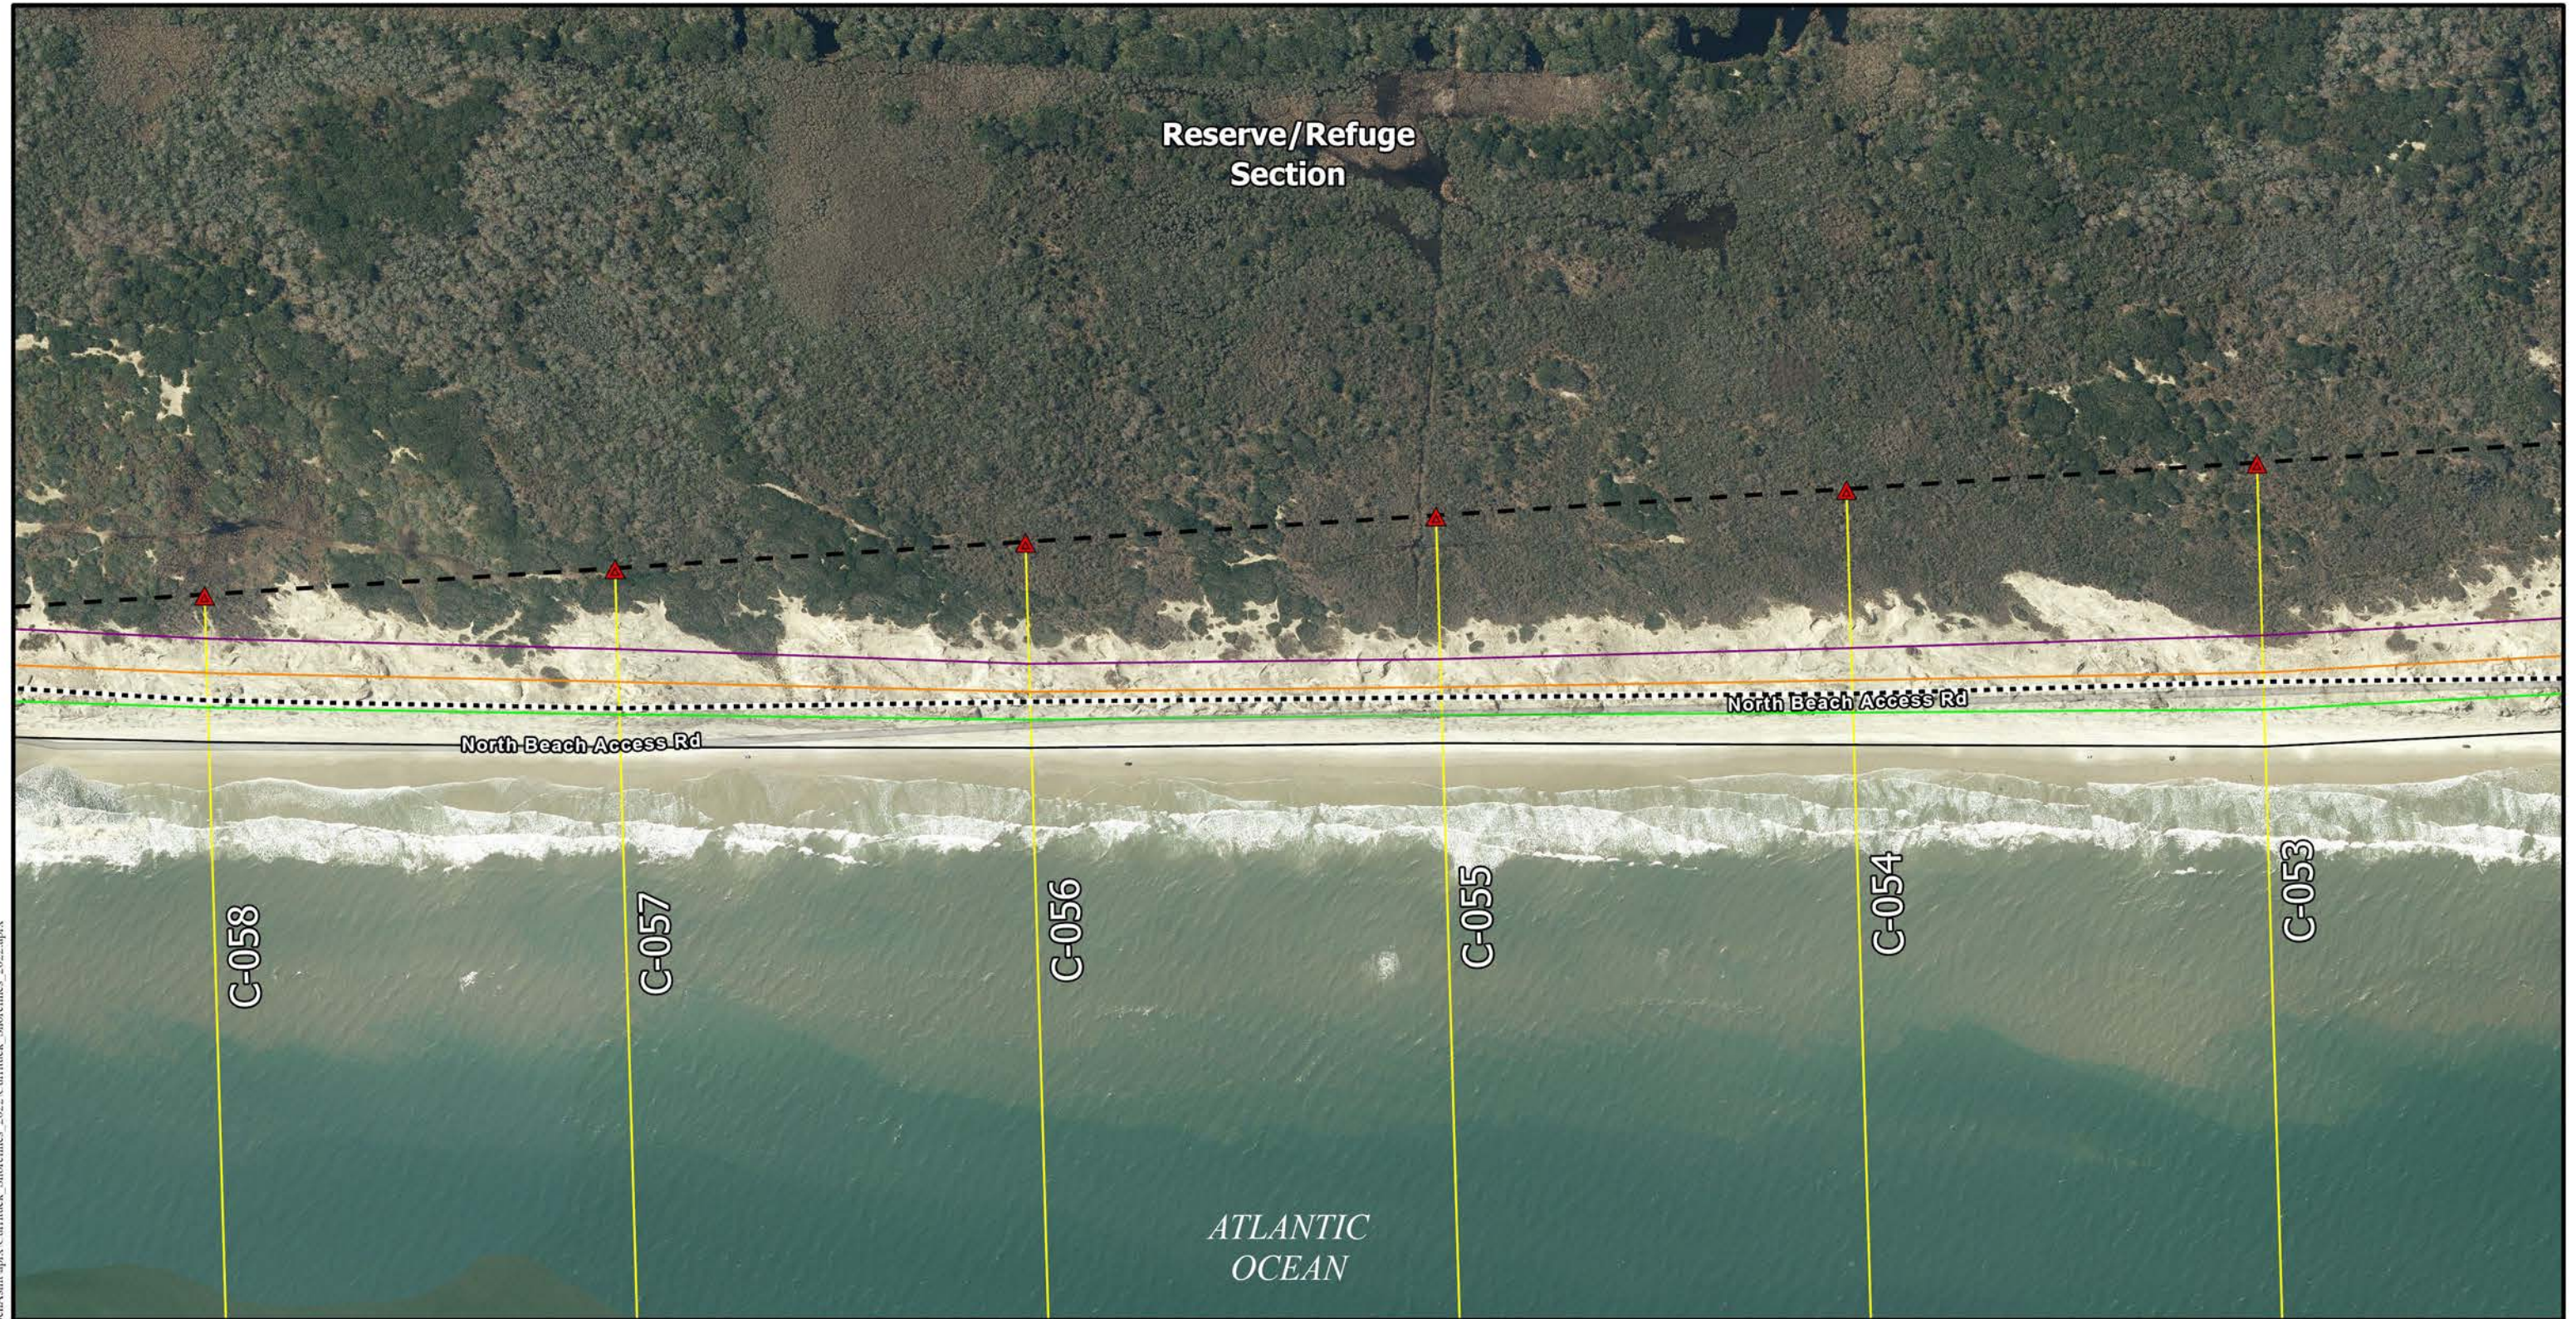
Date: 1/2/2023    By: FMM    Page 11 of 23

**TITLE**    **Impact Line and Projected Shoreline Maps**  
 2022 Beach Monitoring and Stability Assessment  
 Currituck County, NC

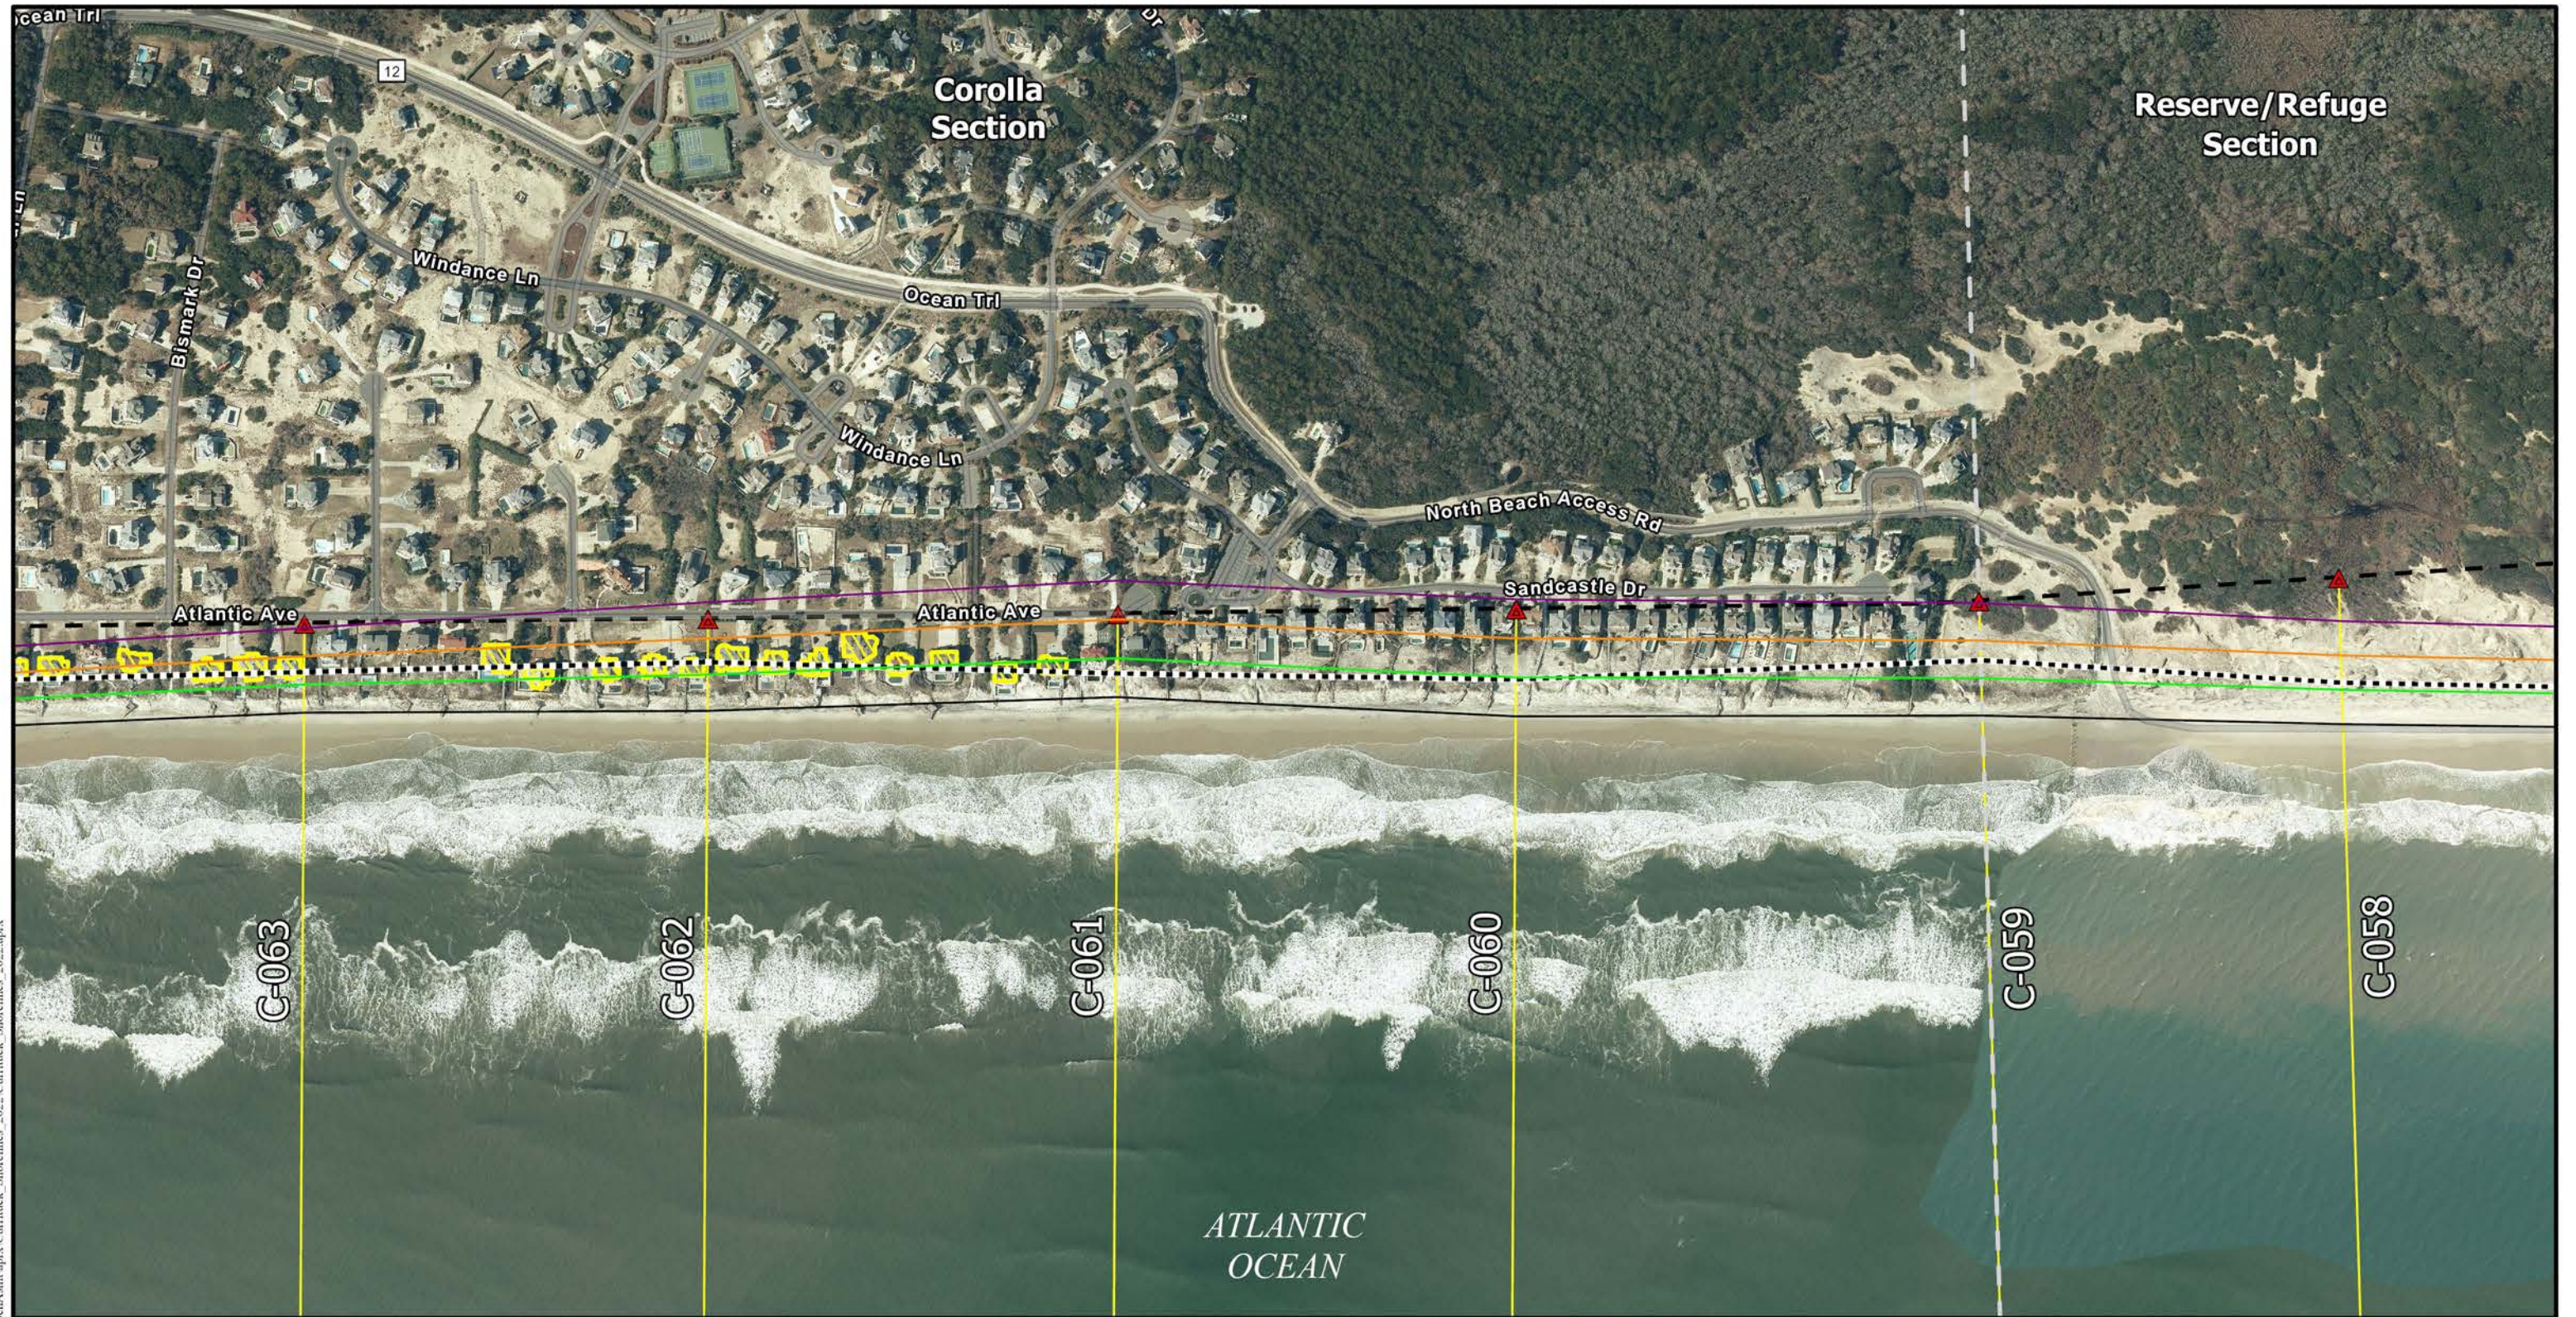
Date: 1/2/2023 By: FMM Page 12 of 23

**TITLE** Impact Line and Projected Shoreline Maps  
2022 Beach Monitoring and Stability Assessment  
Currituck County, NC
