<b>TITLE</b>		
Impact Line and Projected Shoreline Maps 2022 Beach Monitoring and Stability Assessment Currituck County, NC		
COASTAL PROTECTION ENGINEERING OF NORTH CAROLINA, INC. 4038 Masonboro Loop Road Wilmington, NC 28409 PH (910) 399-1905		
Date: 1/2/2023	By: FMM	Page 1 of 23

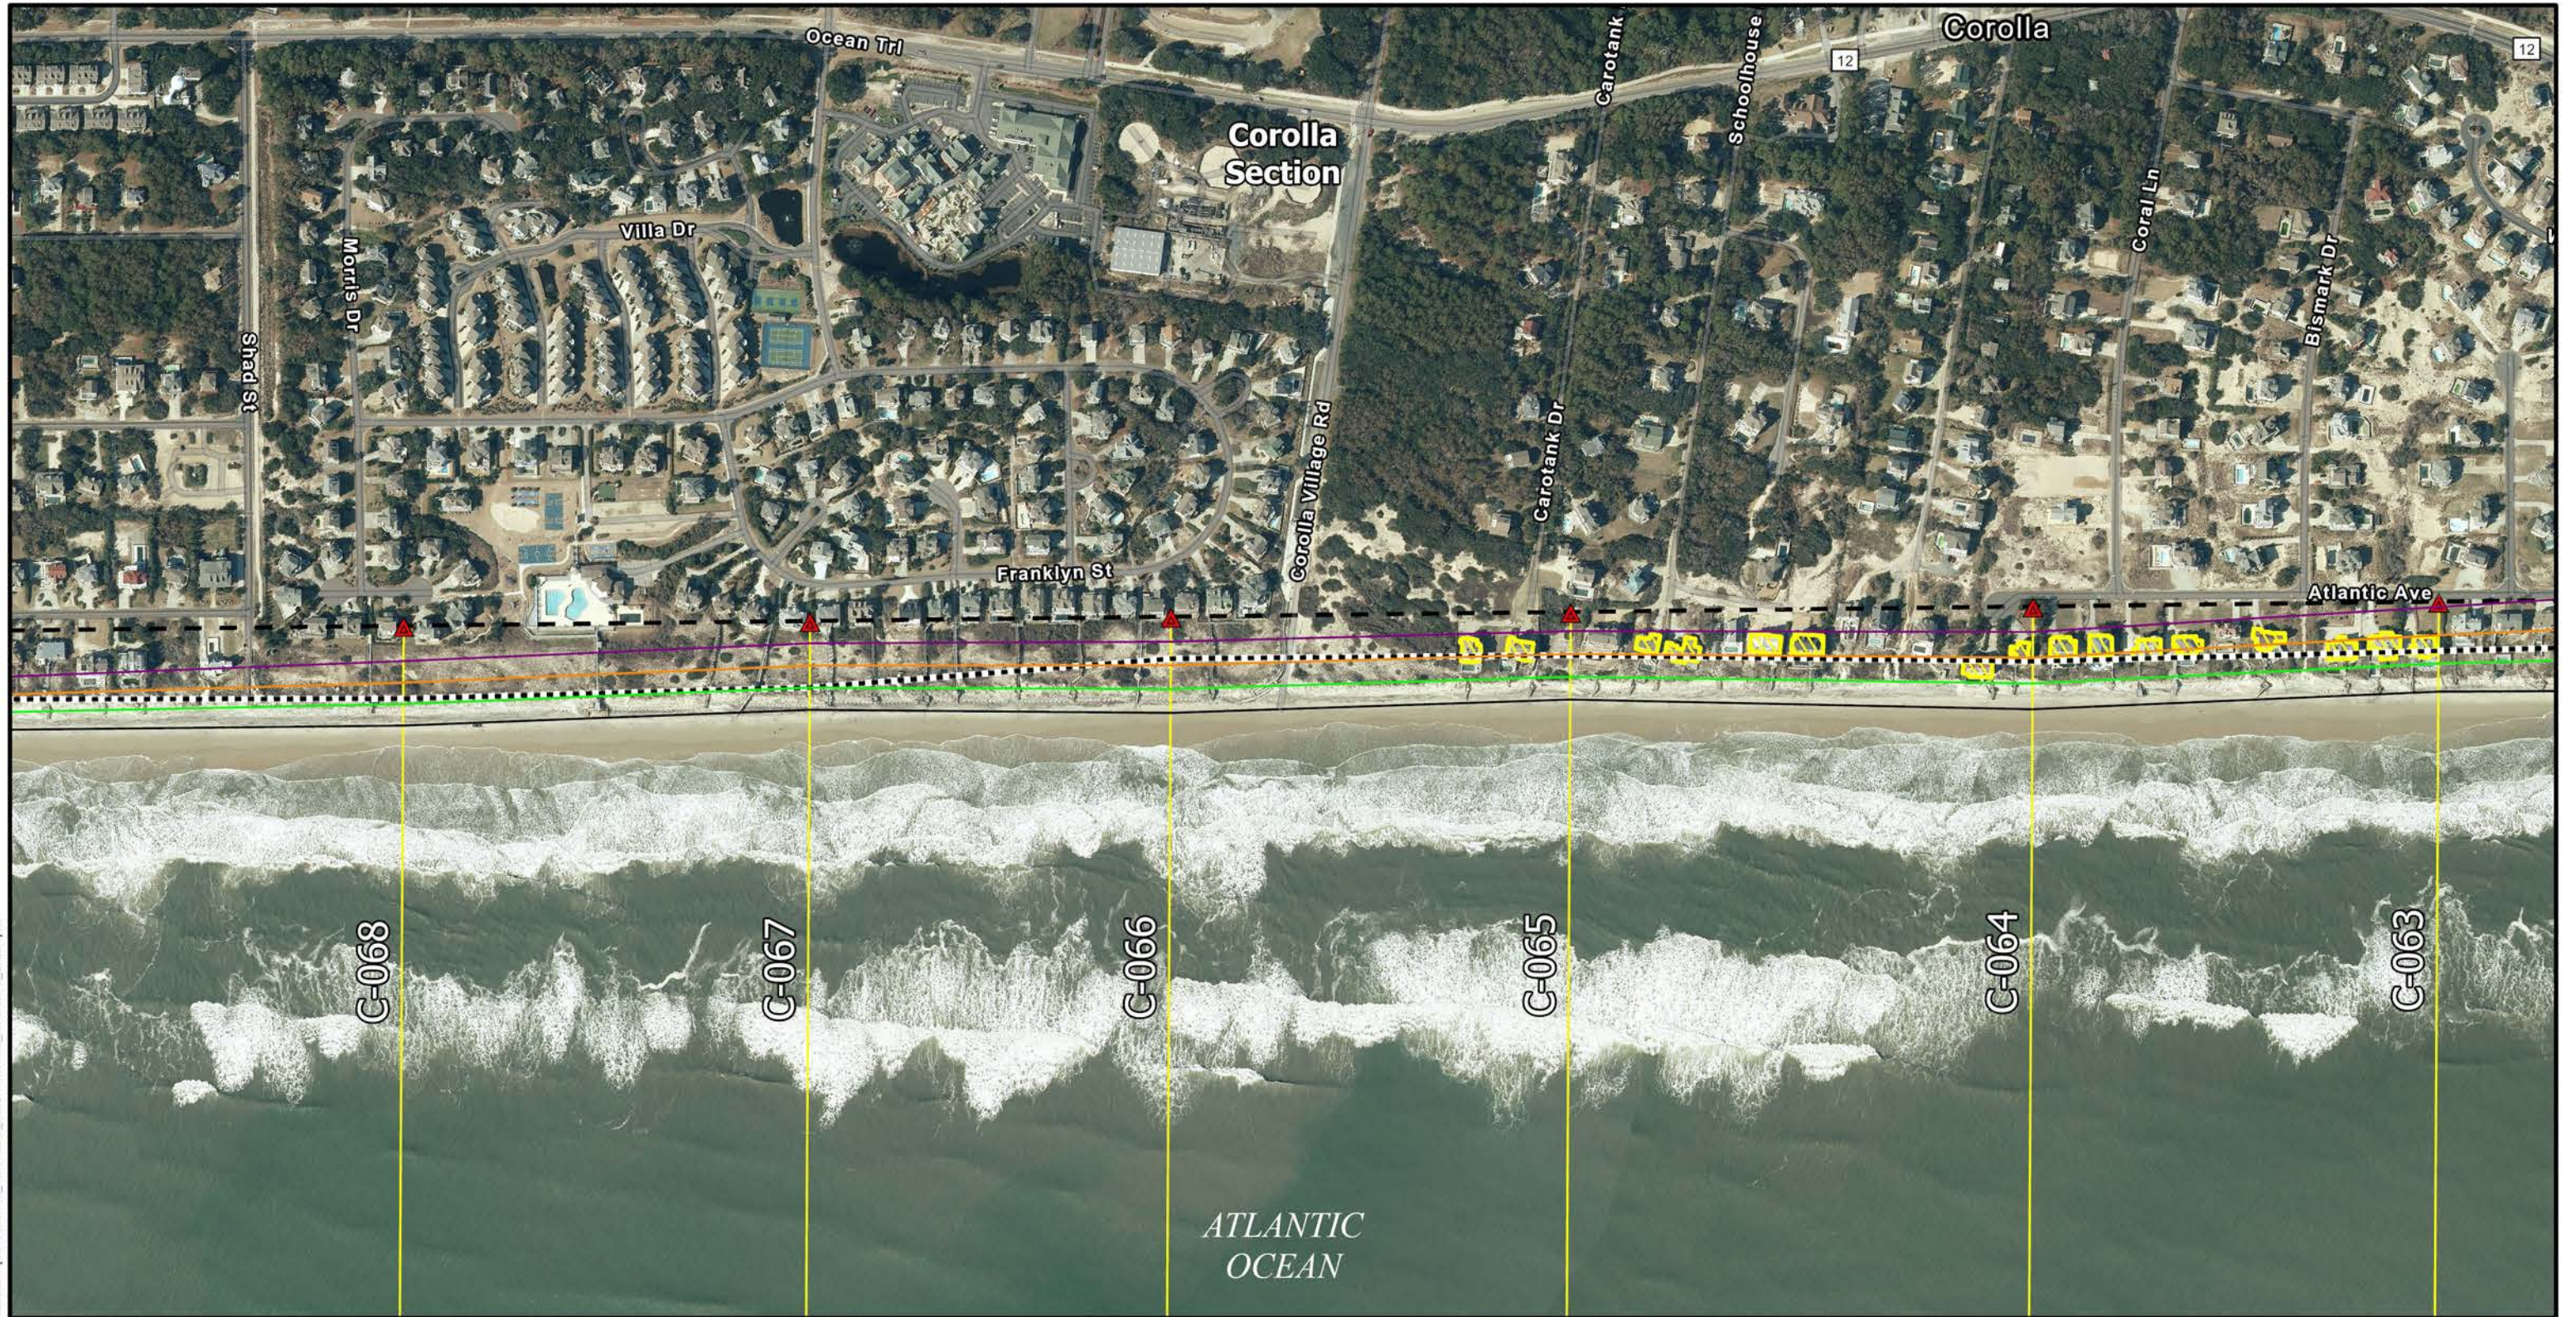
Date: 1/2/2023 By: FMM Page 13 of 23

**TITLE** Impact Line and Projected Shoreline Maps  
2022 Beach Monitoring and Stability Assessment  
Currituck County, NC

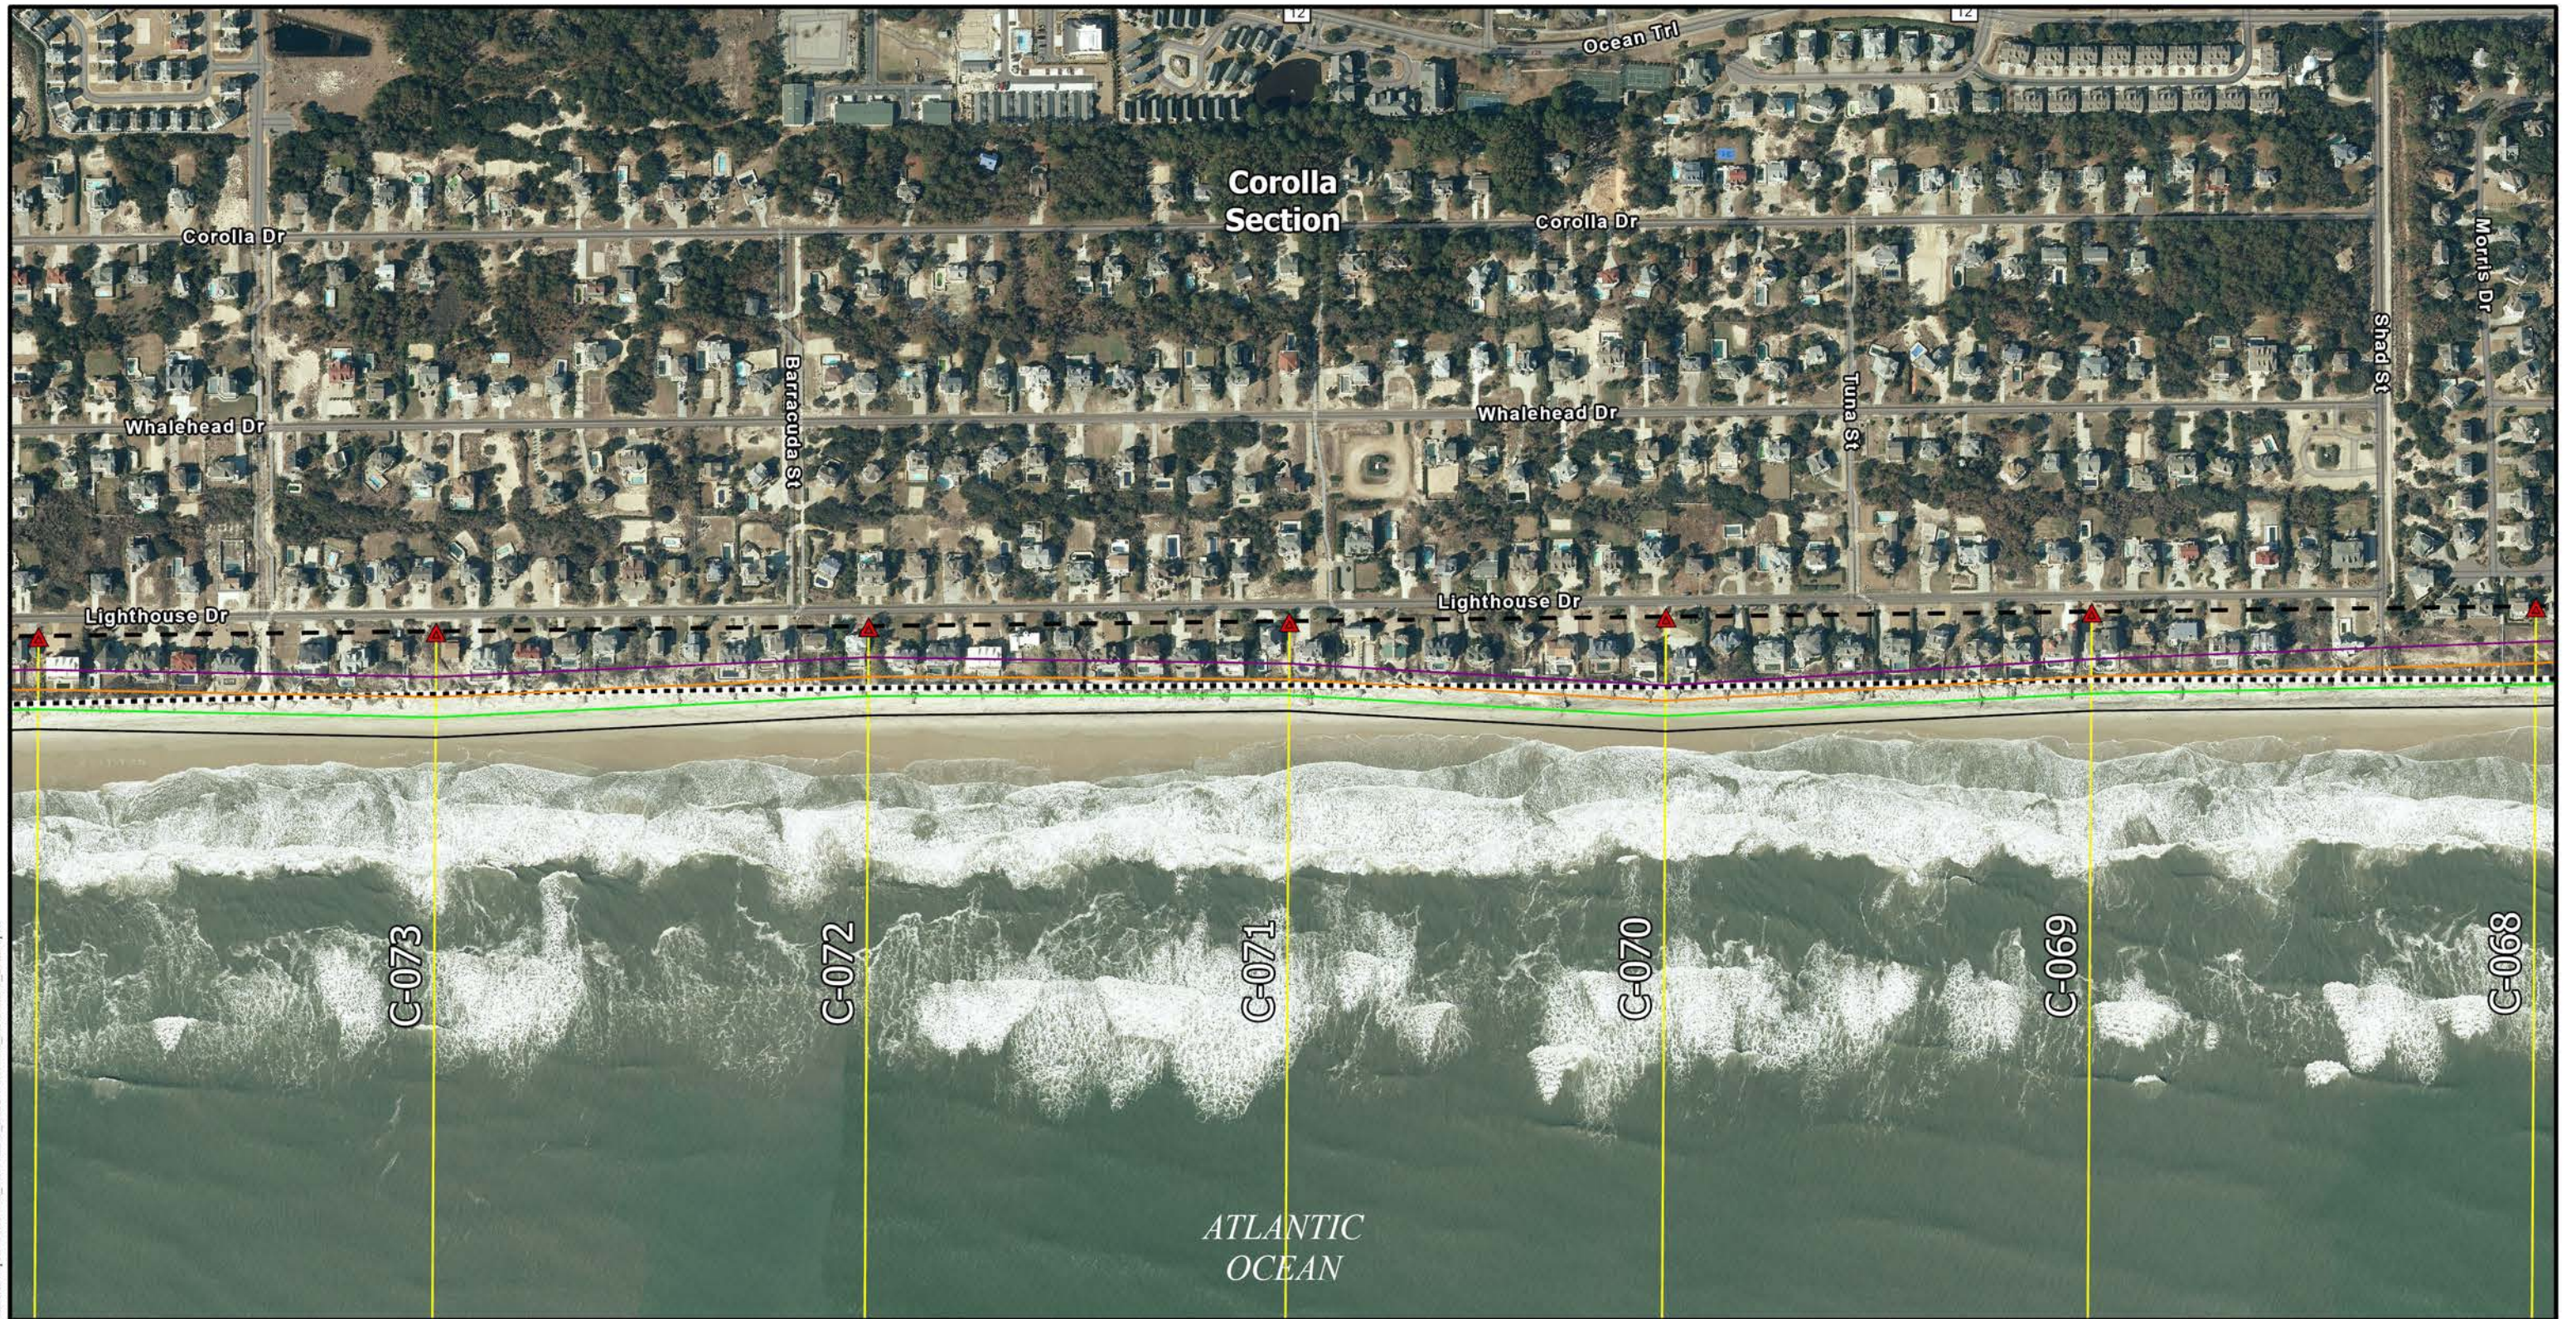
Date: 1/2/2023 By: FMM Page 14 of 23

**TITLE** Impact Line and Projected Shoreline Maps  
2022 Beach Monitoring and Stability Assessment  
Currituck County, NC

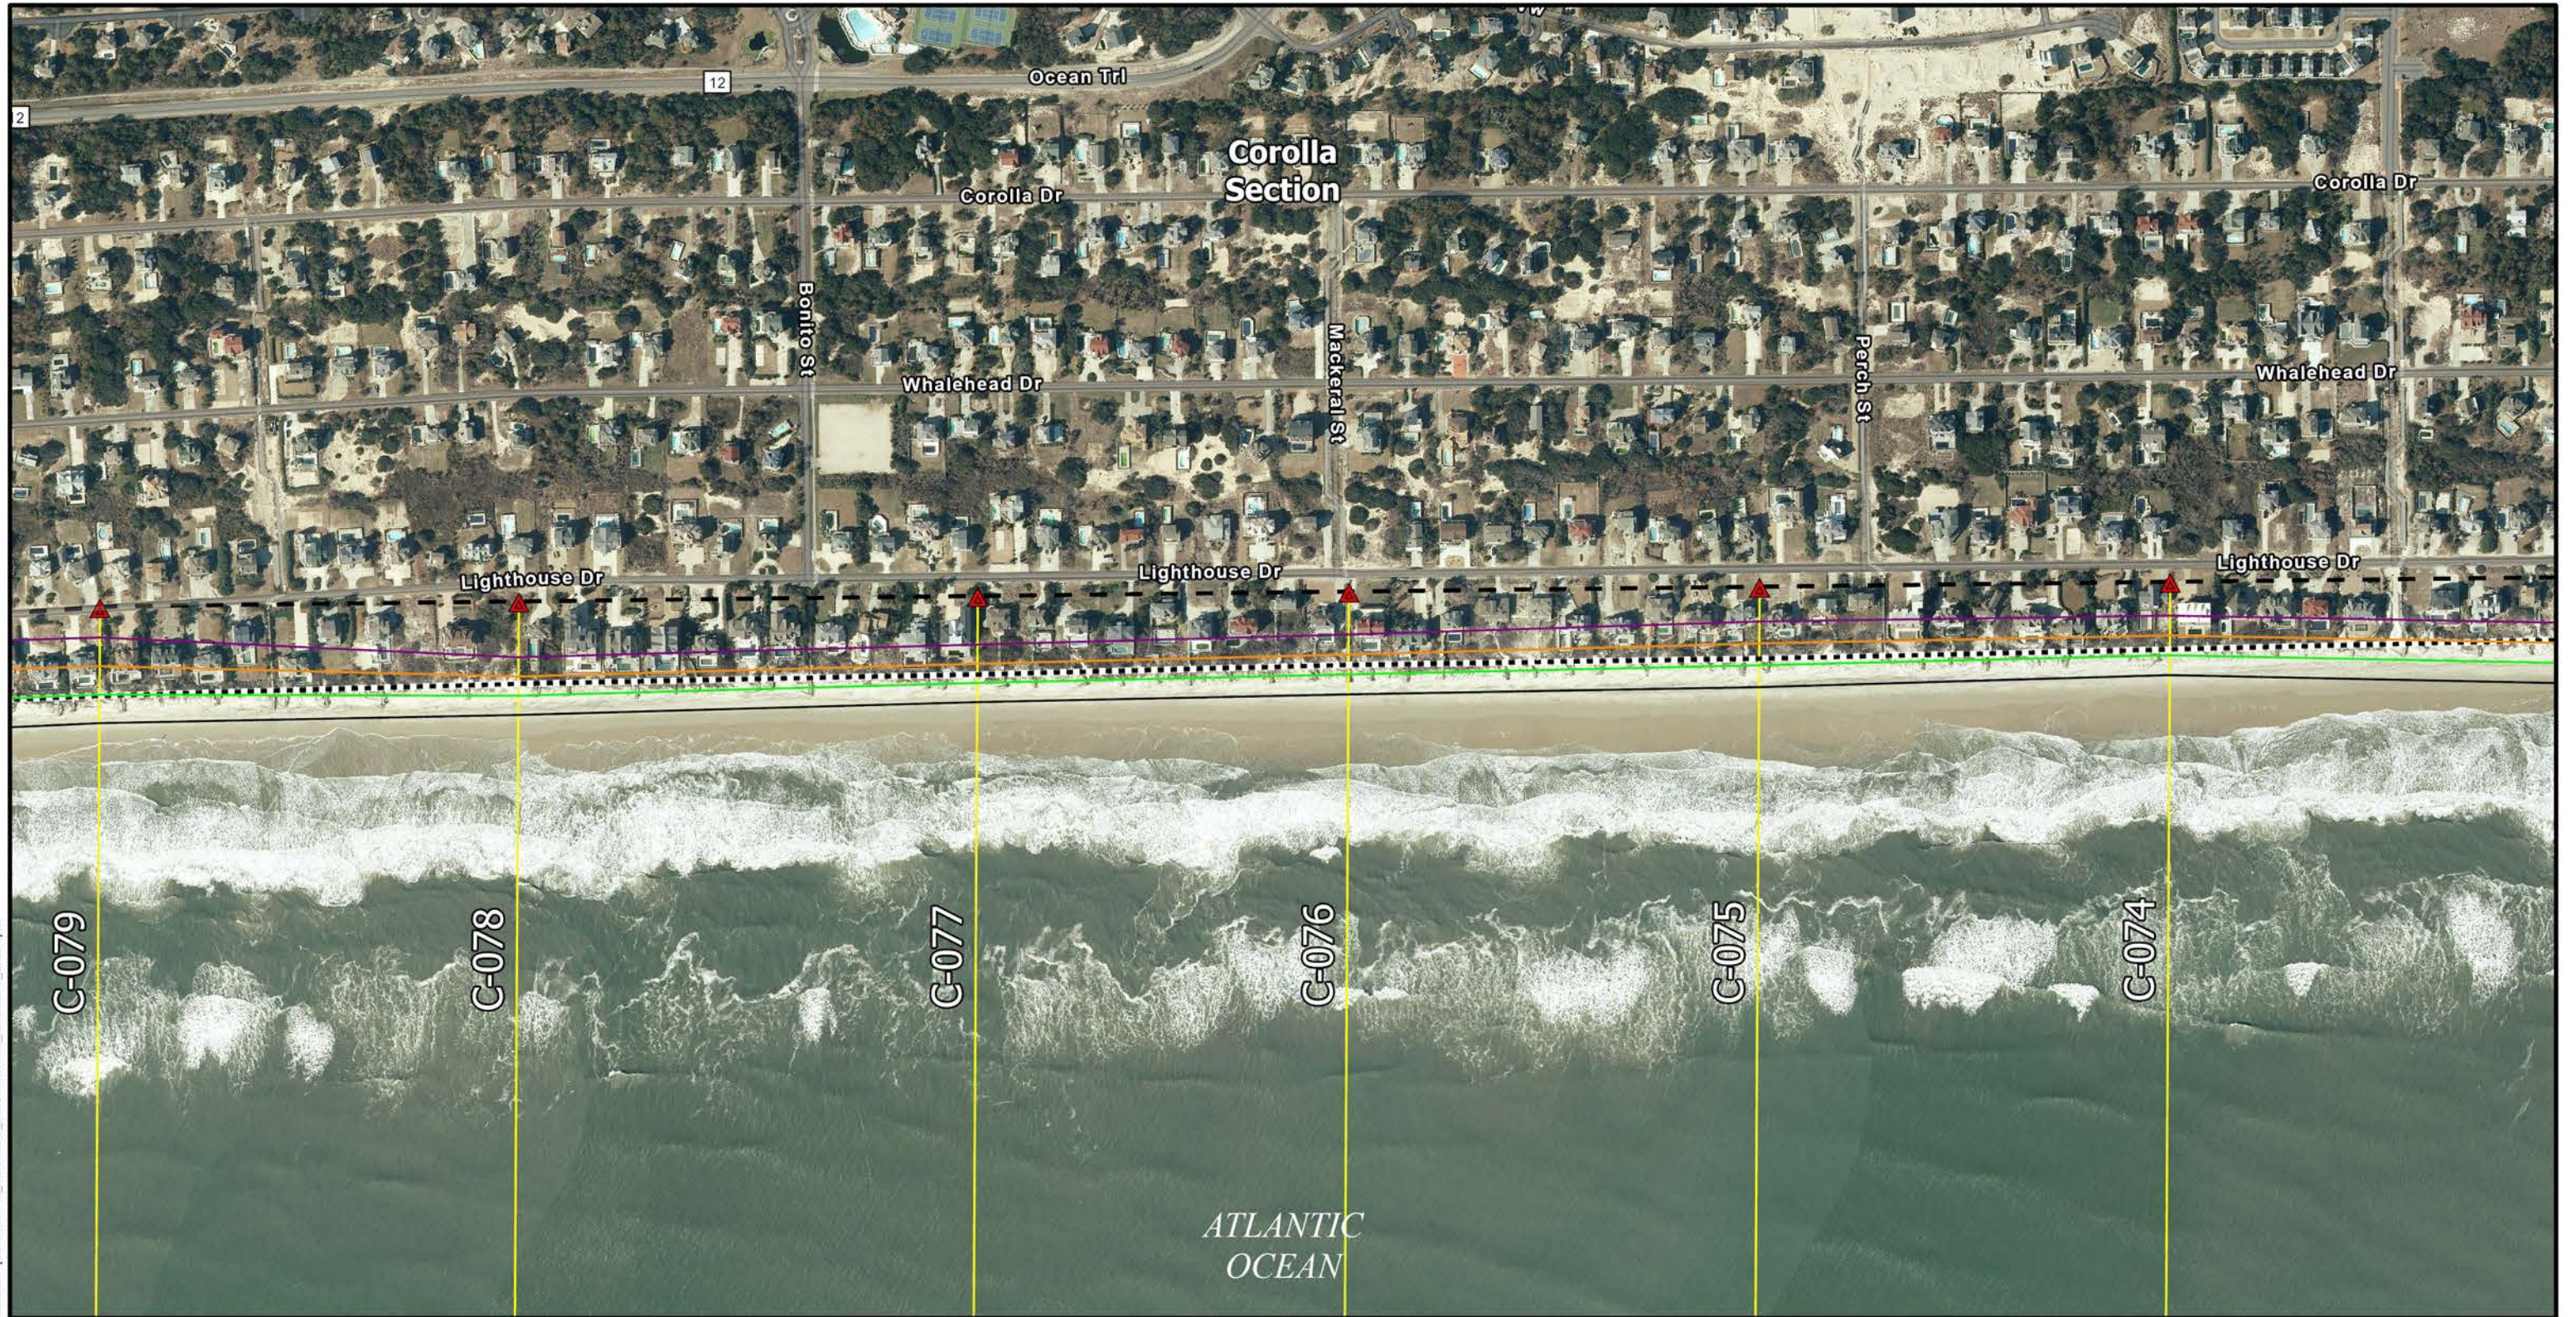
<b>TITLE</b>		
Impact Line and Projected Shoreline Maps 2022 Beach Monitoring and Stability Assessment Currituck County, NC		
COASTAL PROTECTION ENGINEERING OF NORTH CAROLINA, INC. 4038 Masonboro Loop Road Wilmington, NC 28409 PH (910) 399-1905		
Date: 1/2/2023	By: FMM	Page 15 of 23

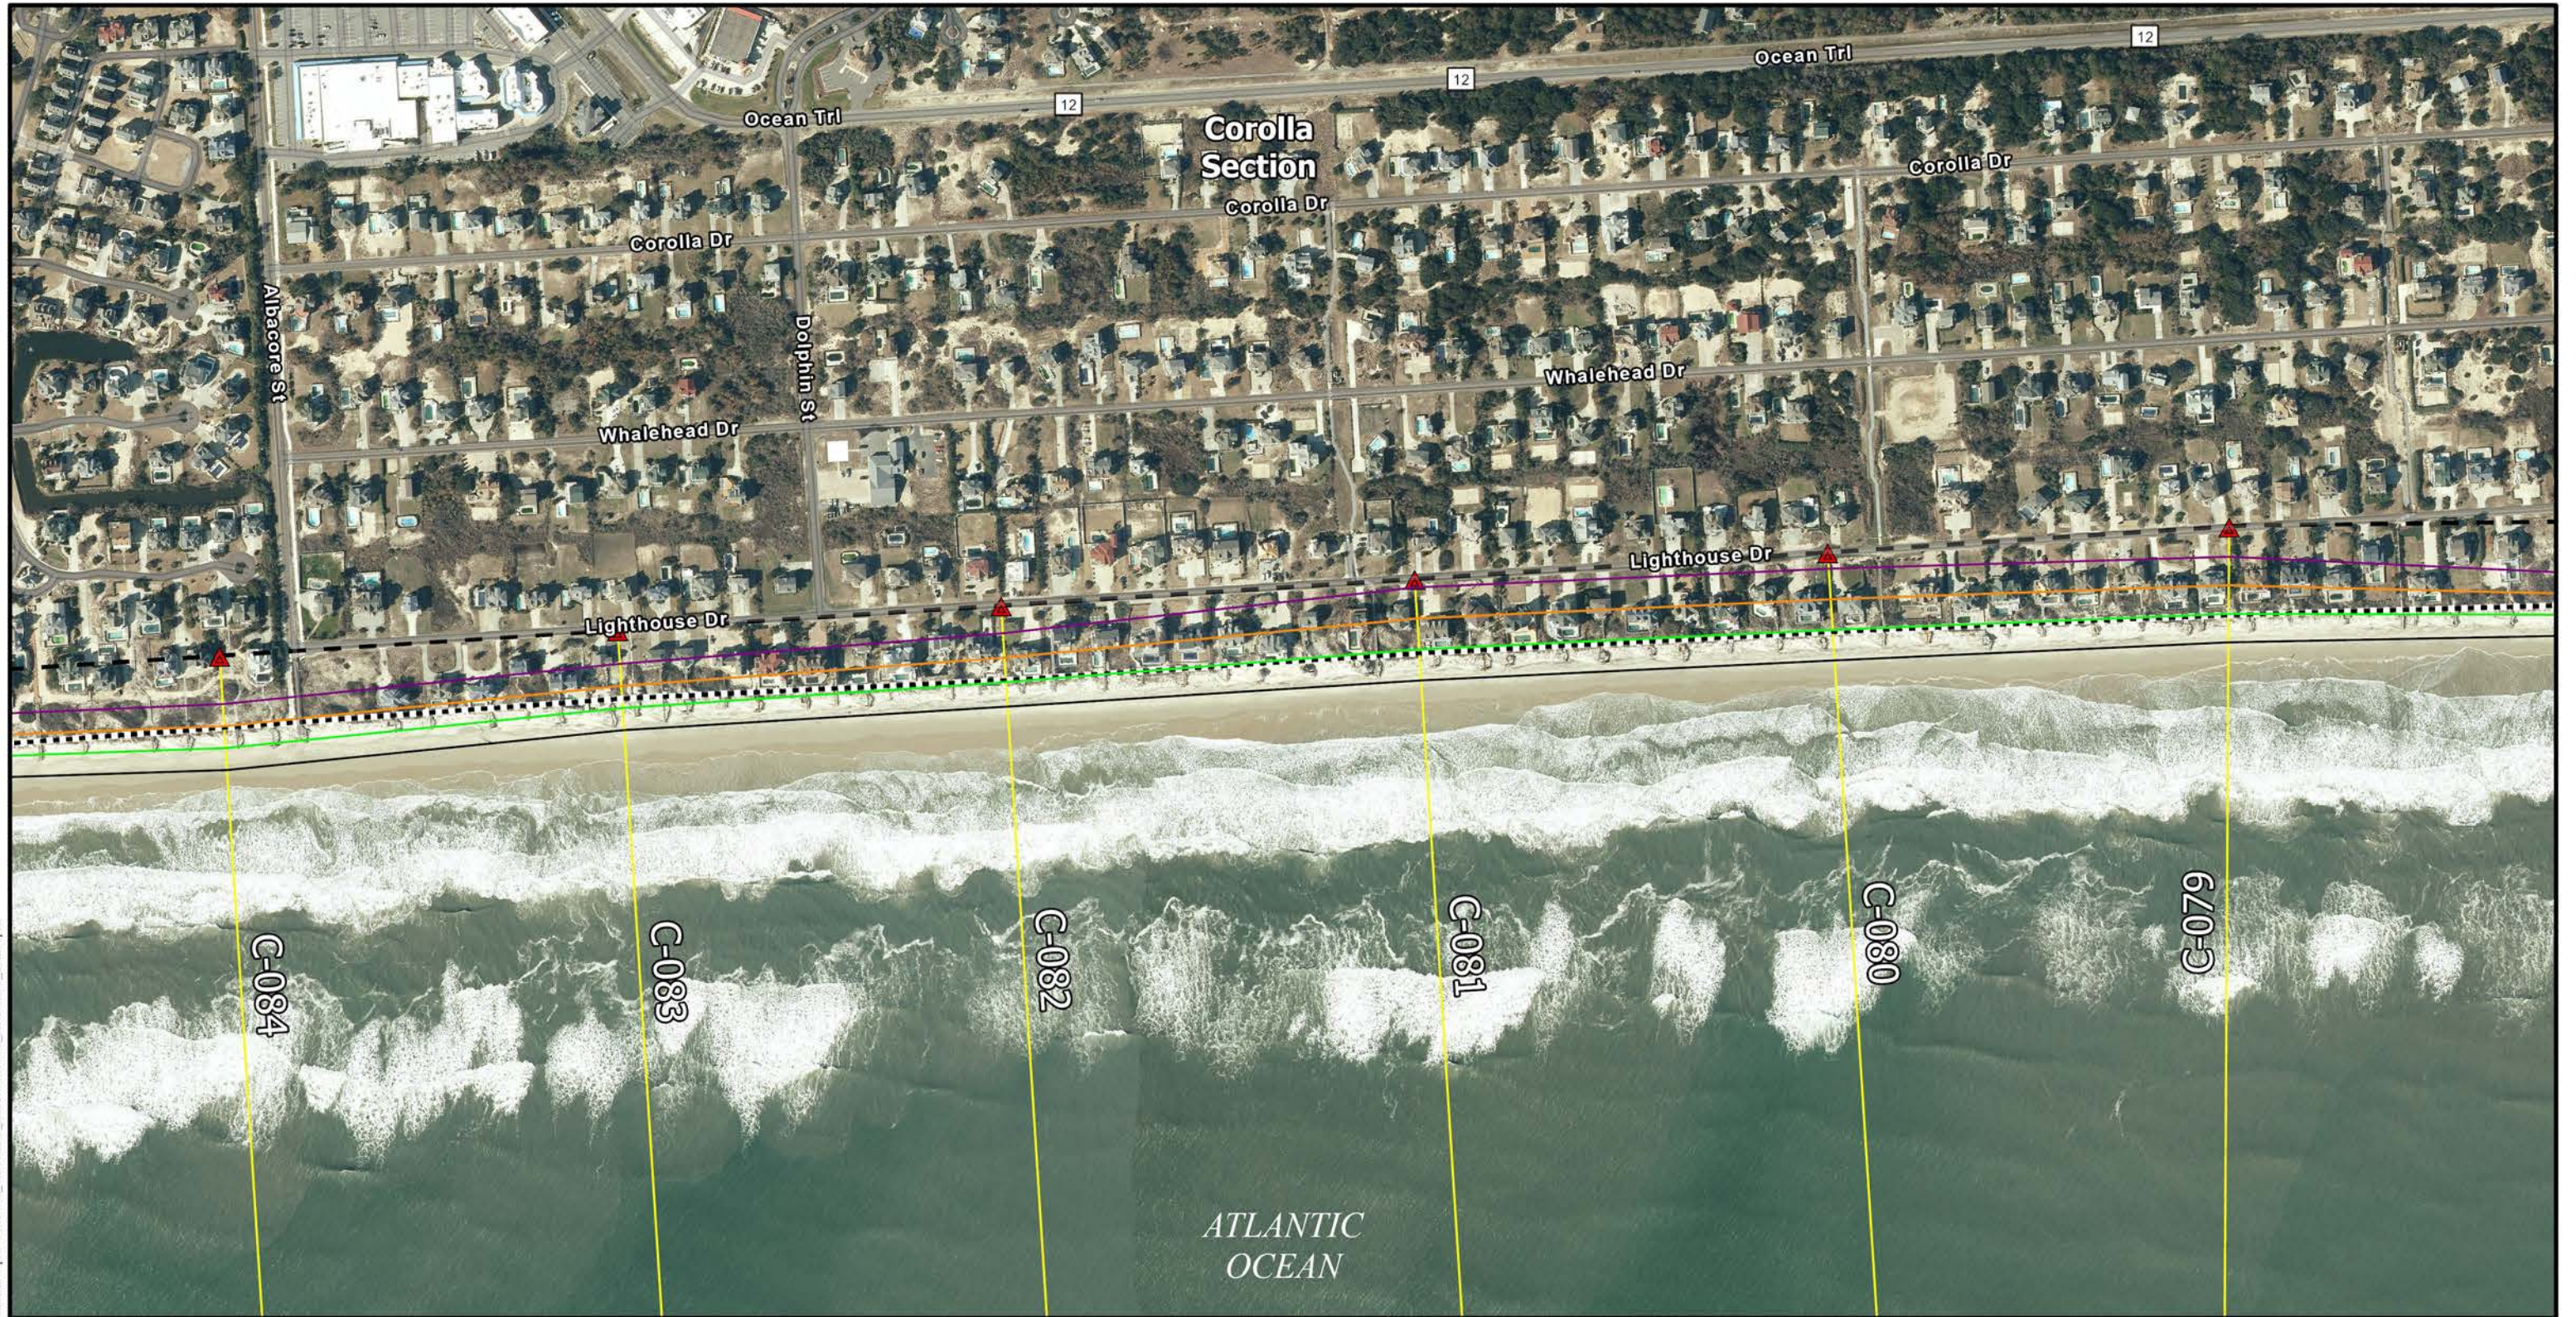
<b>TITLE</b>		
Impact Line and Projected Shoreline Maps 2022 Beach Monitoring and Stability Assessment Currituck County, NC		
COASTAL PROTECTION ENGINEERING OF NORTH CAROLINA, INC. 4038 Masonboro Loop Road Wilmington, NC 28409 PH (910) 399-1905		
Date: 1/2/2023	By: FMM	Page 16 of 23

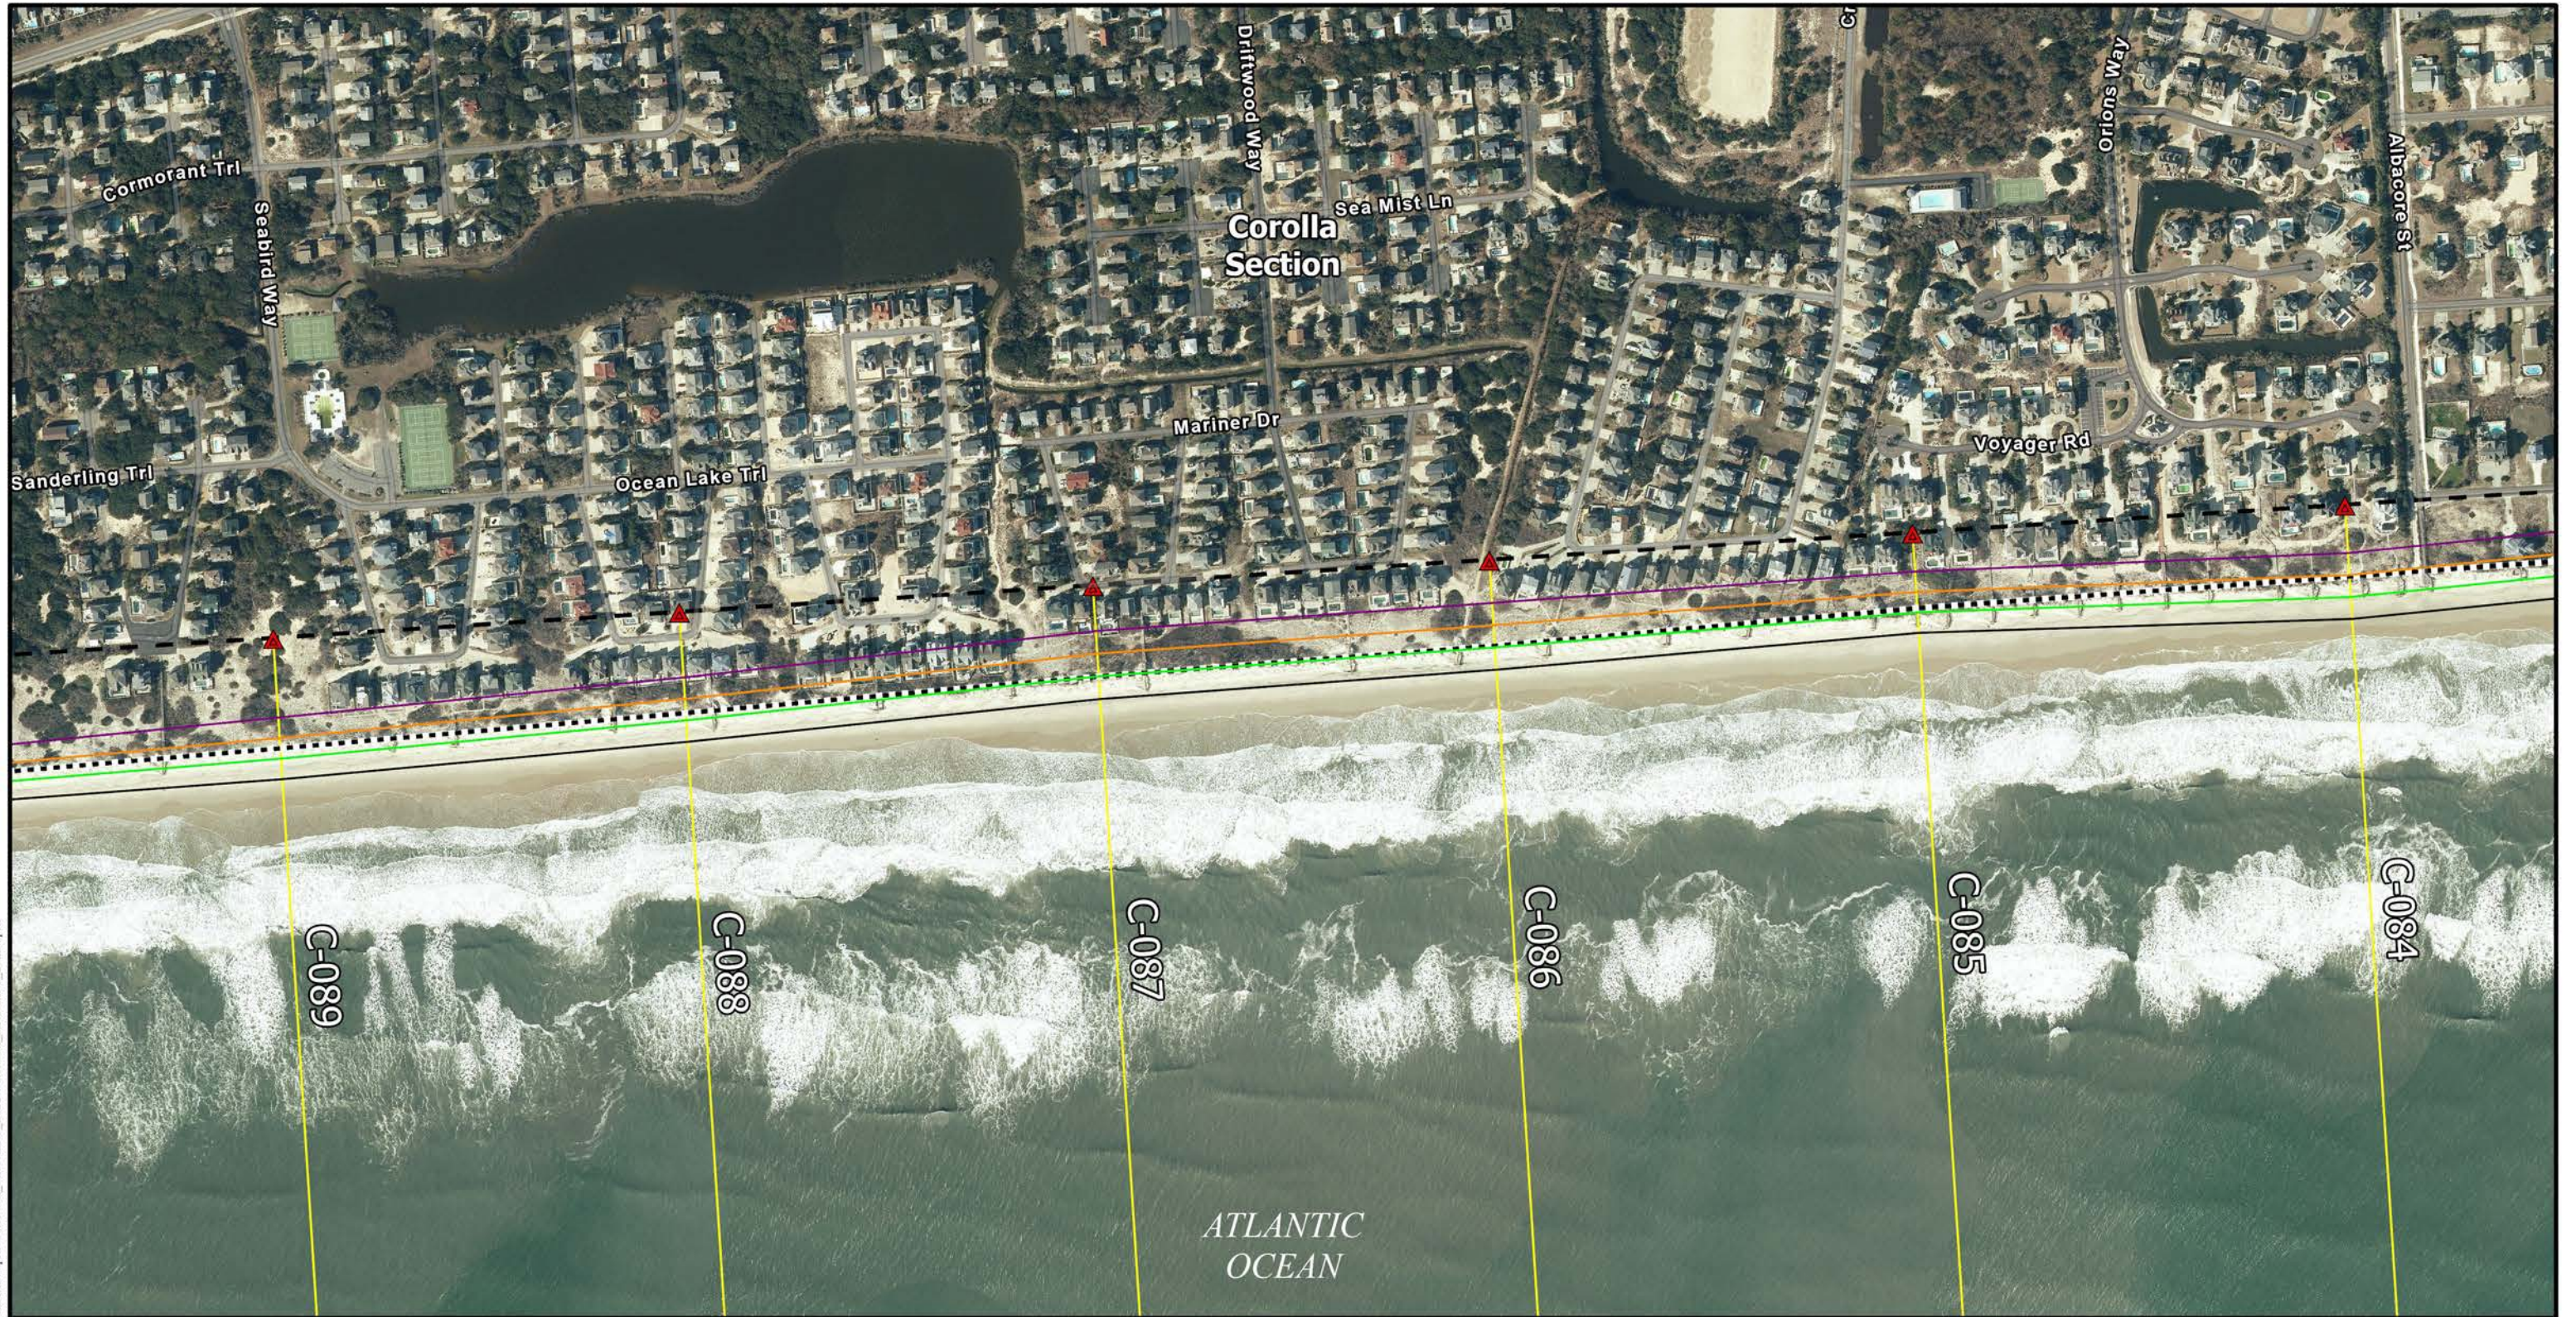
Date: 1/2/2023 By: FMM Page 17 of 23

**TITLE** Impact Line and Projected Shoreline Maps  
2022 Beach Monitoring and Stability Assessment  
Currituck County, NC

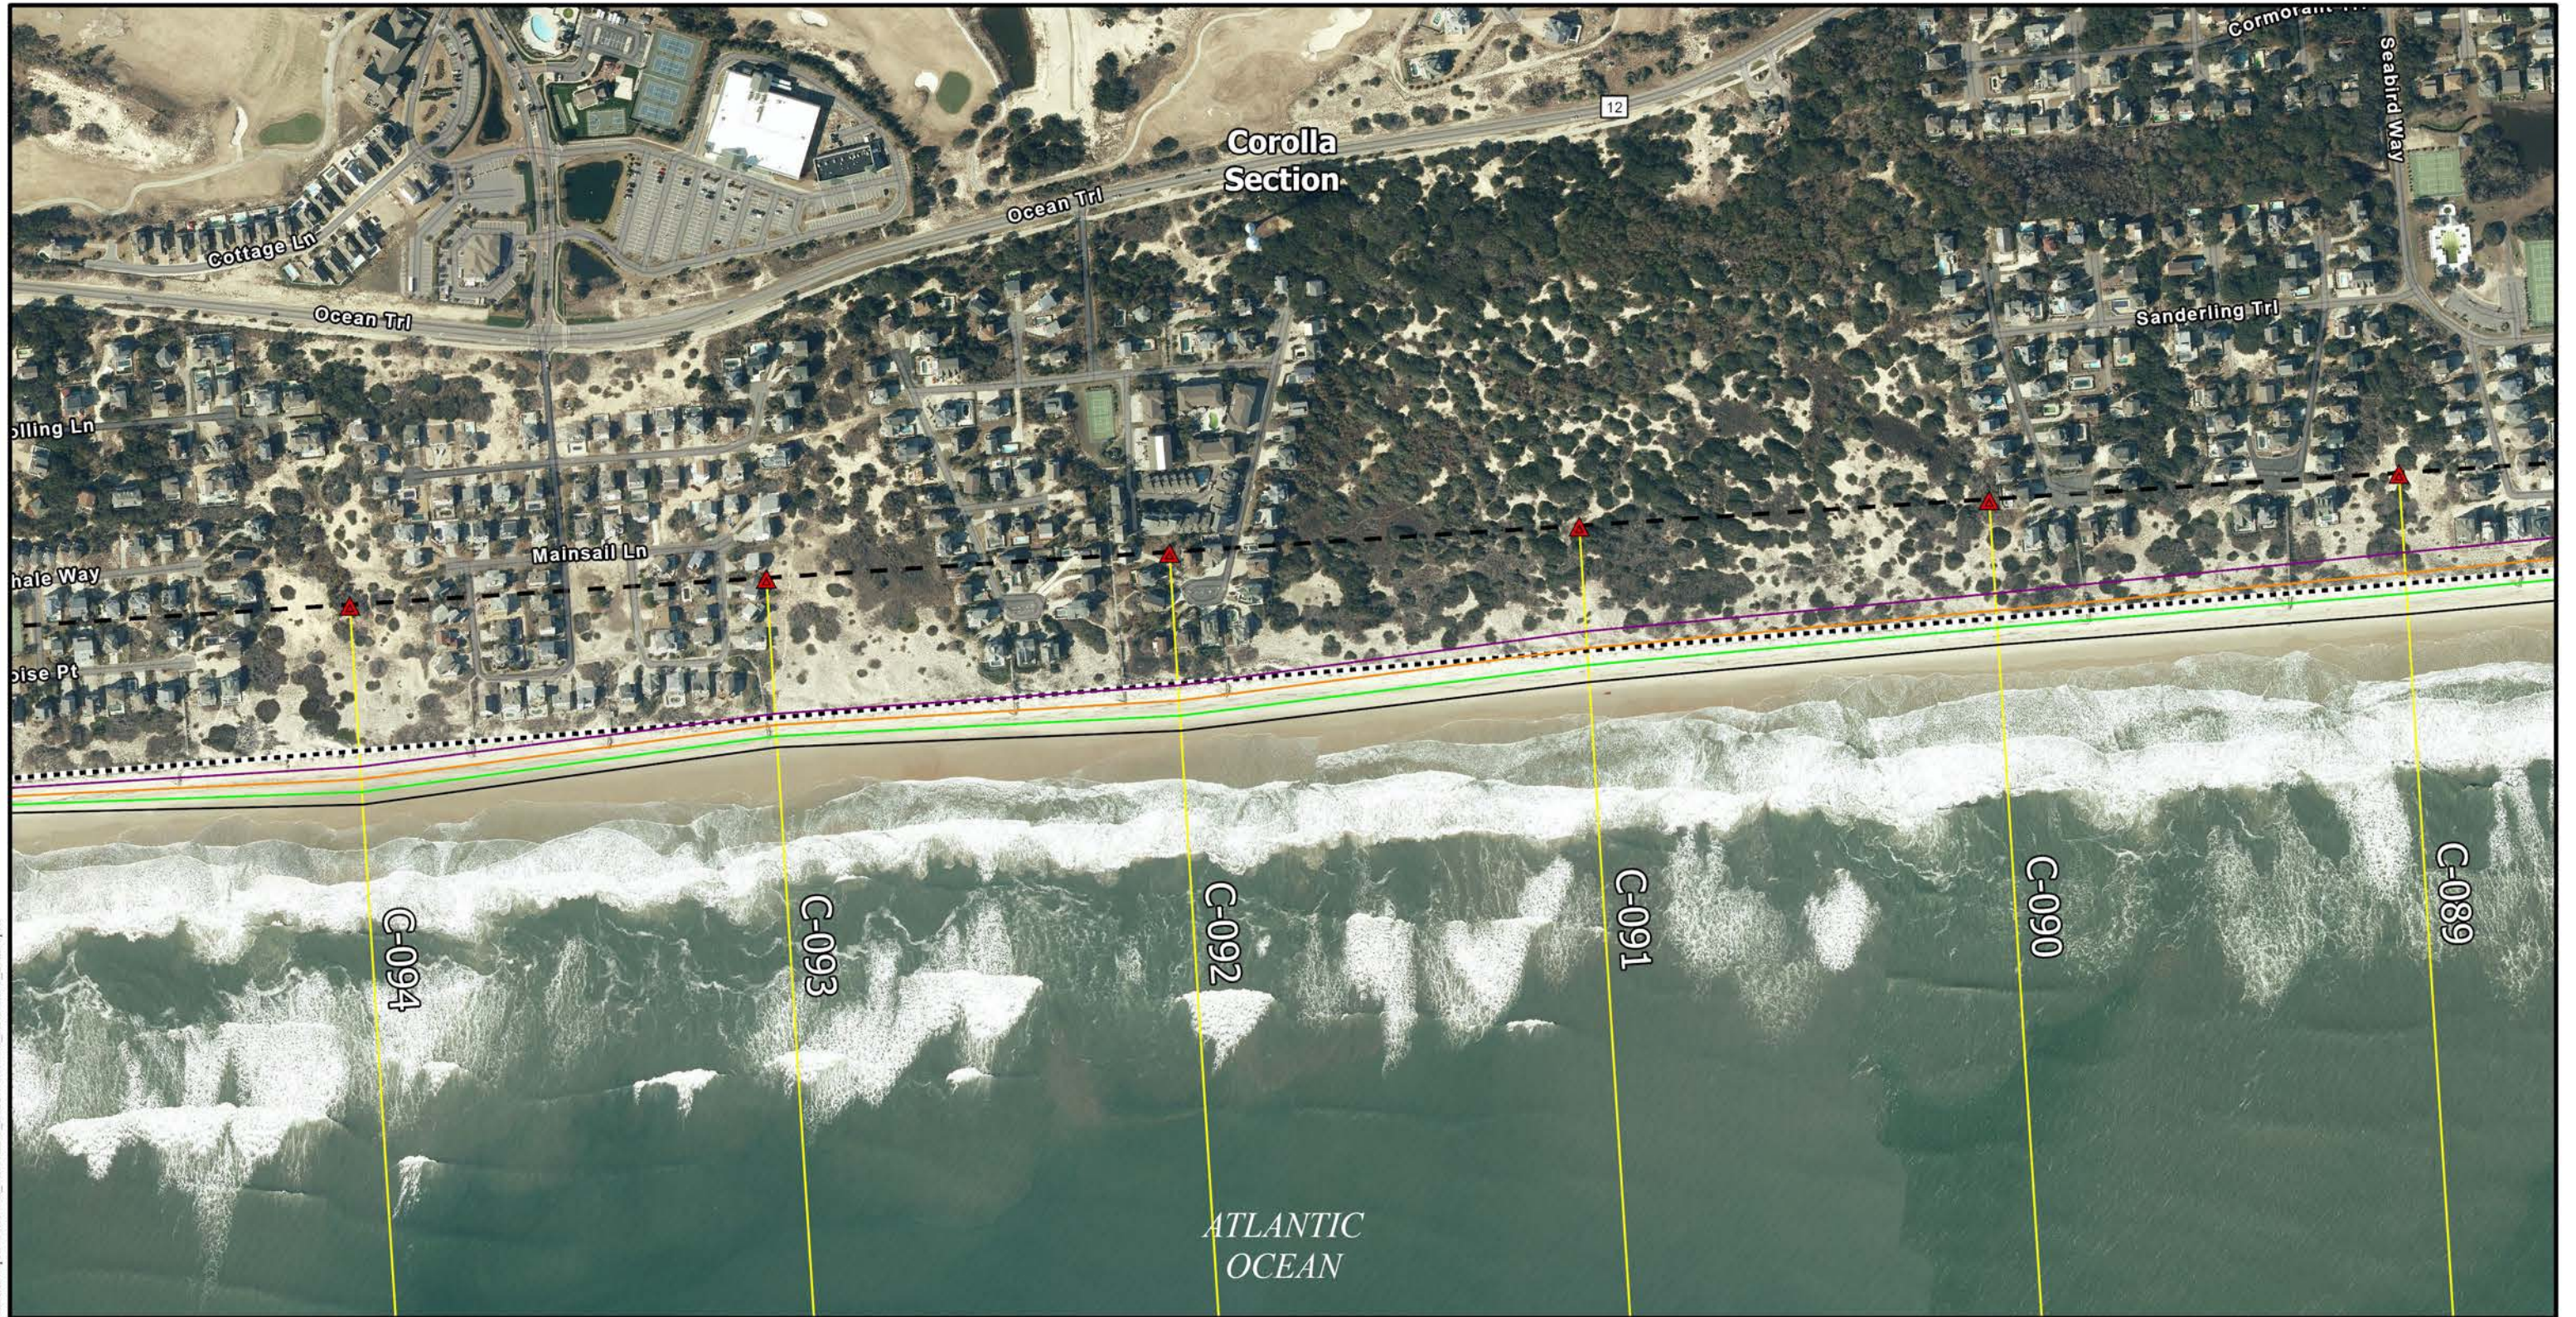
<b>TITLE</b>		
Impact Line and Projected Shoreline Maps 2022 Beach Monitoring and Stability Assessment Currituck County, NC		
COASTAL PROTECTION ENGINEERING OF NORTH CAROLINA, INC. 4038 Masonboro Loop Road Wilmington, NC 28409 PH (910) 399-1905		
Date: 1/2/2023	By: FMM	Page 18 of 23
