<b>TITLE</b>		
Impact Line and Projected Shoreline Maps 2022 Beach Monitoring and Stability Assessment Currituck County, NC		
COASTAL PROTECTION ENGINEERING OF NORTH CAROLINA, INC. 4038 Masonboro Loop Road Wilmington, NC 28409 PH (910) 399-1905		
Date: 1/2/2023	By: FMM	Page 1 of 23

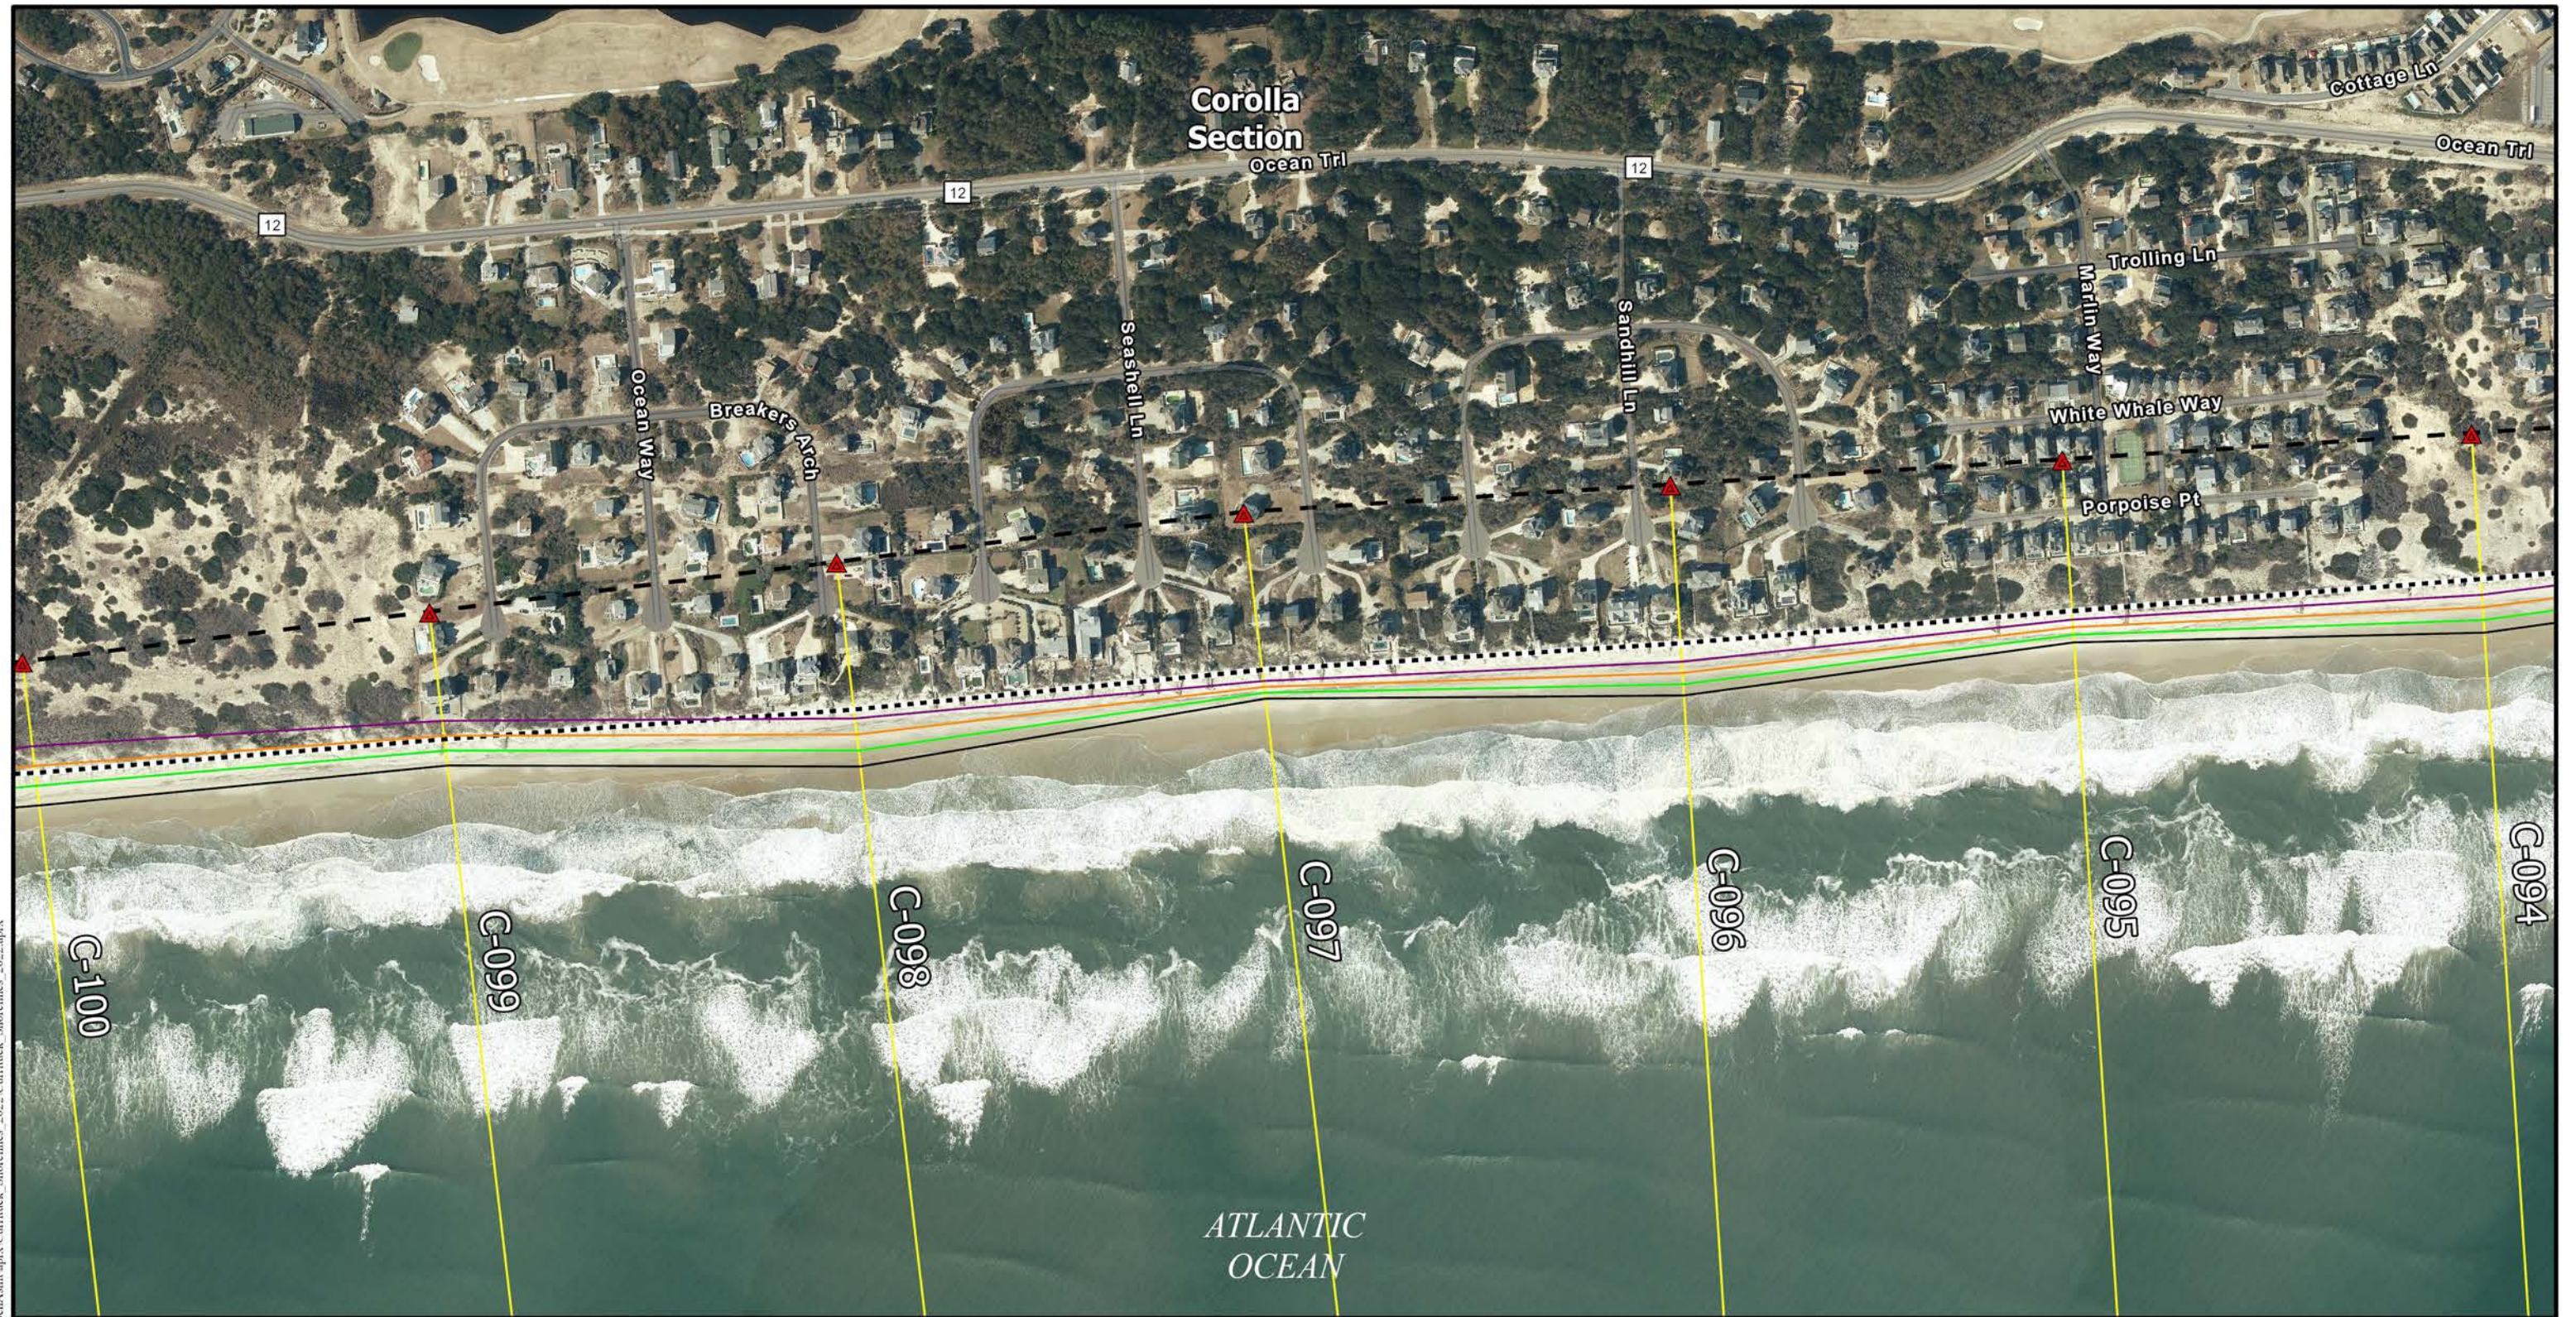
<b>TITLE</b>		
Impact Line and Projected Shoreline Maps 2022 Beach Monitoring and Stability Assessment Currituck County, NC		
COASTAL PROTECTION ENGINEERING OF NORTH CAROLINA, INC. 4038 Masonboro Loop Road Wilmington, NC 28409 PH (910) 399-1905		
Date: 1/2/2023	By: FMM	Page 19 of 23

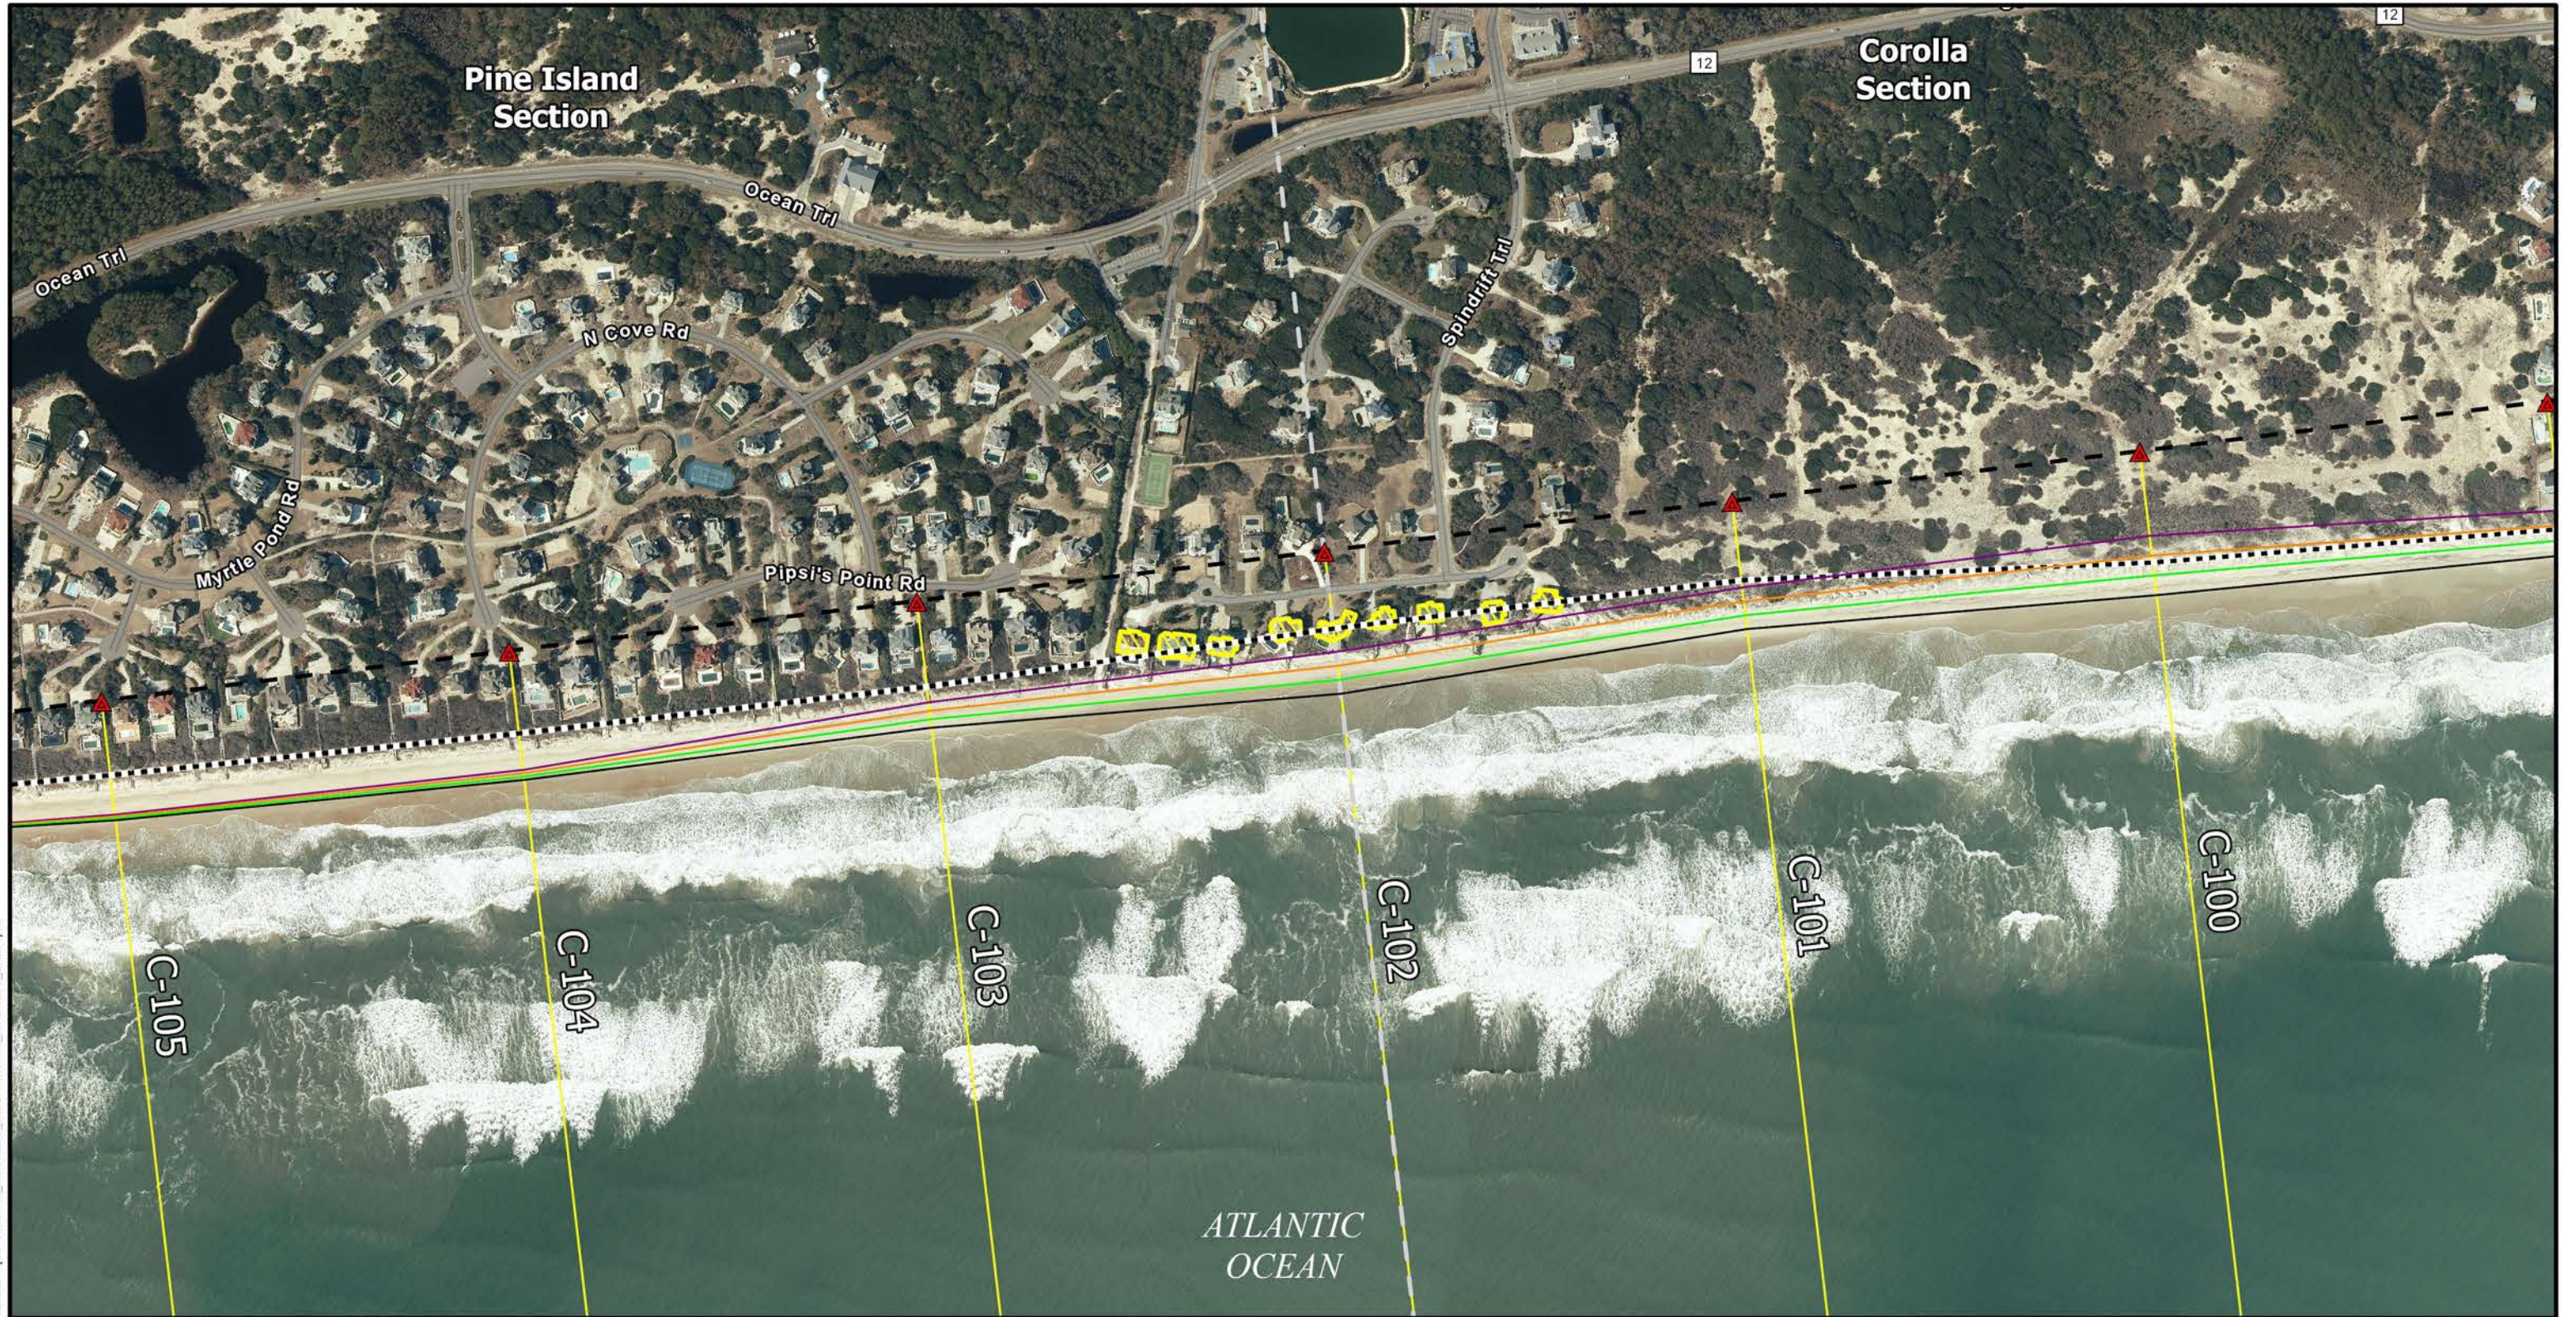
Date: 1/2/2023 By: FMM Page 20 of 23

**TITLE** Impact Line and Projected Shoreline Maps  
2022 Beach Monitoring and Stability Assessment  
Currituck County, NC

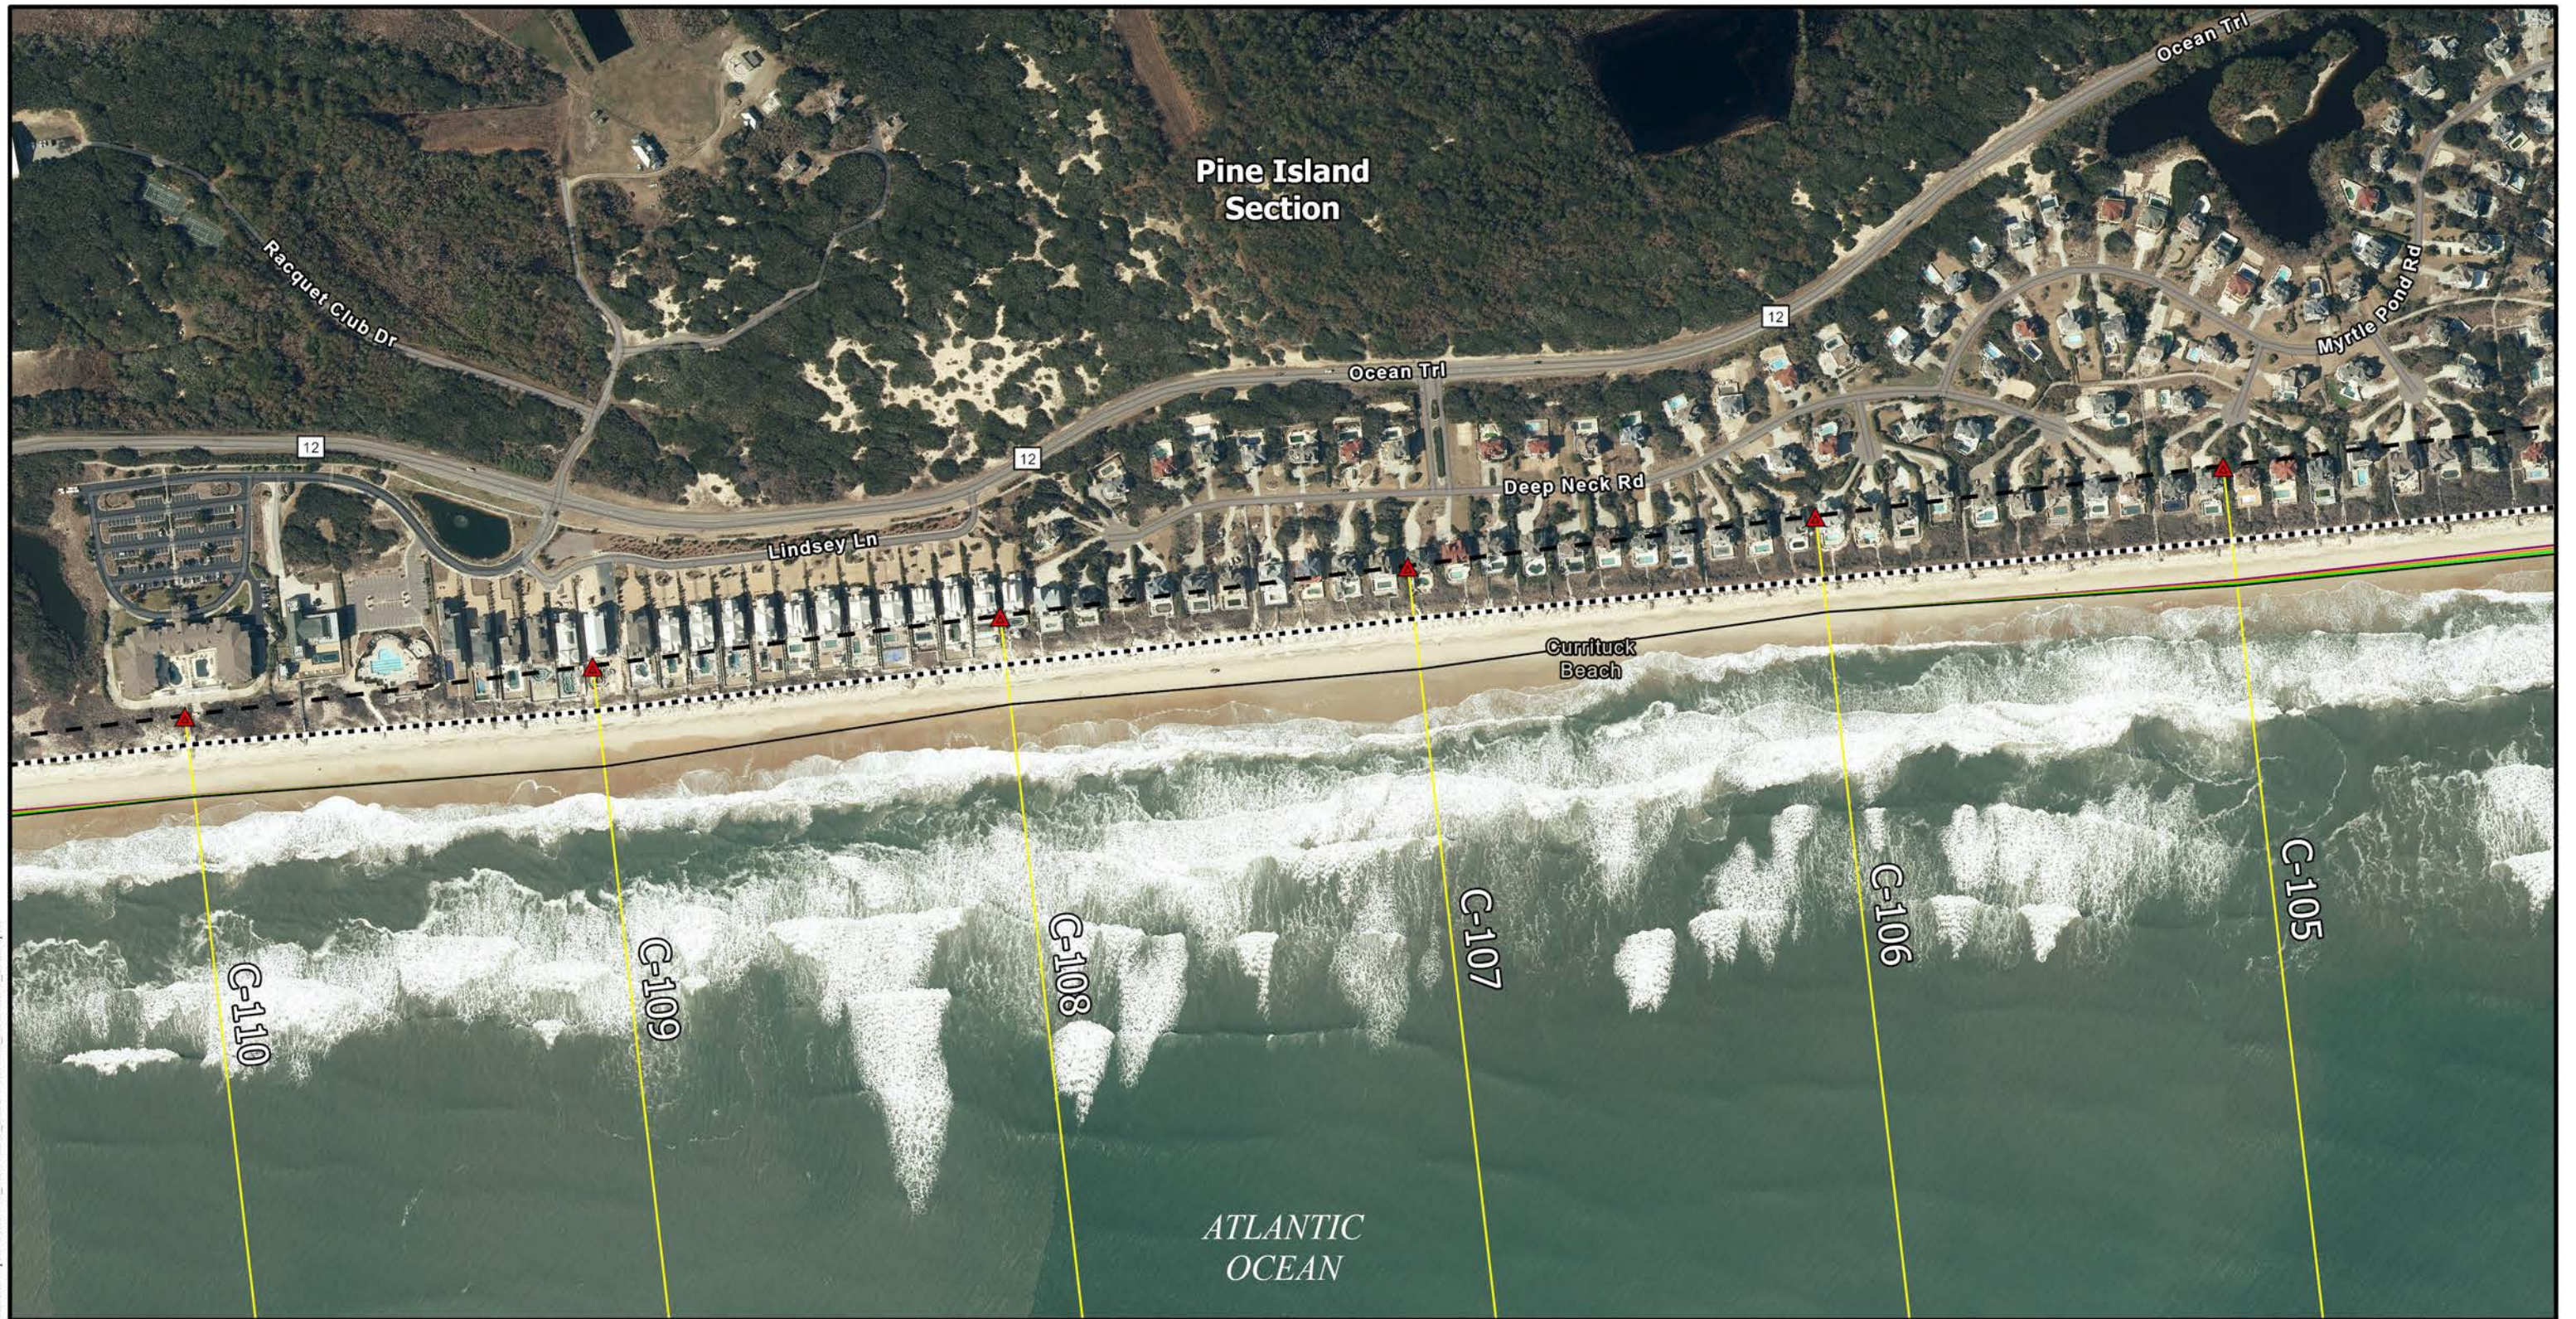
<b>TITLE</b>		
Impact Line and Projected Shoreline Maps 2022 Beach Monitoring and Stability Assessment Currituck County, NC		
COASTAL PROTECTION ENGINEERING OF NORTH CAROLINA, INC. 4038 Masonboro Loop Road Wilmington, NC 28409 PH (910) 399-1905		
Date: 1/2/2023	By: FMM	Page 21 of 23

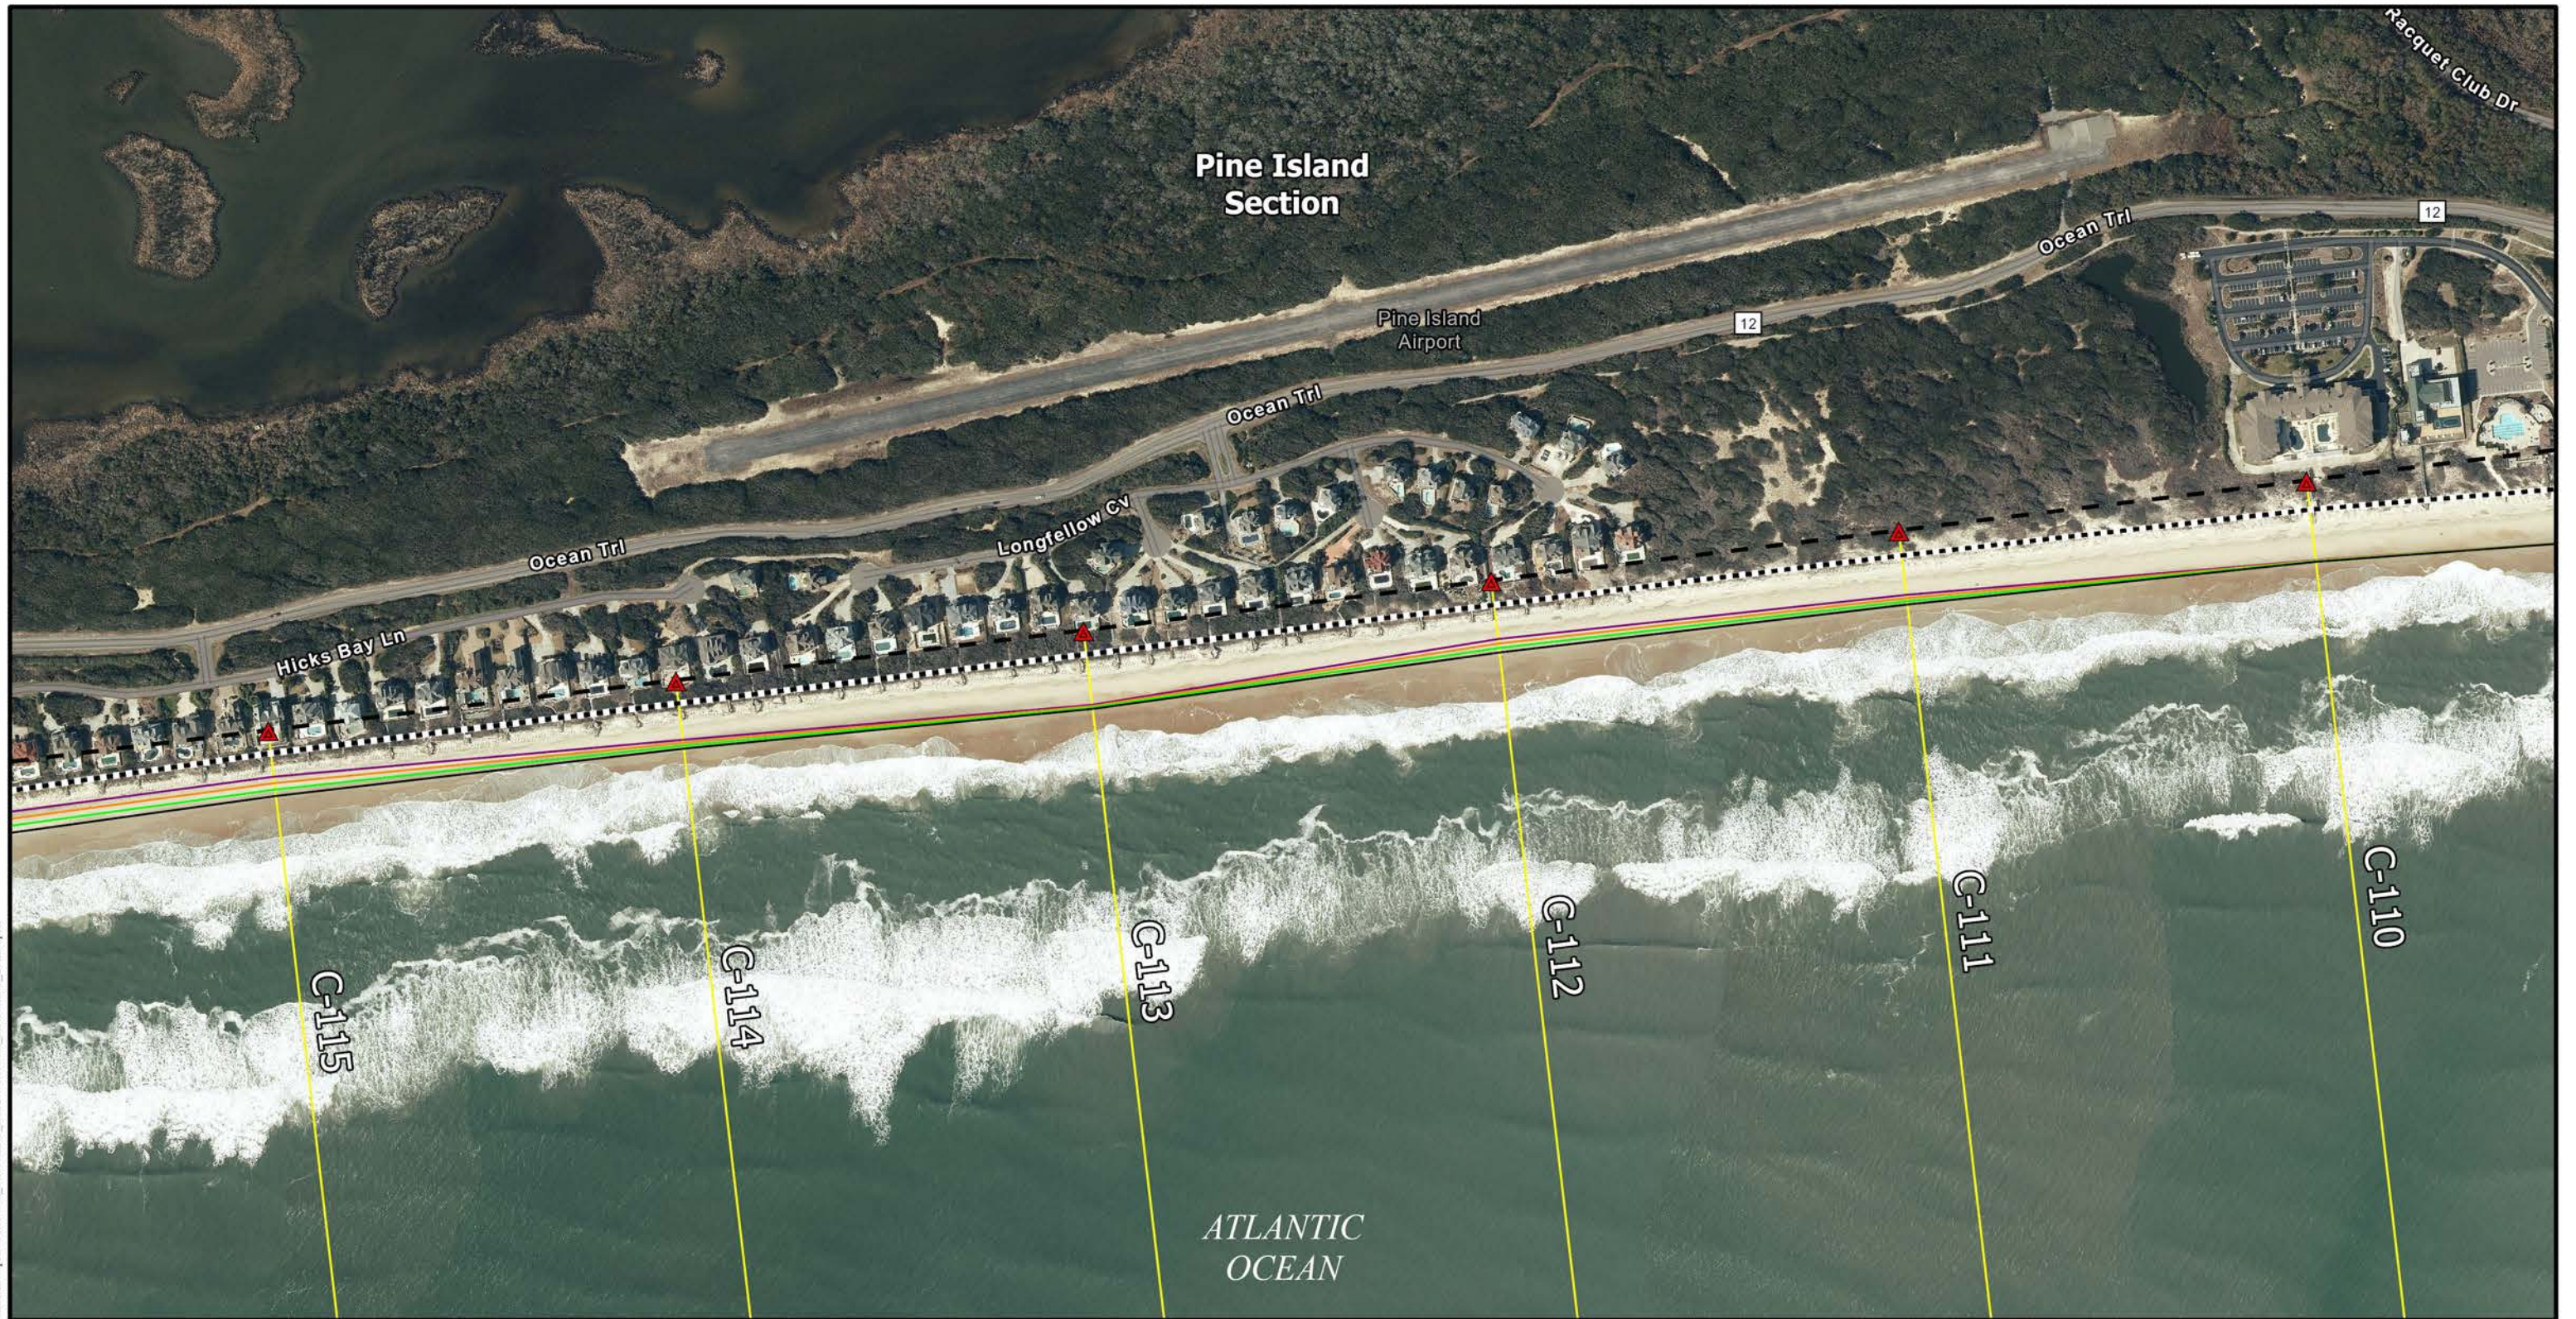
<b>TITLE</b>		
Impact Line and Projected Shoreline Maps 2022 Beach Monitoring and Stability Assessment Currituck County, NC		
COASTAL PROTECTION ENGINEERING OF NORTH CAROLINA, INC.		
4038 Masonboro Loop Road Wilmington, NC 28409 PH (910) 399-1905		
Date: 1/2/2023	By: FMM	Page 22 of 23

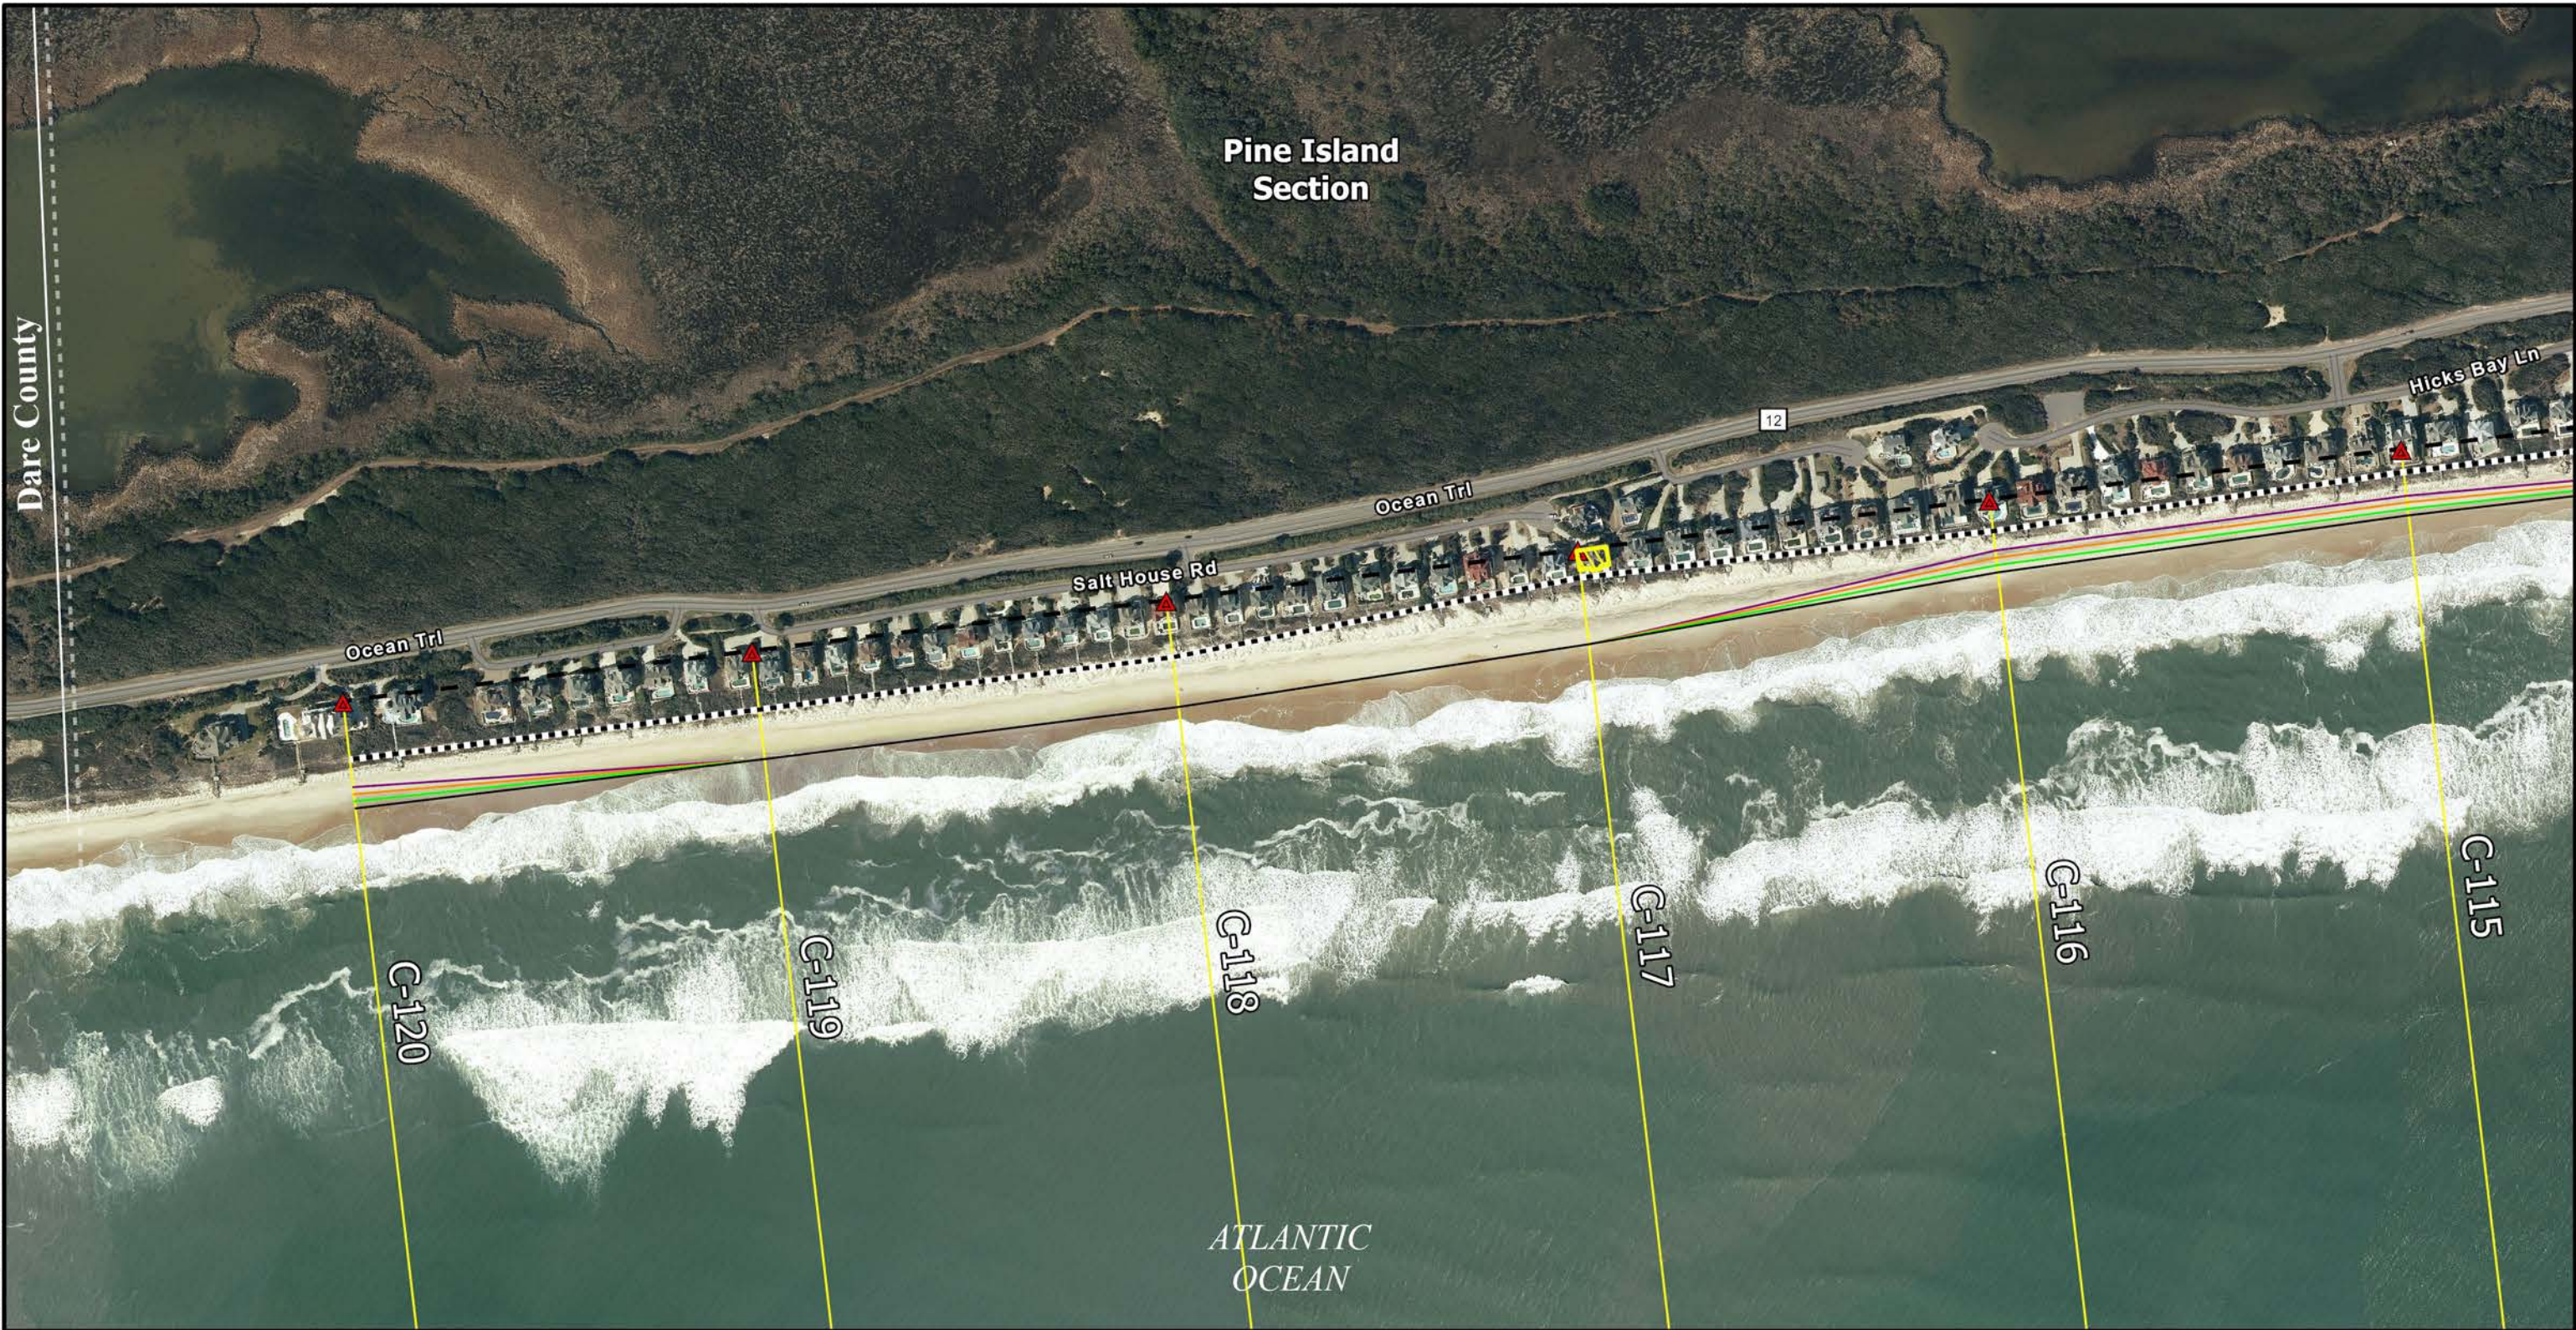
<b>TITLE</b>		
Impact Line and Projected Shoreline Maps 2022 Beach Monitoring and Stability Assessment Currituck County, NC		
COASTAL PROTECTION ENGINEERING OF NORTH CAROLINA, INC. 4038 Masonboro Loop Road Wilmington, NC 28409 PH (910) 399-1905		
Date: 1/2/2023	By: FMM	Page 23 of 23
