DATE: 3/20/20 SCALE: AS SHOWN
CHECKED: CFG DRAWN: JCB/MMH
PROJECT NO: P722.20
CAD FILE: P722 SP1
SHEET: 2 of 3

CAROVA BEACH PARK BULKHEAD REPAIR
FOR: CURRITUCK COUNTY
FRUITVILLE BEACH TOWNSHIP CURRITUCK COUNTY NORTH CAROLINA
DEMOLITION PLAN

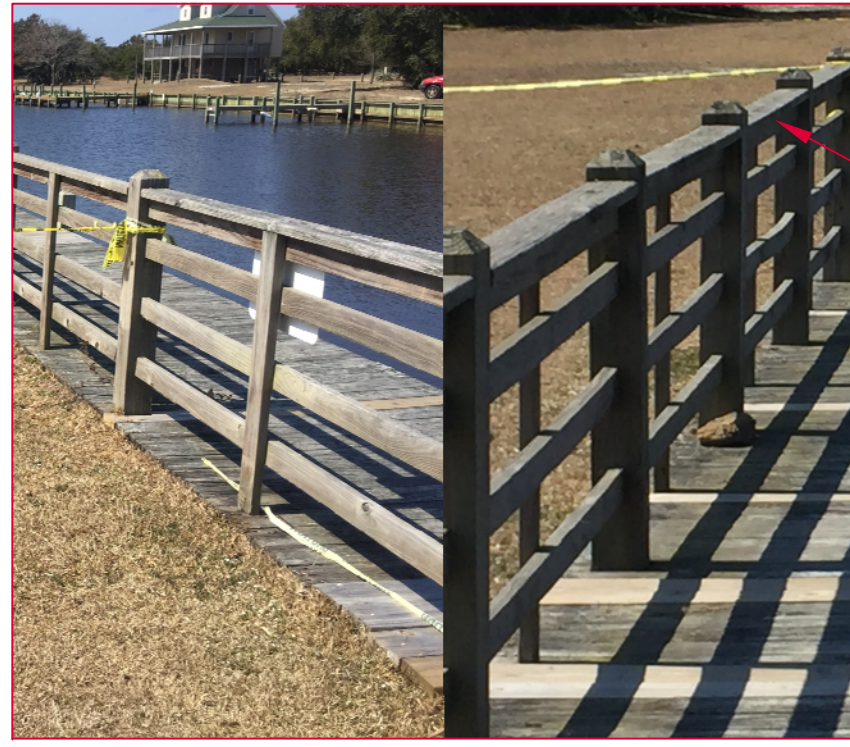
EXISTING FENCE BARRIER WITH TOP RAIL
